Model: Katana		Date:14-Jul-06	No.: RB234015
Subject: Service Manual Revision		Prepared by: S. Ishizu	
From: 2nd Tech Support Sec. Service Support Dept.			
Classification:	<input type="checkbox"/> Troubleshooting <input type="checkbox"/> Mechanical <input type="checkbox"/> Paper path <input type="checkbox"/> Product Safety	<input type="checkbox"/> Part information <input type="checkbox"/> Electrical <input type="checkbox"/> Transmit/receive <input type="checkbox"/> Other ()	<input type="checkbox"/> Action required <input checked="" type="checkbox"/> Service manual revision <input type="checkbox"/> Retrofit information

This document summarizes the corrections in the Service Manual for “Katana” (Machine Code: B234/235/236).

Model: Katana-C1 LCIT RT5010 (B834)		Date: 18-Nov-10	No.: RB834001
Subject: Improvement of the bracket for postcards		Prepared by: T. Komori	
From: PP Service Planning Department 1G			
Classification:	<input type="checkbox"/> Troubleshooting	<input checked="" type="checkbox"/> Part information	<input type="checkbox"/> Action required
	<input type="checkbox"/> Mechanical	<input type="checkbox"/> Electrical	<input type="checkbox"/> Service manual revision
	<input t

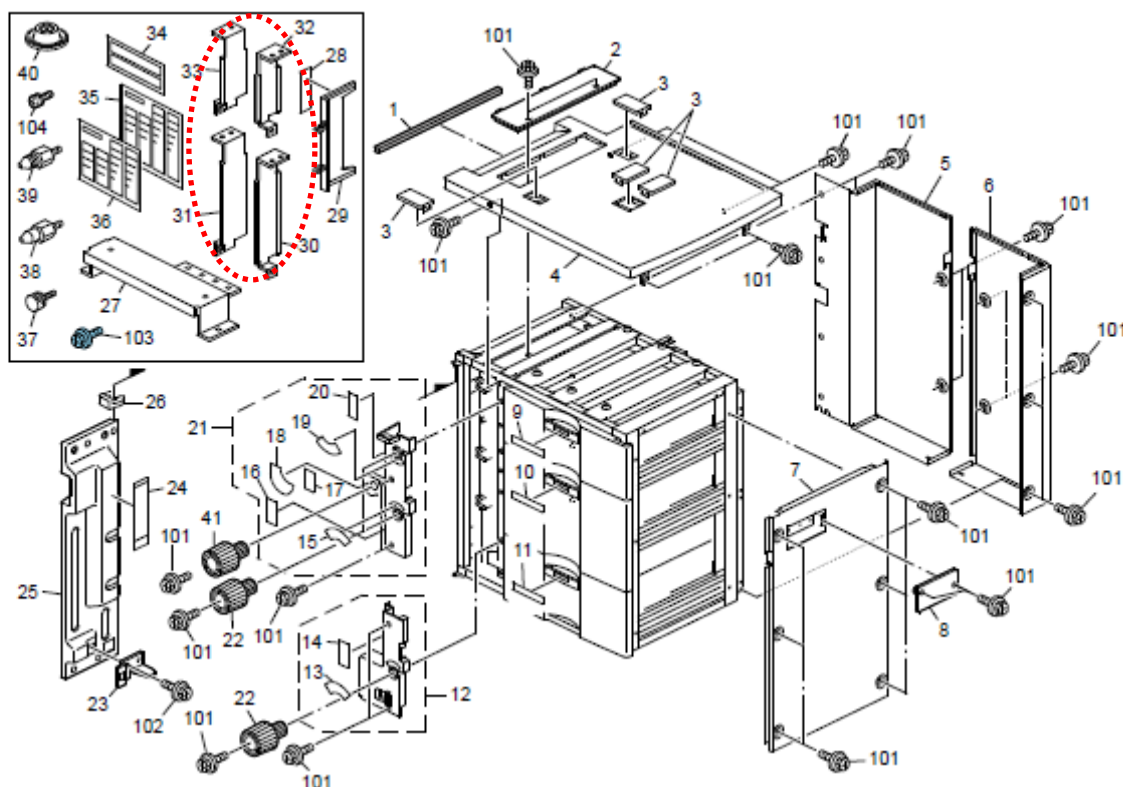
1.EXTERIOR (B834)

Change: Shape of the postcard fence

Old Part Number	New Part Number	Description	Q'ty	Int	Page	Index	Note
B8342713	B8342717	BRACKET:POSTCARD:NO.1: REAR:ADHESION	1	O/O	as a set	3	33
B8342711	B8342719	BRACKET:POSTCARD:NO.2: REAR:ADHESION	1	O/O		3	31

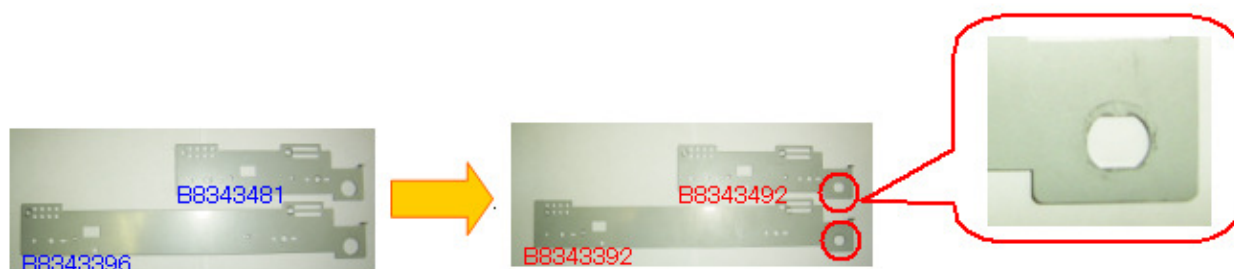
2, The size of the holes on the plates were reduced to correspond with the modified bearings.

Old Part Number	New Part Number	Description	Q'ty	Int	Page	Index	Note
07423808	D5161537	PLAIN SHAFT BEARING:DIA8	4	X/O	4 18	107 105	
B8343395	B8343391	PLATE:LEFT:NO.2	1	X/O	18	3	
B8343396	B8343392	PLATE:RIGHT:NO.2	1	X/O	18	11	
B8343480	B8343491	PLATE:LEFT:NO.1	1	X/O	4	4	
B8343481	B8343492	PLATE:RIGHT:NO.1	1	X/O	4	10

- Make sure all 5 parts shown in the above table are replaced as a set.
- The modification described in this bulletin also applies to RT5010 (B834).
