Model: LCIT RT5040 (D453)		Date: 21-Aug-09	No.: RD453001
Subject: Service Manual Correction: CIS Image Position Adjustment		Prepared by: M. Abe	
From: PPMC Service Planning Department 1G			
Classification:	<input type="checkbox"/> Troubleshooting <input type="checkbox"/> Mechanical <input type="checkbox"/> Paper path <input type="checkbox"/> Product Safety	<input type="checkbox"/> Part information <input type="checkbox"/> Electrical <input type="checkbox"/> Transmit/receive <input type="checkbox"/> Other (     )	<input type="checkbox"/> Action required <input checked="" type="checkbox"/> Service manual revision <input type="checkbox"/> Retrofit information <input type="checkbox"/> Tier2

Model: LCIT RT5040 (D453)		Date: 14-Dec-2010	No.: RD453002
Subject: New P/N for Tray Indication Decals		Prepared by: K. Tsutsui	
From: PP Service Planning Department 1G			
Classification:	<input type="checkbox"/> Troubleshooting <input type="checkbox"/> Mechanical <input type="checkbox"/> Paper path <input type="checkbox"/> Product Safety	<input checked="" type="checkbox"/> Part information <input type="checkbox"/> Electrical <input type="checkbox"/> Transmit/receive <input type="checkbox"/> Other

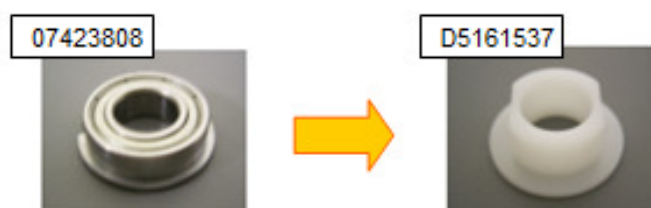
1, The bearing was changed as shown in the photo below.

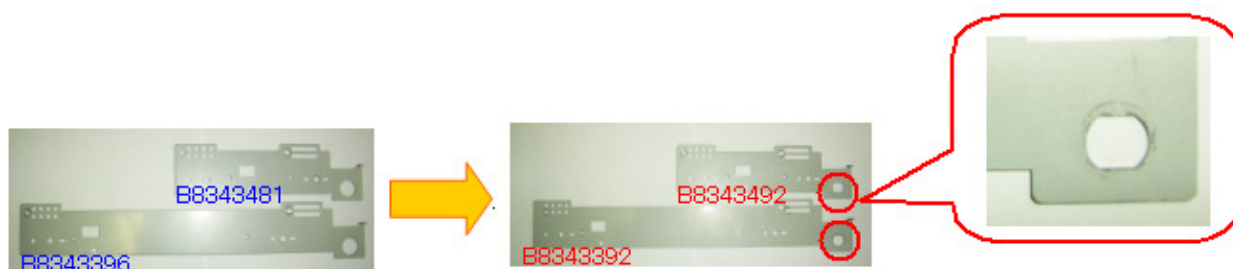
2, The size of the holes on the plates were reduced to correspond with the modified bearings.

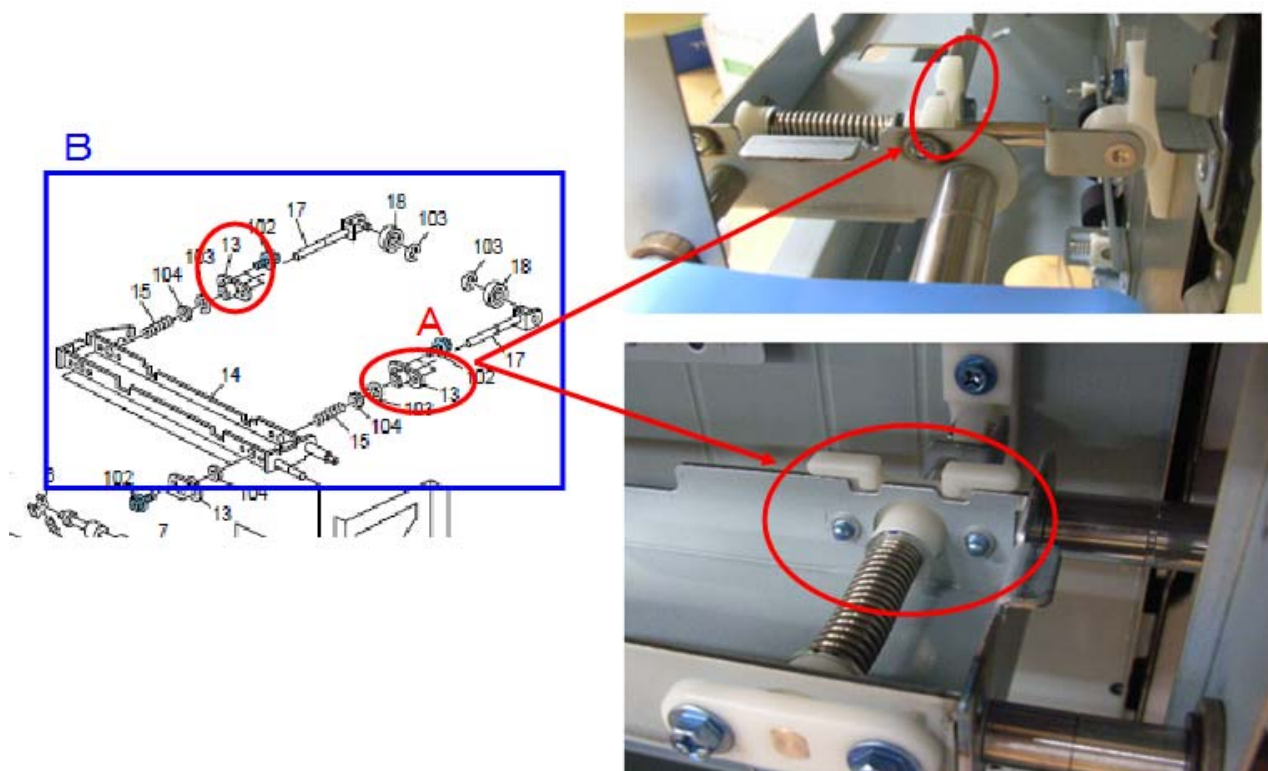
A : Shoe: Handle: Release

Shape of the Shoe was partially modified.

B : Handle: Ass'y

Handle was also modified in accordance with the shape change of the Shoe.  
(Shape of the plate was also modified.)

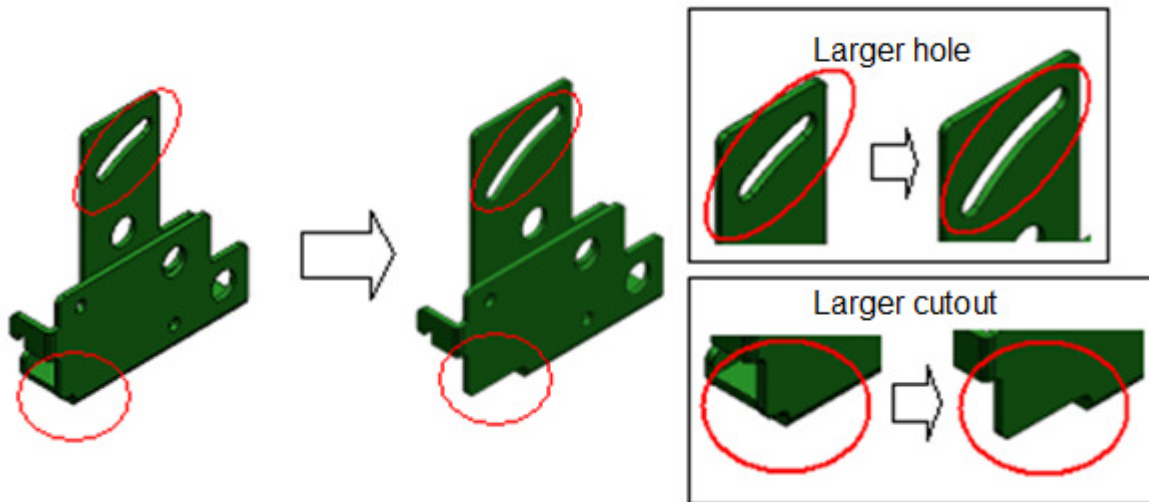
***Modification: Tension Bracket***

Modification 2 – Shapes of the tension brackets

**Reason:** To prevent slippage of the pulley which could occur due to the lack of tension applied to the tension springs installed in Tray 4 and Tray 6

**NOTE:** When replacing the above parts, replace as a set.

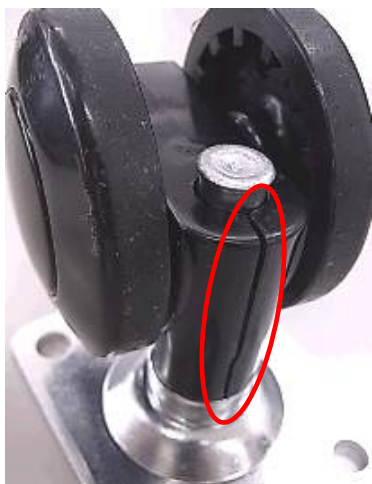
Broken caster on the following LCITs:

RT4000 (D350), RT5040 (D453), RT5060 (D516), RT5030 (D452)

One lot of casters was manufactured with an incorrect molding process, resulting in lower durability.

Among 118 affected casters, 2.8% (= approx 3 pcs) may break according to factory test results.

Replace the caster (p/n: AH012050) when a unit with a broken caster is found.  
See the following page for the replacement procedure.
