Model: LCIT RT5070		Date: 25-Jun-15	No.: RD733001
Subject: New LCT side fence for higher safety		Prepared by: J. Ohno	
From: 1st Tech Service Sect., PP Tech Service Dept.			
Classification:	<input type="checkbox"/> Troubleshooting <input type="checkbox"/> Mechanical <input type="checkbox"/> Paper path <input type="checkbox"/> Product Safety	<input checked="" type="checkbox"/> Part information <input type="checkbox"/> Electrical <input type="checkbox"/> Transmit/receive <input type="checkbox"/> Other ()	<input type="checkbox"/> Action required <input type="checkbox"/> Service manual revision <input type="checkbox"/> Retrofit information <input type="checkbox"/> Tier2

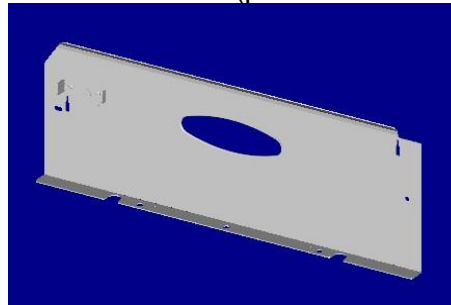
New side fence (p/n: D7332833)

The sharp top rear corner of the side fence of the LCT was rounded off for higher safety.

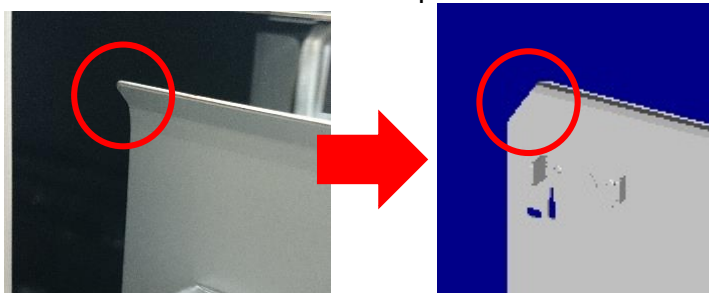
Modification point

To prevent injuries in case operators forcefully stick in their hands to remove jams
