Model: Leo-C1a/C1b (D194/D195)	Date: 23-Feb-15	No.: RD777001b
--------------------------------	-----------------	----------------

Subject: Adjustments in Vacuum Feed LCIT to prevent no-feed and double-feed jams		Prepared by: Shinnosuke Sasaki	
From: 1st PP Tech Service Sec., PP Tech Service Dept.,			
Classification:	<input checked="" type="checkbox"/> Troubleshooting <input type="checkbox"/> Mechanical <input type="checkbox"/> Paper path <input type="checkbox"/> Product Safety	<input type="checkbox"/> Part information <input type="checkbox"/> Electrical <input type="checkbox"/> Transmit/receive <input type="checkbox"/> Other (     )	<input type="checkbox"/> Action required <input type="checkbox"/> Service manual revision <input type="checkbox"/> Retrofit information <input type="checkbox"/> Tier 2

Model: Vacuum Feed LCIT RT5100		Date: 29-Jul-15	No.: RD077002
Subject: Part Catalog Correction Vacuum Feed LCIT RT5100 – Joint bracket		Prepared by: Takezoh Miyamoto	
From: 1st PP Tech Service Sec., PP Tech Service Dept.,			
Classification:	<input type="checkbox"/> Troubleshooting <input type="checkbox"/> Mechanical <input type="checkbox"/> Paper path <input type="checkbox"/> Product Sa

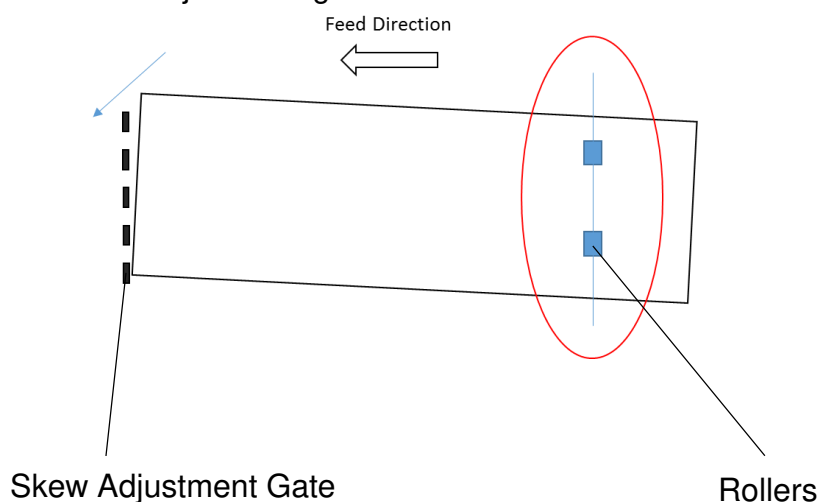
## CAUSE

The skew of the banner sheet cannot be corrected efficiently with the skew adjustment gate, because the trailing edge of the banner sheet is still held by rollers when the leading edge reaches the adjustment gate.

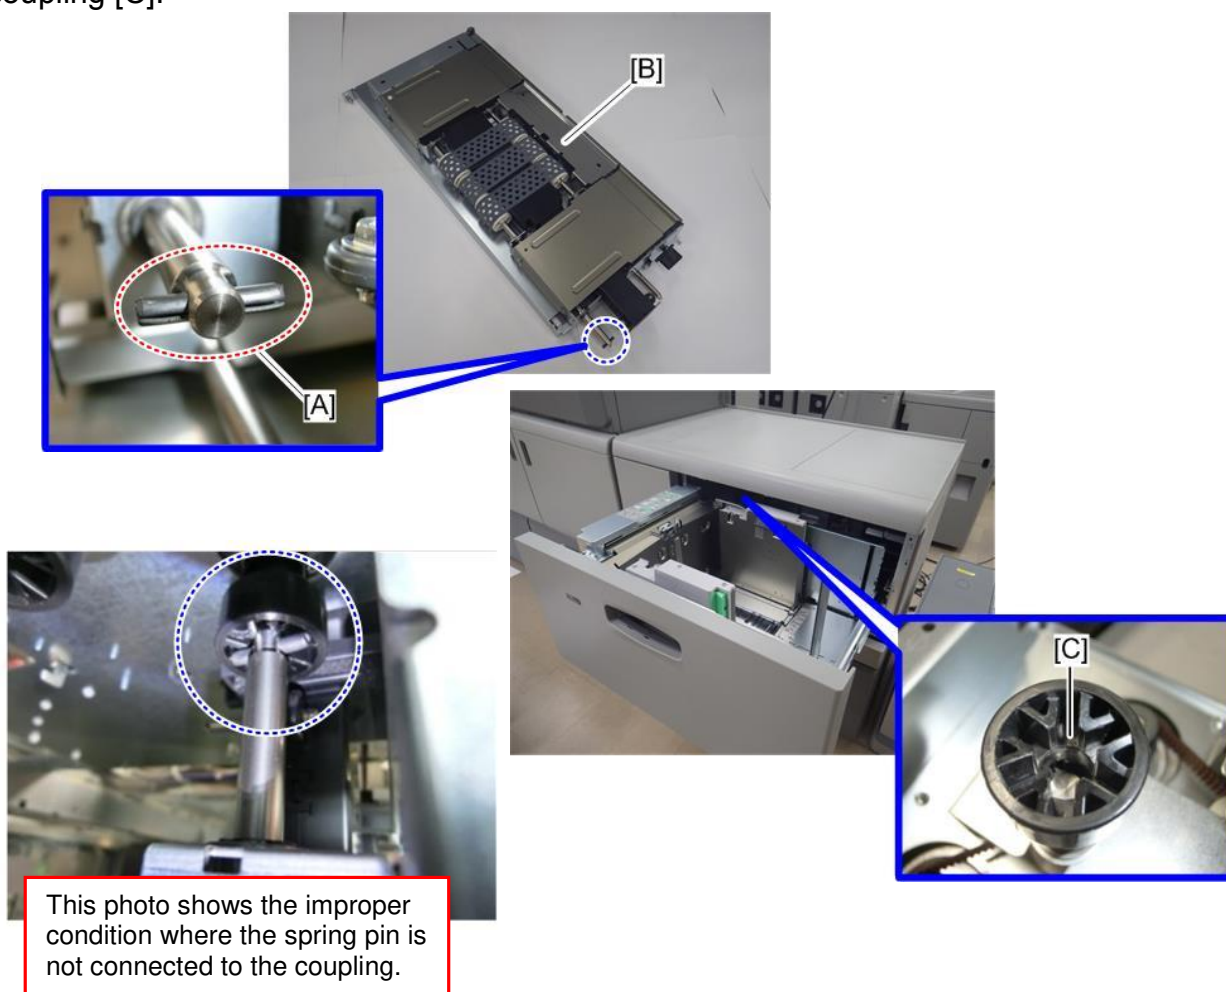
Paper cannot be fed, because the spring pin [A] located at the rear side of the paper feed belt unit [B] (of the main machine or Vacuum Feed LCIT RT5100) is not connected to the coupling [C].

Connect the spring pin to the coupling with the following procedure. The procedure is the same for the paper feed belt unit of the main machine and of the Vacuum Feed LCIT RT5100, and can be performed either when the main power switch is turned ON or OFF.

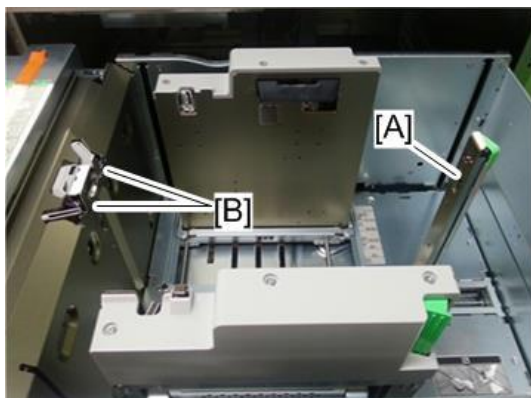
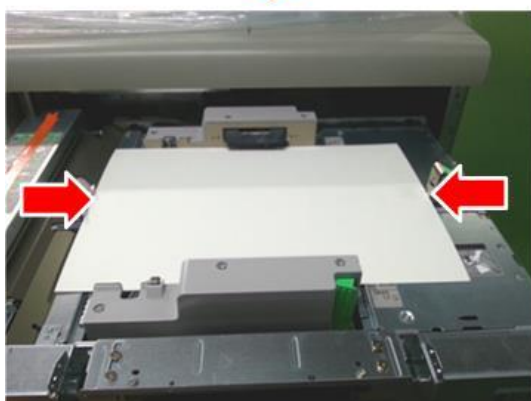
The above type of paper tends to get caught between the spring [A] of the end fence and the paper stopper plates [B], and does not float up.

Attach the magnet sheet to the end fence.

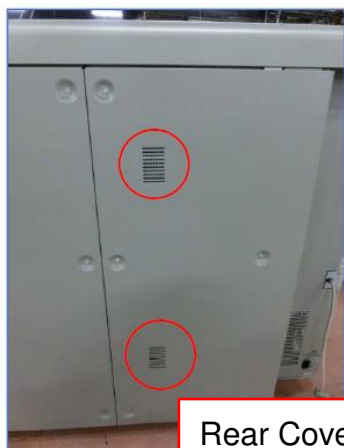
Rear Cover

The exhaust fan filter becomes clogged with paper dust.

Replace the filter with the new type (see **PROCEDURE** below).

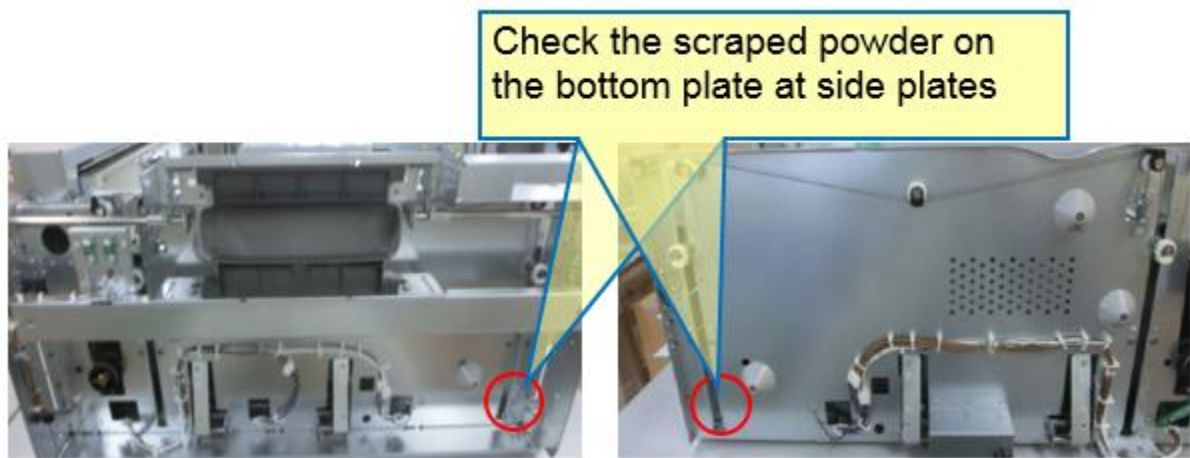
**Fig. 5**

- 1) Presence of scraped powder generated by bottom plate sliding

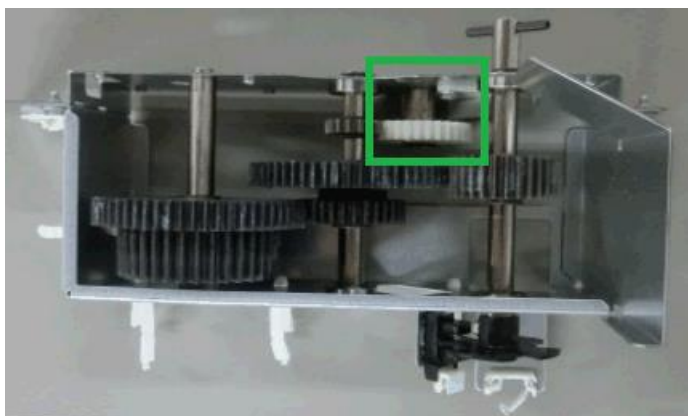
A tray loaded with A3/DLT or larger paper causes the shaft of the tray lift-up gear to slant over time due to the heavy load, preventing proper engagement of the gears.
