Model: B-C4	Date: 04-Mar-09	No.: RD447001a
-------------	-----------------	----------------

Subject: Firmware Release Note: Stacker_LOIRE1		Prepared by: T. Tadokoro	
From: PPBG QA/Service Planning Dept.			
Classification:	<input type="checkbox"/> Troubleshooting <input type="checkbox"/> Mechanical <input type="checkbox"/> Paper path <input type="checkbox"/> Product Safety	<input type="checkbox"/> Part information <input type="checkbox"/> Electrical <input type="checkbox"/> Transmit/receive <input checked="" type="checkbox"/> Other ()	<input type="checkbox"/> Action required <input type="checkbox"/> Service manual revision <input type="checkbox"/> Retrofit information <input type="checkbox"/> Tier 2

Model: High Capacity Stacker SK5010		Date: 04-Des-09	No.: RD447003
Subject: Request for Replacement of Parts Containing RoHS Restricted Substances		Prepared by: K. Tsutsui	
From: PP Service Planning Department 1G			
Classification:	<input type="checkbox"/> Troubleshooting <input type="checkbox"/> Mechanical <input type="checkbox"/> Paper path <input type="checkbox"/> Product Safety	<input type="checkbox"/> Part information <input type="checkbox"/> Electrical <input type="checkbox"/> Tr

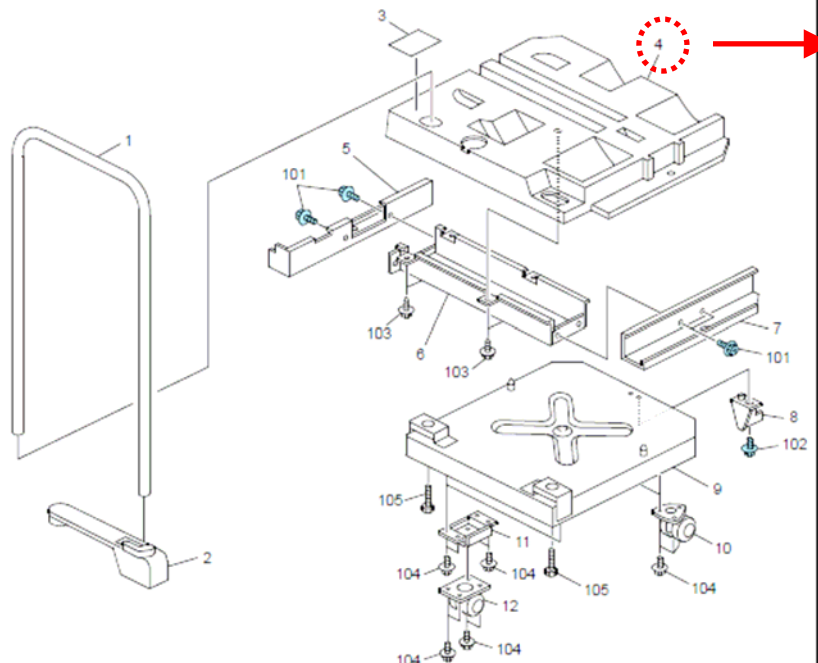
15.Paper Cart Section (D447)

Static electricity could cause the first sheet to stick to the shift tray of the Stacker (indexed 4 in the diagram below) and the succeeding sheets to curl up. Three mylars have been added to discharge static electricity for better stacking.

Mylar (black)

- Wipe the area with alcohol before attaching the mylar.
- Work carefully to avoid air bubbles. If air bubbles cannot be avoided, the only areas permissible are the two areas indicated in pink in the diagram below.
- Align the corners "A", "B", and "C" so that the edges are positioned within 2mm from the grooves.
- The curved areas "D" should be double-checked. Rub the mylars thoroughly for firm attachment.
- Wipe the surface of the mylars with alcohol to complete the procedure. (Make sure alcohol does not leak in between the mylar and the tray.)

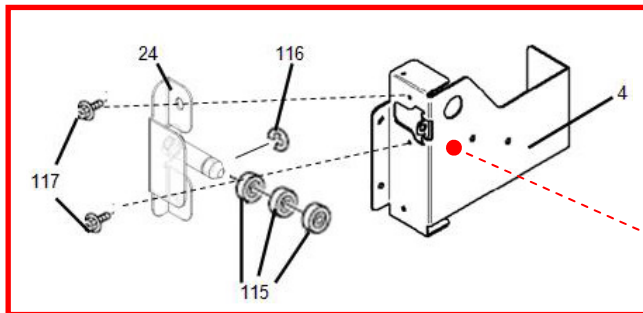
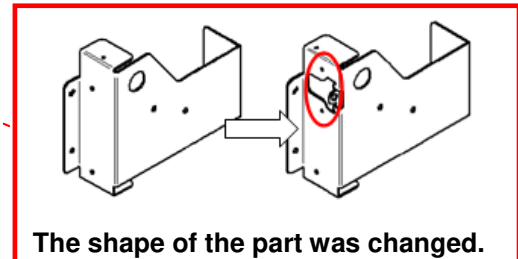
The shape of the part was changed.

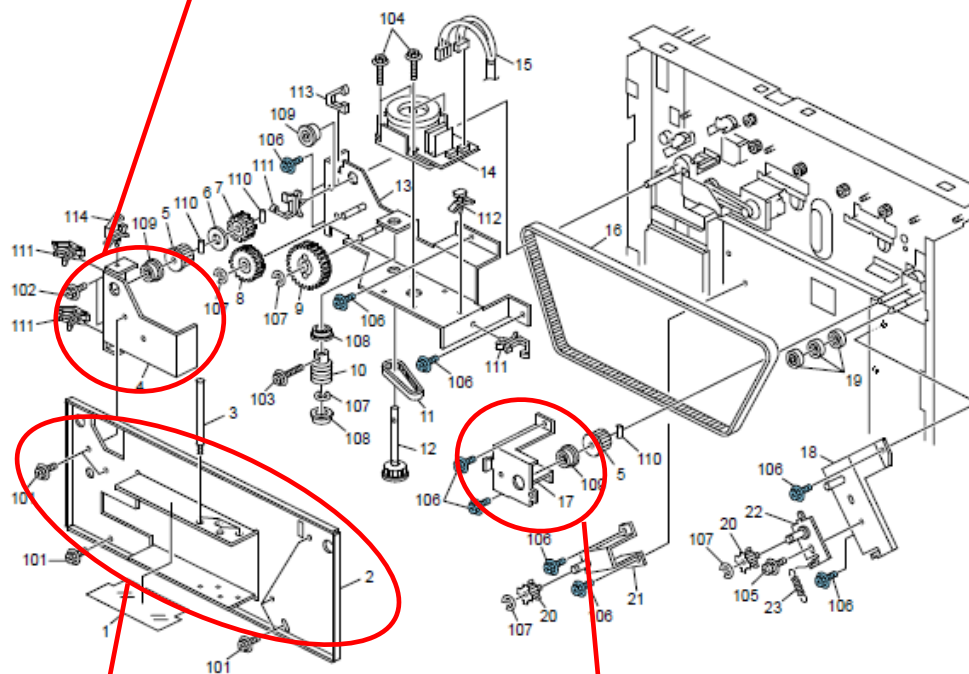
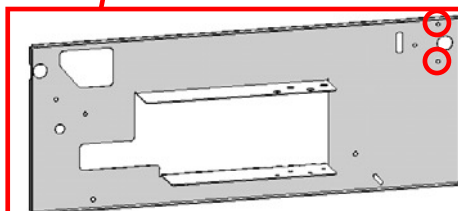
17.Drive Section 2 (D447)

The two screw holes were added.

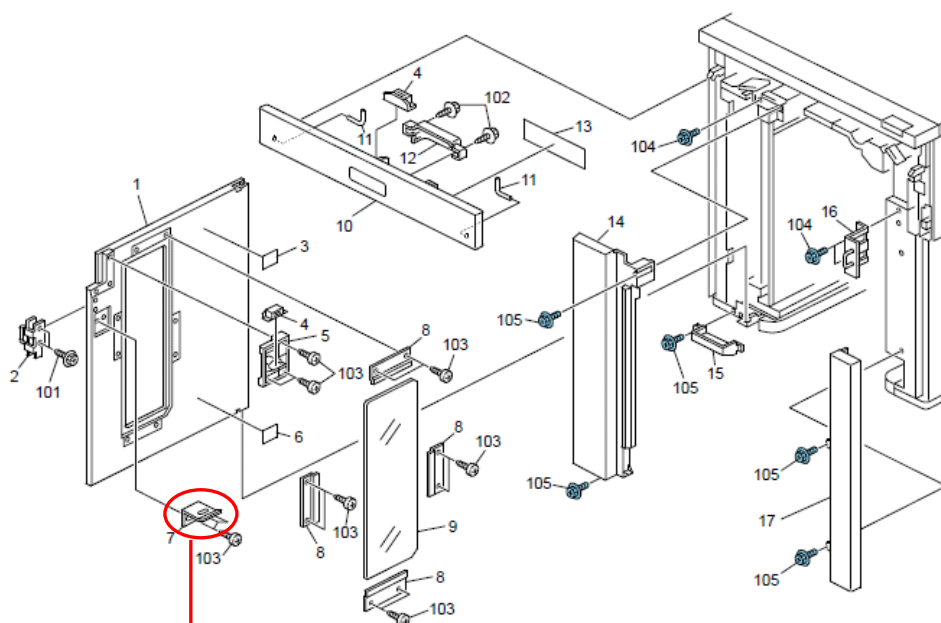
1.Exterior 1 (D447)

Change 1: The door-lock bracket was modified.

D447 6143 → D447 6150

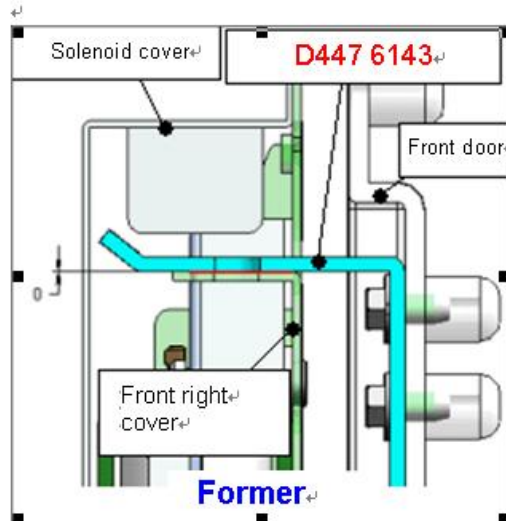
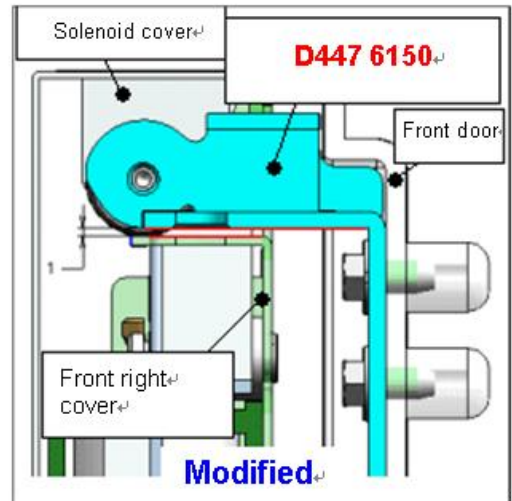
Opening and closing the front door many times could cause the Mylar Sheet, which is attached to the door-lock bracket to prevent friction between the door bracket and the mainframe bracket, to come off over time. When the Mylar Sheet comes off, the double-sided adhesive tape remains on the bracket, and causes the door to jam.

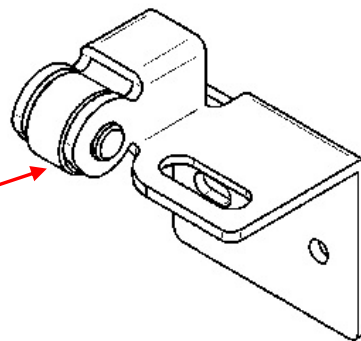
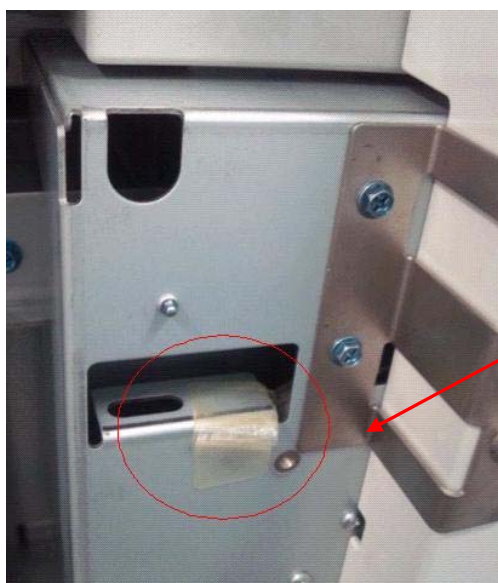
This photo shows the Bracket missing the Mylar Sheet, leaving only the double-sided adhesive tape.

As a substitute for the Mylar Sheet, the modified Bracket incorporates a roller to reduce the friction between the brackets.
