Model: Stacker_SK5030		Date: 1-Mar-16	No.: RD776003
Subject: High Capacity Stacker SK5030: Label Paper Jams in the Straight Paper Path		Prepared by: T.Miyamoto	
From: 1st Tech Service Sect., PP Tech Service Dept.			
Classification:	<input checked="" type="checkbox"/> Troubleshooting <input type="checkbox"/> Mechanical <input type="checkbox"/> Paper path <input type="checkbox"/> Product Safety	<input type="checkbox"/> Part information <input type="checkbox"/> Electrical <input type="checkbox"/> Transmit/receive <input type="checkbox"/> Other ()	<input type="checkbox"/> Action required <input type="checkbox"/> Service manual revision <input type="checkbox"/> Retrofit information <input checked="" type="checkbox"/> Tier 2 <input type="checkbox"/> Tier 0.5

Model: Stacker_SK5030		Date: 2-Mar-16	No.: RD776004
Subject: High Capacity Stacker SK5030: Top most sheet separates from the stack when pulling out the cart		Prepared by: T.Miyamoto	
From: 1st Tech Service Sect., PP Tech Service Dept.			
Classification:	<input checked="" type="checkbox"/> Troubleshooting <input type="checkbox"/> Mechanical <input type="checkbox"/> Paper path <input type="checkbox"/> Product Safety	<input type="check

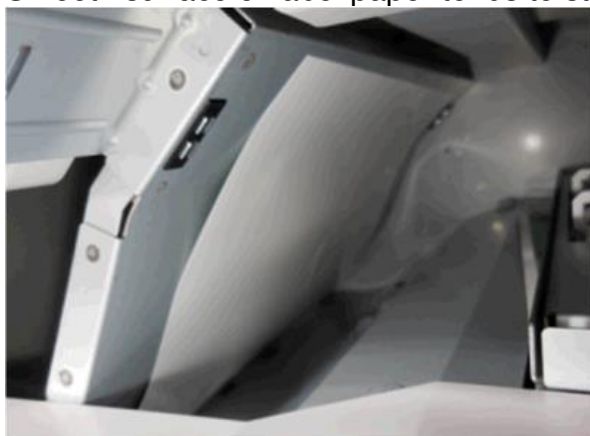
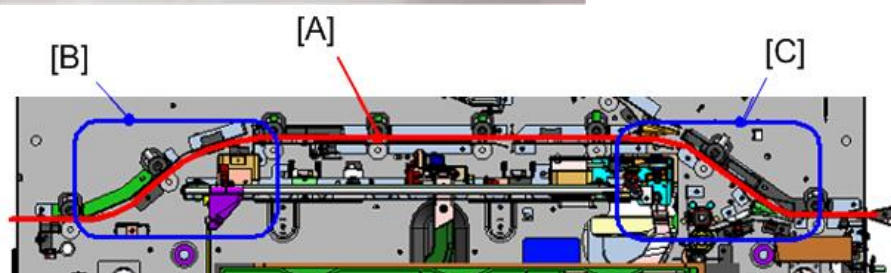
Jam occurs with LEF A4 adhesive label paper fed through the straight paper path of High Capacity Stacker SK5030.

Smooth surface of label paper tends to stick to the curved guide plate at the exit.

[A]: Straight paper path

[B]: Exit

[C]: Entrance

The problem does not occur at the entrance, because the junction gate prevents the paper from adhering to the guide plate.

Switch to SEF. This will reduce the surface contact area between the sheet and exit guide plate. Also, the sheet becomes longer in the feed direction, enabling transport by two rollers in the guide plate, instead of one.

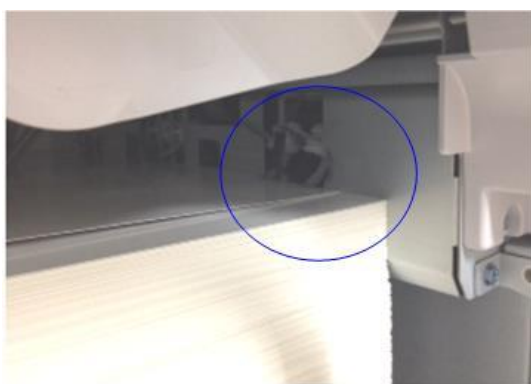
When the cart is pulled out after the stacker is full, the top sheet of the stack separates from the stack.

The paddle catches the top sheet of the stack.

- Slippery paper
- Solid images

Place the paper holder on the paper stack before moving the cart.

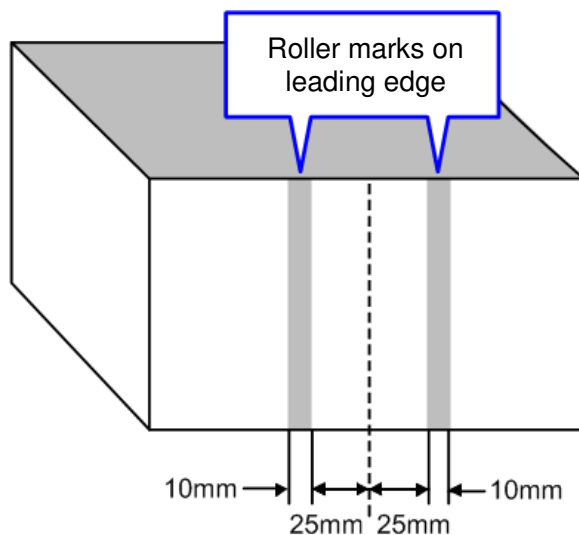
<Fig.1>

Roller marks 10mm in width appear on the leading edge of the paper, 25mm from the center of the paper, when using the High Capacity Stacker SK5030.

Toner adheres to the feed rollers of the High Capacity Stacker SK5030.

Clean the following 9 rollers in the High Capacity Stacker.

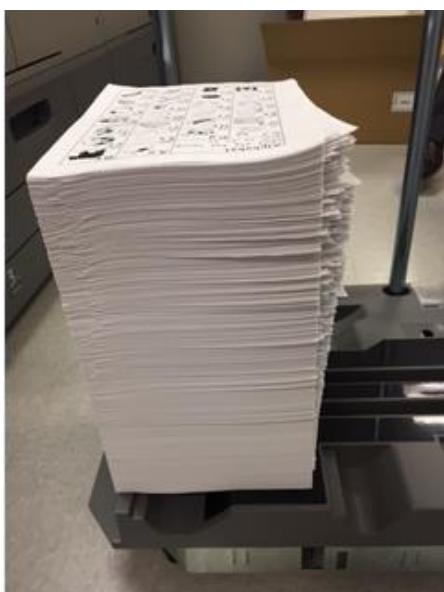
Poor stacking with the High Capacity Stacker SK5030 when using the following paper type.

- Thickness 4 (163.0g/m2) or less plain paper (uncoated)

Feed direction⇒

Paper with the characteristics above enable the vibration caused by the paddle rotation to travel to the stacked sheets. As a result, the leading edge stopper cannot be moved to the correct position. (See APPENDIX below for more details).

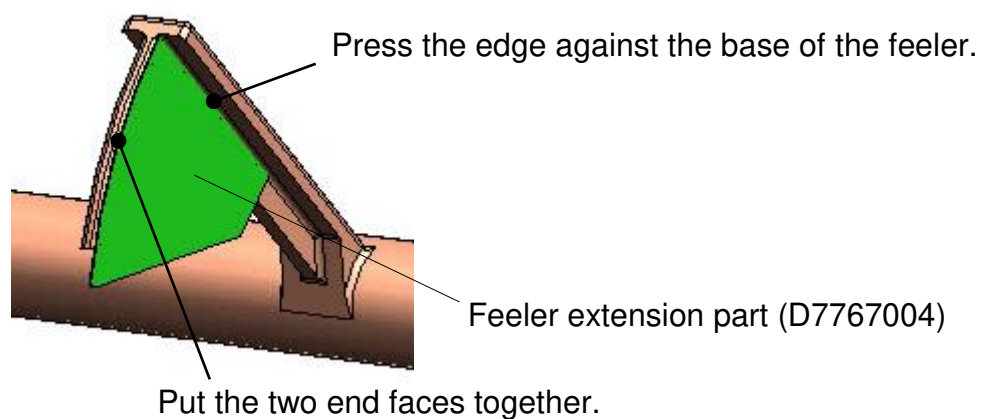
The paper height is lowered 3mm from the normal position, and the vibration of the paddle against the stacked papers will be reduced.

- 3) Attach the feeler extension part to the feeler as shown below.

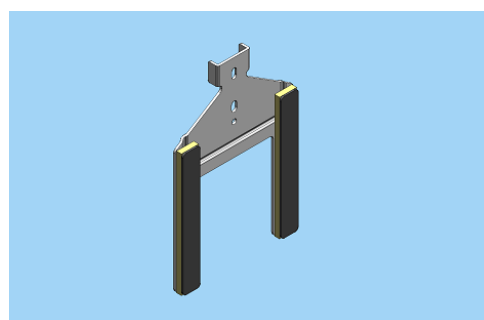
The pushing force of the paddle is reduced by lowering the paper height. As a result, the alignment accuracy of the stacked paper will get worse. To prevent this, add the cushion parts to the stopper to improve the pushing force.

- The sponge parts (D7767003) will deteriorate over time. Check them whenever visiting the site and replace if necessary.
- Adjust the SP settings to improve the alignment accuracy as necessary.

Stopper:

1 st Stacker	SP6-603
2 nd Stacker	SP6-609

Jog fence

1 st Stacker	SP6-602
2 nd Stacker	SP6-608

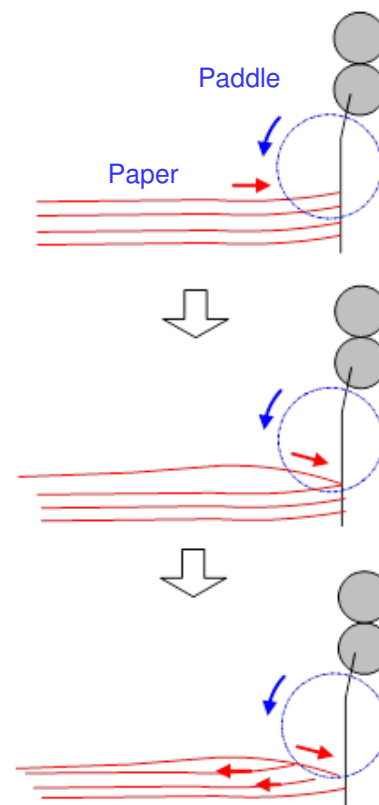
1. Normally, paper is pushed against the end fence by both the paddle and the leading edge stopper.
2. Depending on the conditions and characteristics of the paper, the top of the paper can push some of the lower sheets toward the stopper. The vibration from the paddle rotation is transmitted to the stack.
3. At this time, the stopper cannot push the paper correctly, because some of the shifted sheets are interfering with the stopper. The stop position is then shifted from the normal position, which worsens the stacking quality.

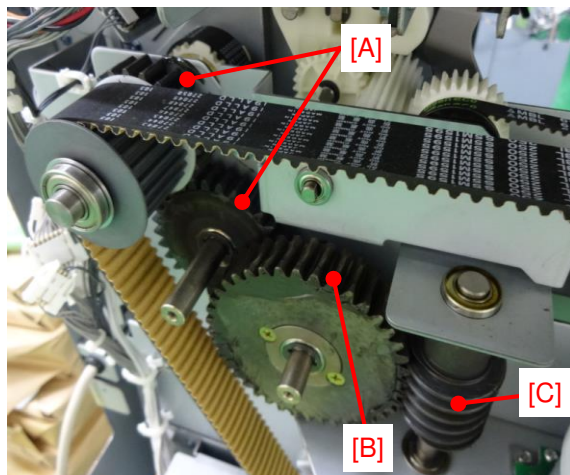
The tray is stuck and does not lift up/down properly, because the drive gear is broken and the tray bracket is slanted against the belts.

Grease applied to the drive components of the shift tray is dried up.

5. Apply grease to the gears/wheel by dividing the drops, each approximately 6mm (1/4 inch) in diameter.

Gears [A] : 5 drops
Worm wheel [B] : 10 drops
Worm gear [C] : 5 drops

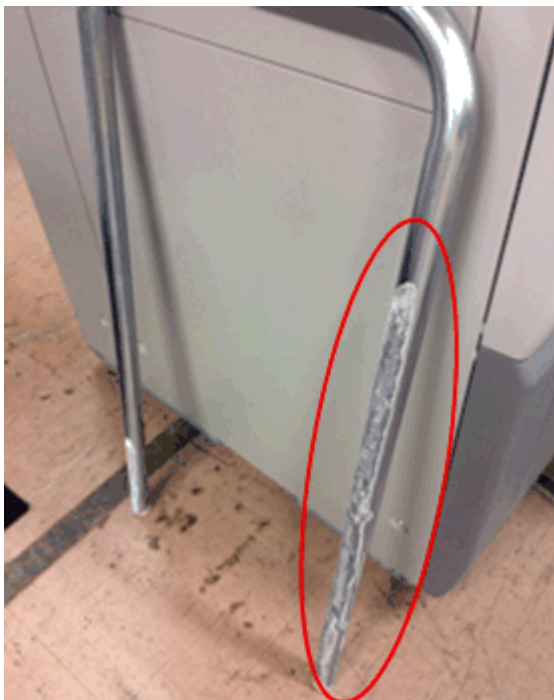
White-colored rust forms on the handle for the tray cart.

Some of the liquid coating (plating solution) applied to the handle remained inside the structure, and later leaked out of the hole(s). As a result, the coating could not dry properly, and reacted with the handle's metallic exterior.

If the rust appears on the handle at installation, replace with the following part:

P/N: D7769901
 Description: Grip : Shift Tray : Ass'y

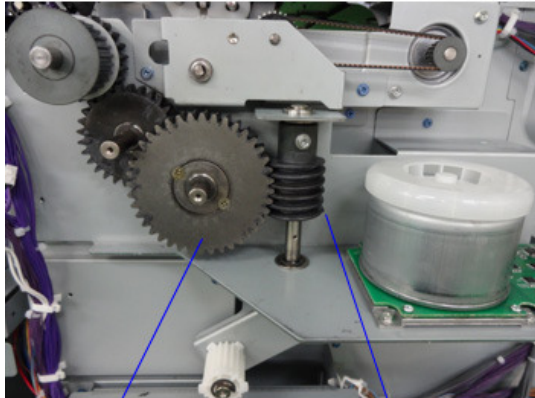
A loud noise is heard coming from the stacker, and the shift tray does not move.

The worm gear gets worn when the paper tray is full with relatively heavy paper.

5. Remove the "Worm Wheel", "Worm Gear ASSY" and "Motor Timing Belt" (e-ring x 1 each; screws x 1 for the "Worm Gear").

Worm Wheel

Worm Gear ASSY
