Model: SP3		Date: 31-Oct-97	No: 4
Subject: Controller Board ROM Modification		Prepared by: A.Tokoyama	
From: QAC Field Information Dept.			
Classification:	<input type="checkbox"/> Troubleshooting	<input checked="" type="checkbox"/> Part information	<input type="checkbox"/> Action required
	<input type="checkbox"/> Mechanical	<input type="checkbox"/> Electrical	<input type="checkbox"/> Service manual revision
	<input type="checkbox"/> Paper path	<input type="checkbox"/> Transmit/receive	<input type="checkbox"/> Retrofit information
	<input type="checkbox"/> Other ()

Model: SP3		Date: 15-Jan-98	No: 5
Subject: Controller Error		Prepared by: E.Fukuyama	
From: QAC Field Information Dept.			
Classification:	<input checked="" type="checkbox"/> Troubleshooting	<input type="checkbox"/> Part information	<input type="checkbox"/> Action required
	<input type="checkbox"/> Mechanical	<input type="checkbox"/> Electrical	<input type="checkbox"/> Service manual revision
	<input type="checkbox"/> Paper path	<input type="checkbox"/> Transmit/receive	<input type="checkbox"/> Retrofit information
	<input type="checkbox"/> Other ()

Model: NIC Option for SP3		Date: 15-Mar-98	No: 9
Subject: The floppy

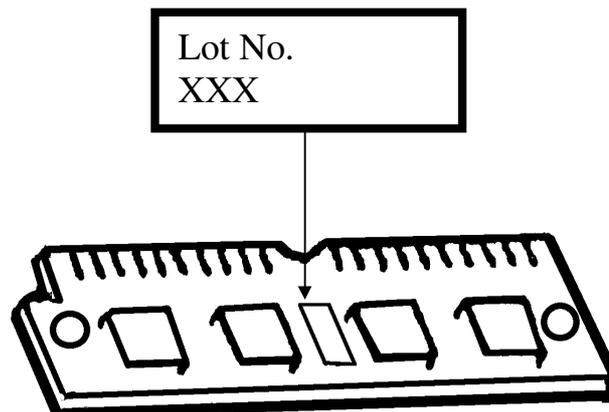
1. The program in some PS2 options was damaged due to noise on the cable between the PC and the checker in the factory which downloads the software.
2. The PS2 option uses flash ROMs from two vendors (Fujitsu and AMD). The AMD chips were used for the December production in 1997 and January production in 1998. These chips cannot be erased before programming new software.

- A. Stocked PS2 options in the warehouse
Please replace them with new ones and send back the old ones.
- B. PS2 options in the field
 1. When the PS2 board cannot be recognized after installing it, please replace it with a new one.
(Note) Before replacing it, please reinstall again and confirm that it can be recognized.
 2. Please replace all boards with the lot no. of 7Zxxx and 81xxx with new ones.
The lot no. is shown on the carton or on the label on the board as shown below.
