Model: <b>AT-C1 Booklet Finisher (SR3000)</b>	Date: 25-Jul-08	No.: RB793001a
---	-----------------	----------------

Model: AT-C1 Booklet Finisher (SR3000)		Date: 15-Jun-09	No.: RB793002
Subject: SR3000 Jam		Prepared by: M. Kumagai	
From: 2nd Tech Support Sec. Service Support Dept.			
Classification:	<input checked="" type="checkbox"/> Troubleshooting	<input type="checkbox"/> Part information	<input type="checkbox"/> Action required
	<input type="checkbox"/> Mechanical	<input type="checkbox"/> Electrical	<input type="checkbox"/> Service manual revision
	<input type="checkbox"/> Paper path	<input type="checkbox"/> Transmit/receive	<input type="checkbox"/> Retrofit information
	<input type="checkbox"/> Product Safety	<input type="checkbox"/> Other (      )	<input checked="" type="checkbox"/> Tier 2

Model: AT-C1 Booklet Finisher (SR3000)		Date: 24-Dec-10	No.: RB793003
Subject: Parts information		Prepared by: M. Kumagai	
From: 1st Overseas Tech Support Sec., 1st PQM Dept.			
Classification:	<input type="checkbox"/> Troubleshooting <input type="checkbox"/> Mechanical <input type="checkbox"/> Paper path <input type="checkbox"/> Product Safety	<input checked="" type="checkbox"/> Part inf

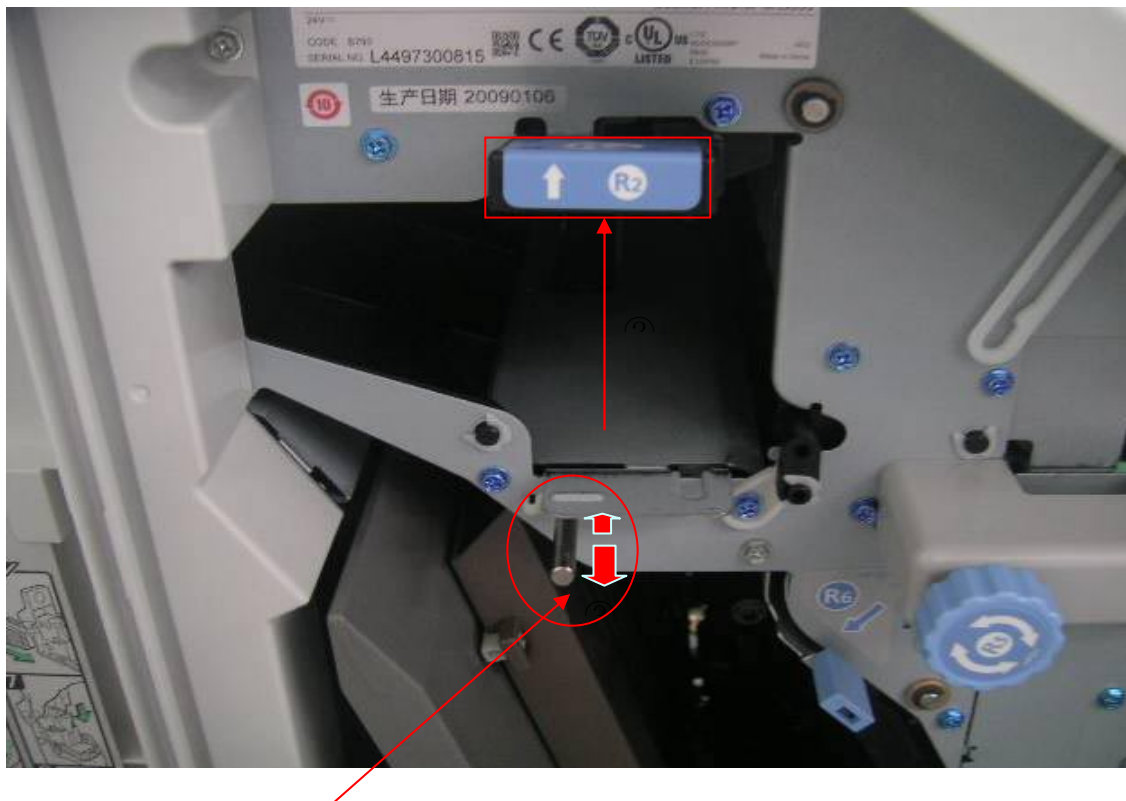
**Photo 1**

The rotation of the four SR3000 motors is not checked when the SR3000 is installed. As a result, the dried vaporized glue on the motor shafts causes the motors to lock.

1. Open the front cover of the finisher.
  2. Pull up the "R2" shift guide.
  3. Move the shift roller shaft (circled in red) back and forth slowly. **Do not** turn the shaft.
- Note:** This will cause the shift motor (**B7935817**) to rotate.

**IMPORTANT:** Only move the shaft back and forth. **Do not** rotate.

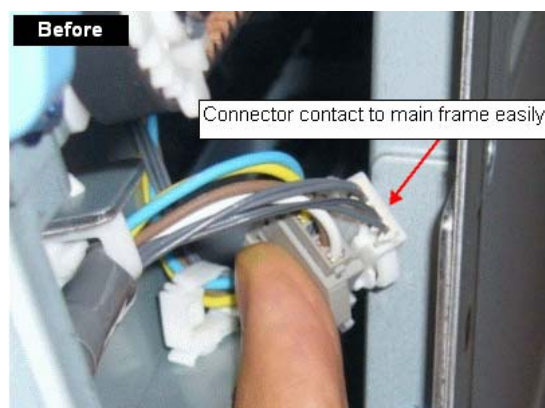
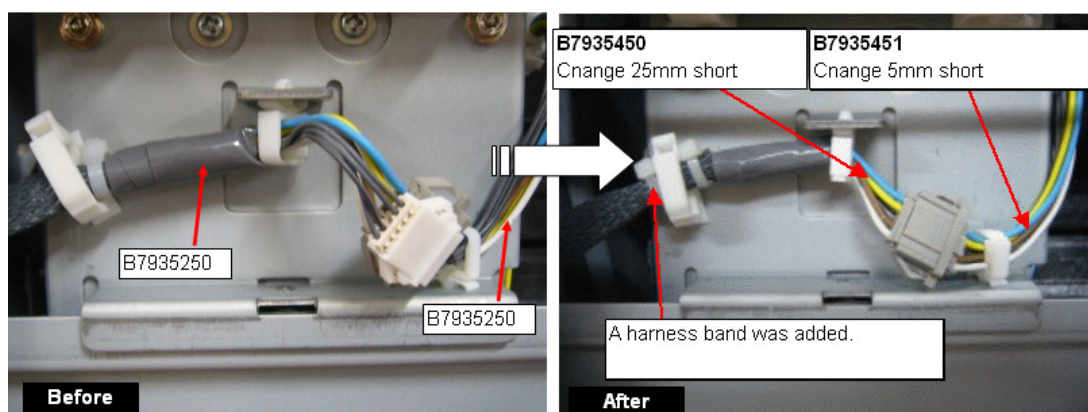
**Change / Reason:** The lengths of the following harnesses were changed to prevent connectors contacting the main frame.

Old parts number	New parts number	Description	Q'ty	Int	Page	Index
B7935250	B7935450	HARNESS:STAPLER	1	X/O As a Set	23	24
B7935251	B7935451	HARNESS:CONNECTIN G:STAPLER	1		23	23

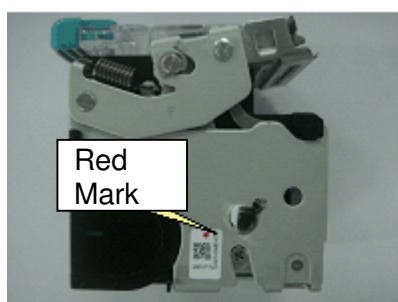
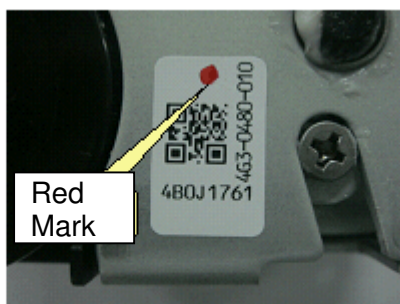
**Important:** Stapler units on some of these affected finishers have already been replaced with the normal ones. If there is a **red dot** on the stapler unit's label (see the photo below), you **do not need to replace** these units.
