| Model: Model AT-C1 Finisher (SR3010) | | Date: 28-Jun-06 | No.: RB792001 |

| Subject: SR3010 JAM | | Prepared by: N.Yoshida | |

| Subject: RoHS Compliance Issue (Stapler) | | Prepared by: T. Nihei | |

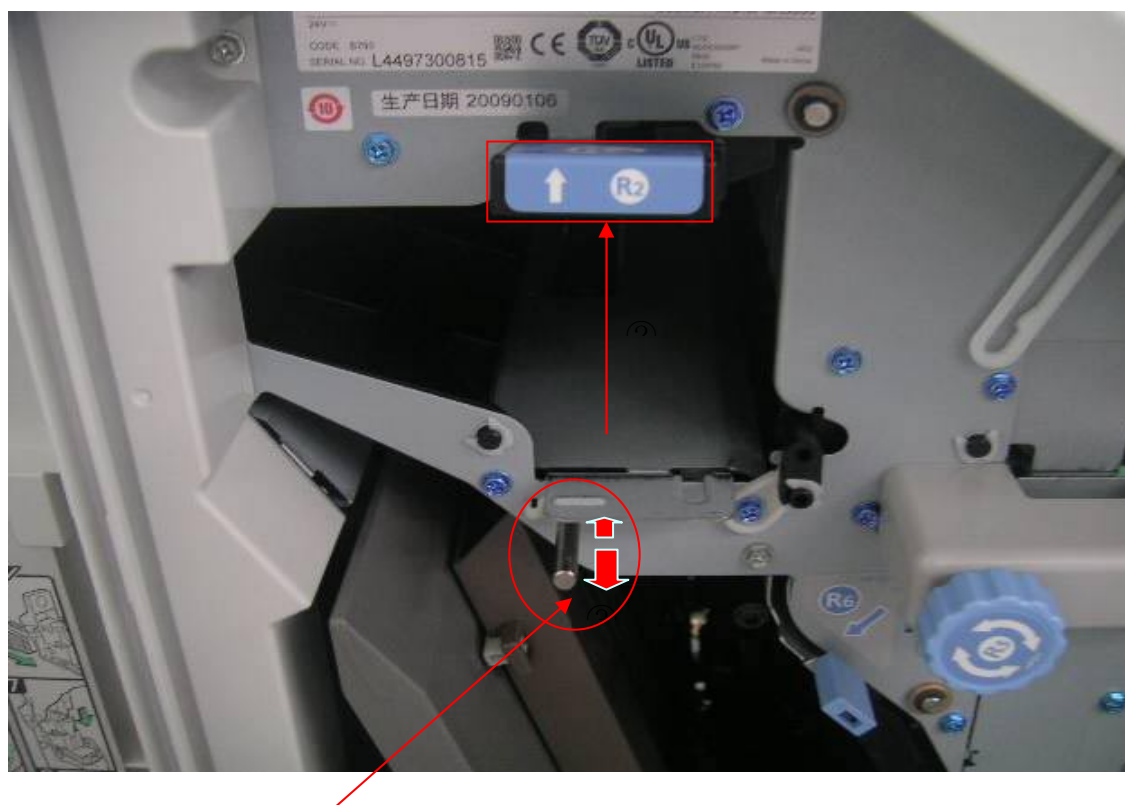
**Photo 1**

1. Open the front cover of the finisher.
  2. Pull up the "R2" shift guide.
  3. Move the shift roller shaft (circled in red) back and forth slowly. **Do not** turn the shaft.
- Note:** This will cause the shift motor (**B7935817**) to rotate.

**IMPORTANT:** Only move the shaft back and forth. **Do not** rotate.

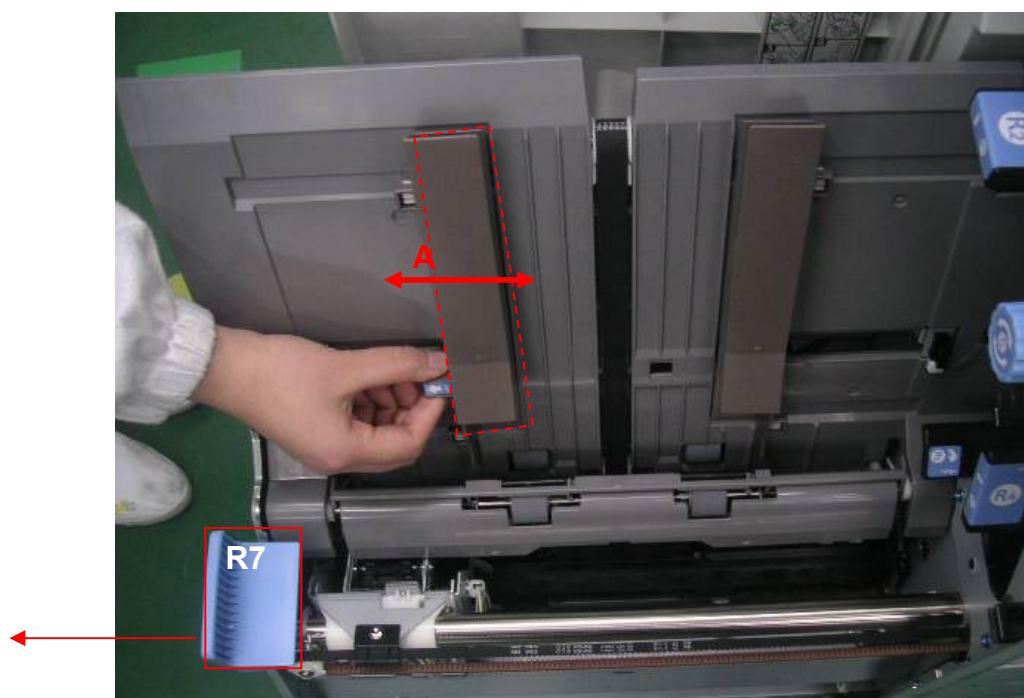
**Photo 2**

4. Pull out the stapler unit using the “R7” guide.
5. Move the operator-side jogger fence back and forth slowly three times within the range of movement shown by arrow “A”.

**Note:** This will cause the **first B7935815 motor** (“Motor 1” in Photo 5) to rotate.

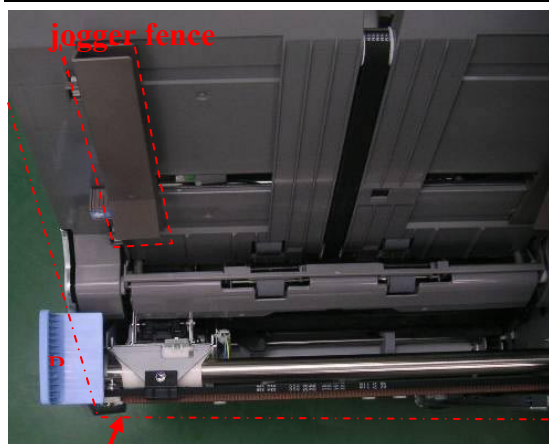
Photo 3

6. Confirm the following (See Photo 3):
  - The stapler unit is pulled out as far as it can go
  - The operator-side jogger fence is at its front-most position
7. Turn the white gear in Photo 5 clockwise 360 degrees.

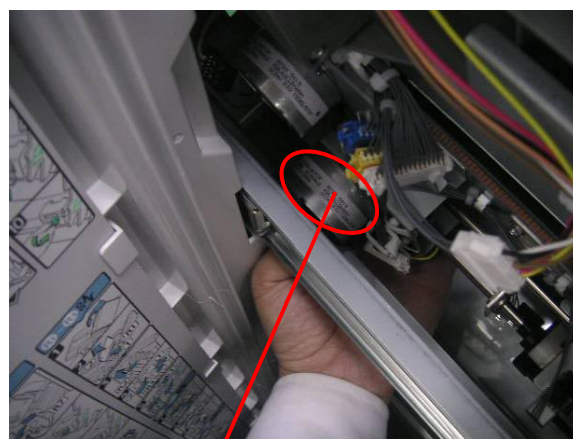
Photo 4

**Important:** Reach under the rail to access the gear (see Photo 4).

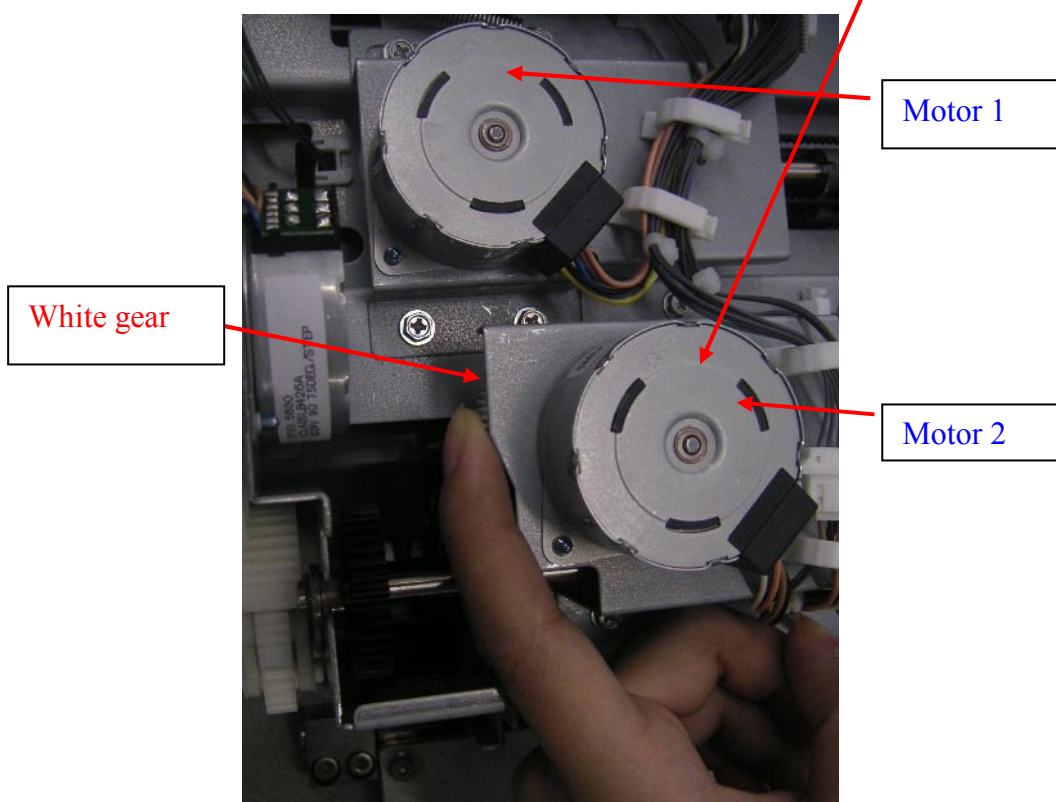
Photo 5

**Note:** This will cause the **second B7935815 motor** (“Motor 2” in Photo 5) to rotate.

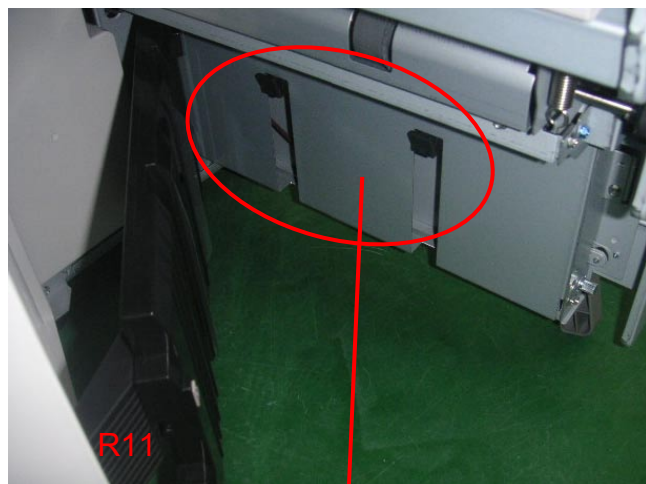
Photo 6

8. Open the black guide plate ("R11" in Photo 6).
9. Move the black grips up and down within the range of movement shown in Photo 7.  
**Important:** Move both grips together at the same time, in the same position, and with the same amount of force.
