Technical Bulletin

Model: SR3020 Date			e: 21-Oct-	09	No.: RB804001	
Subject: Parts catalog correction				Prepare	d by: M.	Kumagai
From: 1st Tech. Support Sec. Service Support Dept.						
Classification:	Troubleshooting	□ Part info	orma	ition Action requi		n required
		☐ Electric	al		Service	ce manual revision
	☐ Paper path	☐ Transmit/red		eive	☐ Retrofit information	
	☐ Product Safety	\square Other ()	☐ Tier 2

Model: AP-C1 Finisher SR3020/3030 Dat			e: 31-Mar	-10	No.: RB804002	
Subject: Parts information				Prepared by: M. Kumagai		
From: 1st Overseas Tech Support Sec., 1st PQM Dept.						
Classification:	☐ Troubleshooting	⊠ Part info	orma	tion Action		required
	☐ Mechanical	☐ Electric	al		Service	e manual revision
	☐ Paper path ☐ Transmit/red		eive	☐ Retrof	fit information	
	☐ Product Safety	Other ()	☐ Tier 2

Model: General			Dat	Date: 11-Jan-11		No.: RGene042
Subject: RoHS Compliance Issue (Stapler)				Prepared by: T. Nihei		
From: 1st Overseas Tech Support Sec., 1st PQM Dept.						
Classification:	Troubleshooting	☐ Part info	ormat	tion		required
	☐ Mechanical	☐ Electric	al		☐ Service	e manual revision
	☐ Paper path	☐ Transm	it/rec	eive	☐ Retrof	it information
	☐ Product Safe

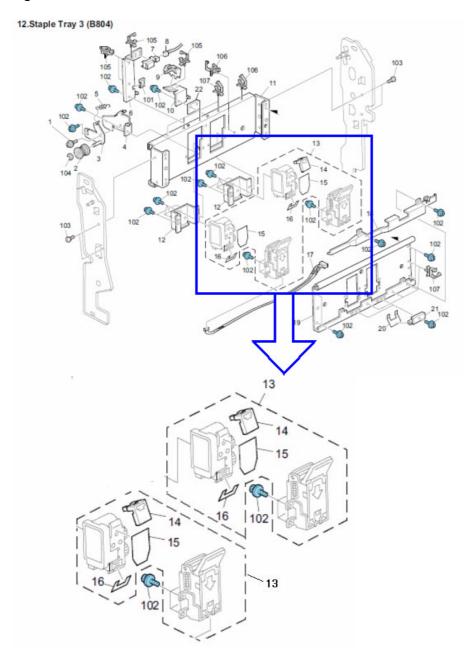
Pg. 24

Change/Reason: The illustration on pg. 24 was corrected as follows (the dashed line for index #13 was separated into two sections).

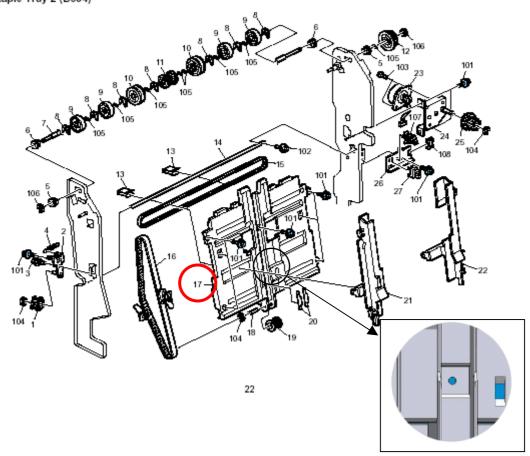
Stapler Tray (Pg.23 Index#17)

Change: A tapping screw was added for attaching the stapler tray to the lower stay

positioning sensor, and screw holes were added as shown below.

Reason: To further improve structural reliability.

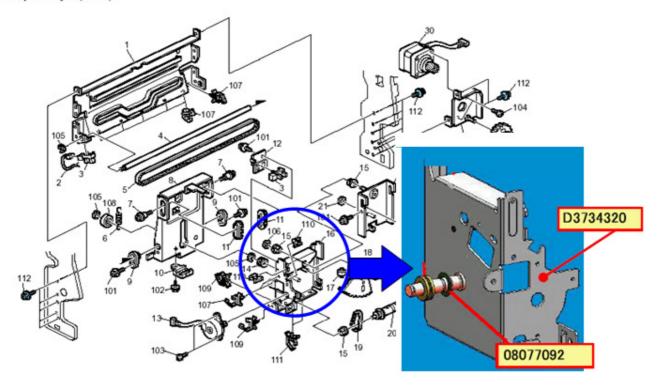
15.Staple Tray 6 (B804)

Change: A spacer was added to the shaft of the stapler bracket.

Reason: To improve the reliability of staple positioning.

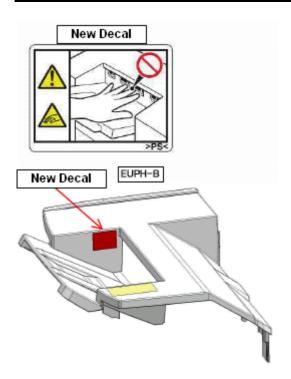
Change/Reason: A new decal was added to improve product safety
