Model: Finisher SR4010/SR4020	Date: 15-Nov-07	No.: RD373001b
-------------------------------	-----------------	----------------

Subject: Firmware Release Note: Finisher SR4010/SR4020		Prepared by: H.Matsui	
From: 2nd Tech. Support Sec. Service Support Dept.			
Classification:	<input type="checkbox"/> Troubleshooting	<input type="checkbox"/> Part information	<input type="checkbox"/> Action required
	<input type="checkbox"/> Mechanical	<input type="checkbox"/> Electrical	<input type="checkbox"/> Service manual revision
	<input type="checkbox"/> Paper path	<input type="checkbox"/> Transmit/receive	<input type="checkbox"/> Retrofit information
	<input checked="" type="checkbox"/> Other ()	<input checked="" type="checkbox"/> Tier 2

Model: V-C2/MT-C4 Finisher(SR4010/4020/4030/4040)

Subject: SHIELDING PLATE: RIGHT: UPPER

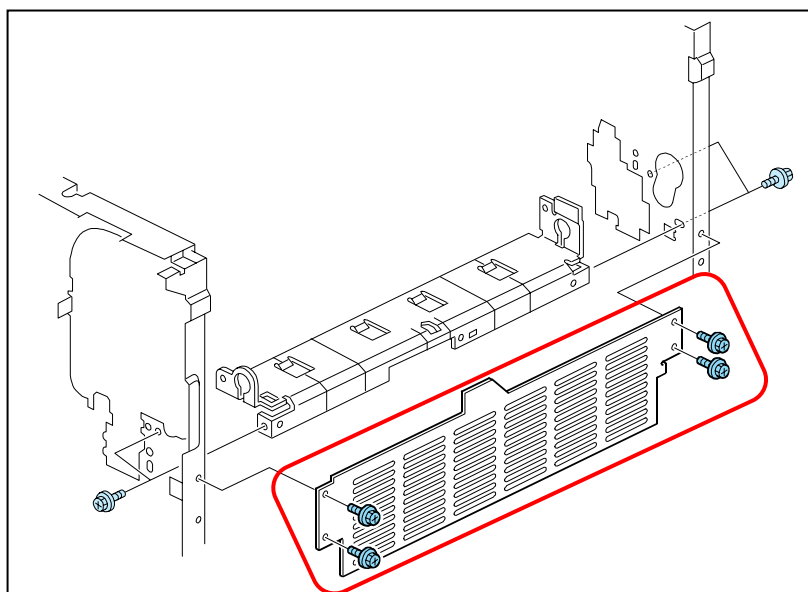
Change: The following part framed in red is added for the following reason.

Reason: To further protect the inside of the SR4010/4020/4030/4040 from being touched.

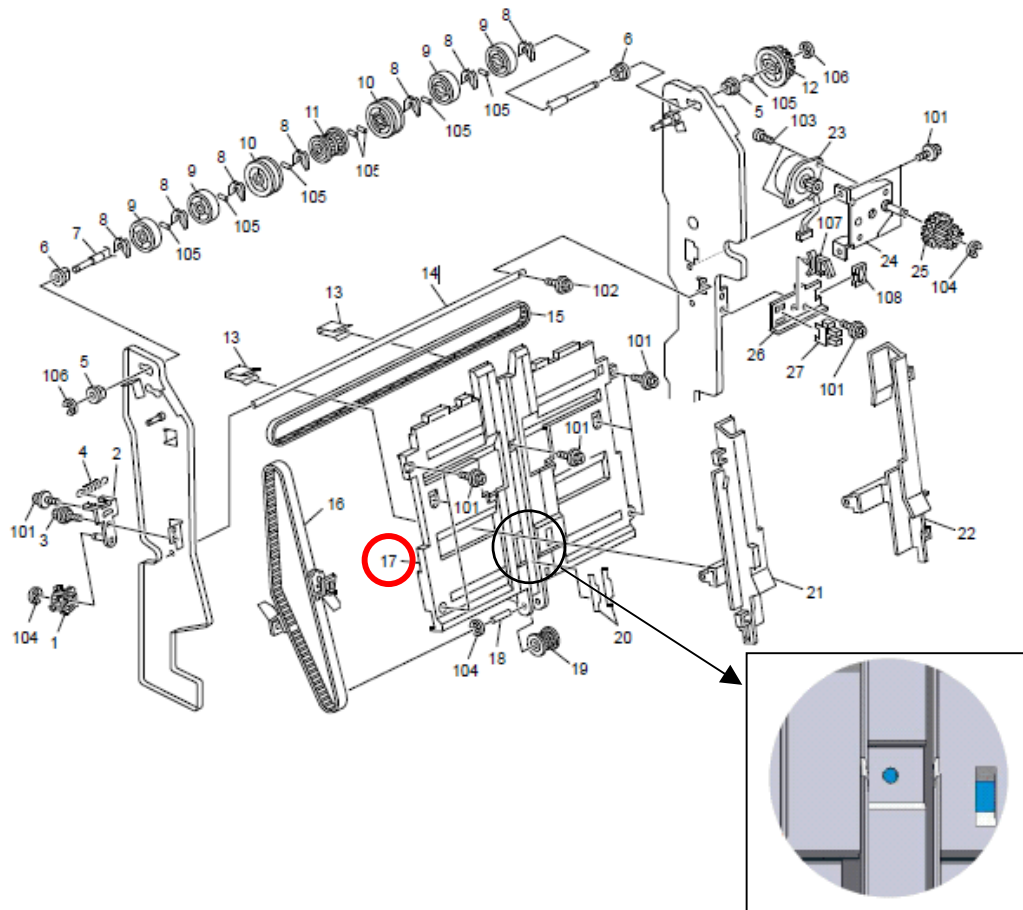
[Stapler Tray (Pg.23 Index#17)]

Change: A tapping screw was added for attaching the stapler tray to the lower stay positioning sensor, and screw holes were added as shown below.

Reason: To further improve structural reliability.

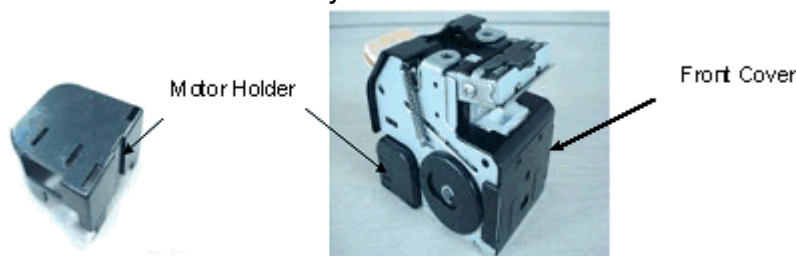
Some parts of the stapler unit (black resin parts shown below) contained PBDE material in excess of the limits set by the RoHS Directive.

The vendor of these parts used irregular materials during the manufacturing process.
 Production period: June to September 2010 (refer to the S/N table below)

Replace the stapler unit.

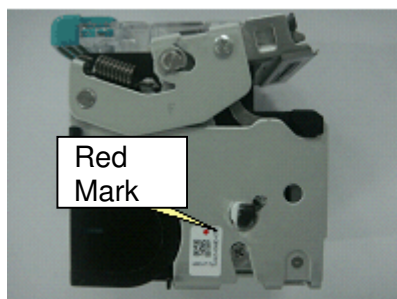
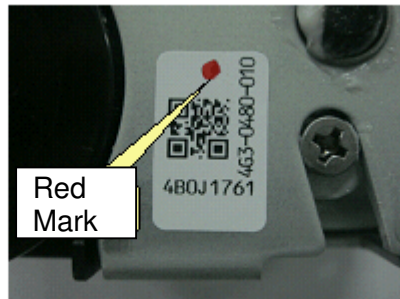
Important: Stapler units on some of these affected finishers have already been replaced with the normal ones. If there is a **red dot** on the stapler unit's label (see the photo below), you **do not need to replace** these units.

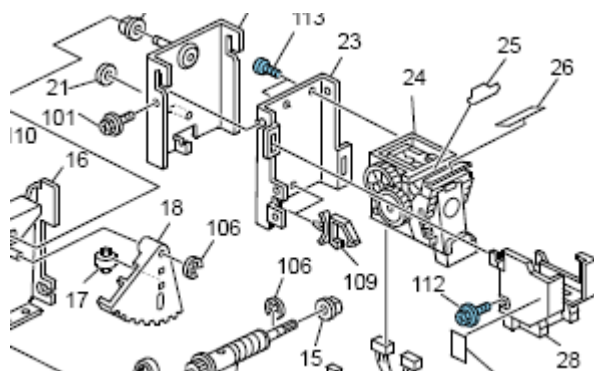
The affected stapler unit is shown in the illustration below (Index #24):

Replace the affected stapler units with the following part numbers for the intended models
