Model: V-C2/MT-C4 Finisher(SR4010/4020/4030/4040)

No.: RD373002

Subject: SHIELDING PLATE: RIGHT: UPPER

Subject: Stapler Tray

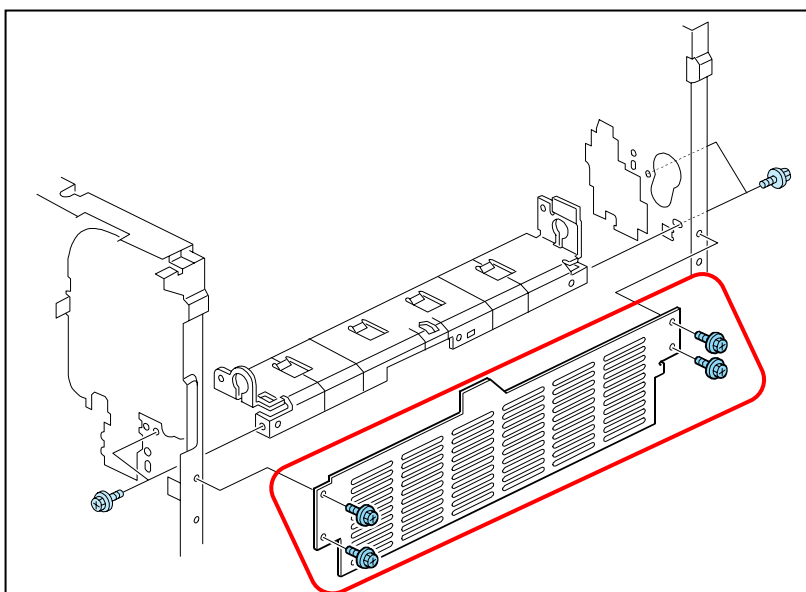
Change: The following part framed in red is added for the following reason.

Reason: To further protect the inside of the SR4010/4020/4030/4040 from being touched.

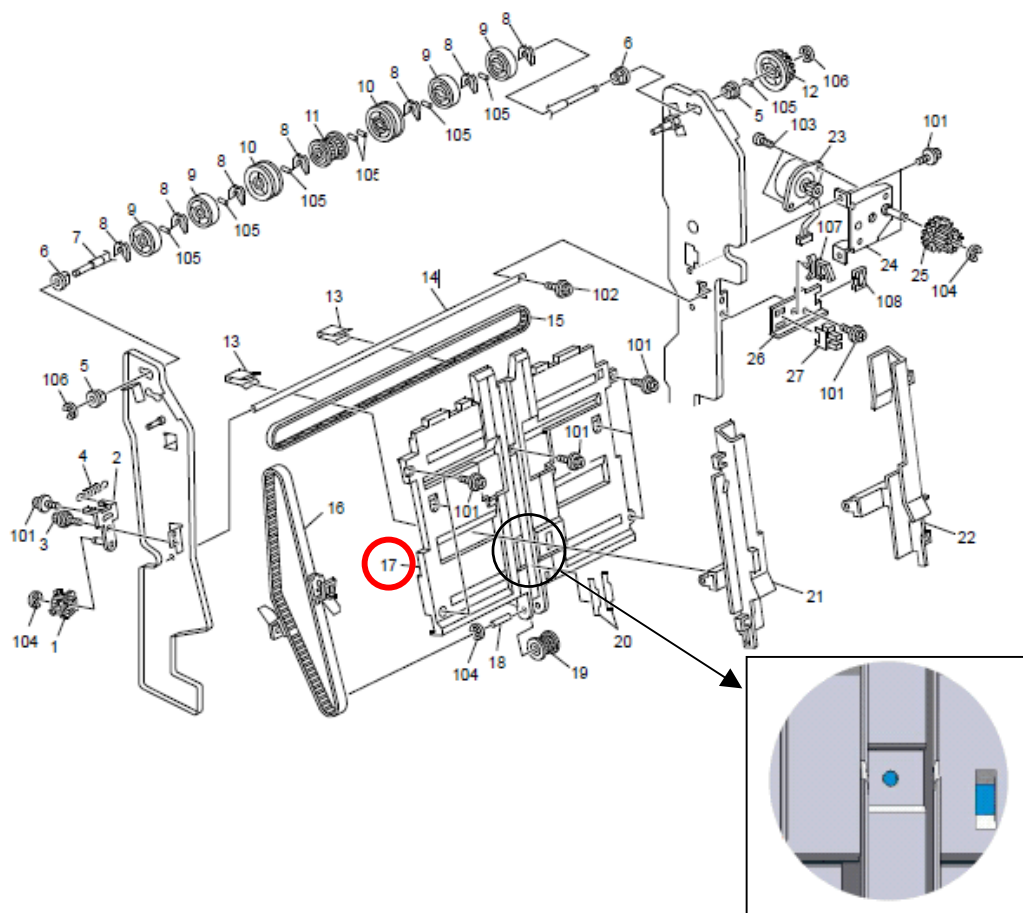
Stapler Tray

Change: A tapping screw was added for attaching the stapler tray to the lower stay positioning sensor, and screw holes were added as shown below.

Reason: ***To ensure that Jam Code 194 does not occur due to deformation of the stapler tray.***

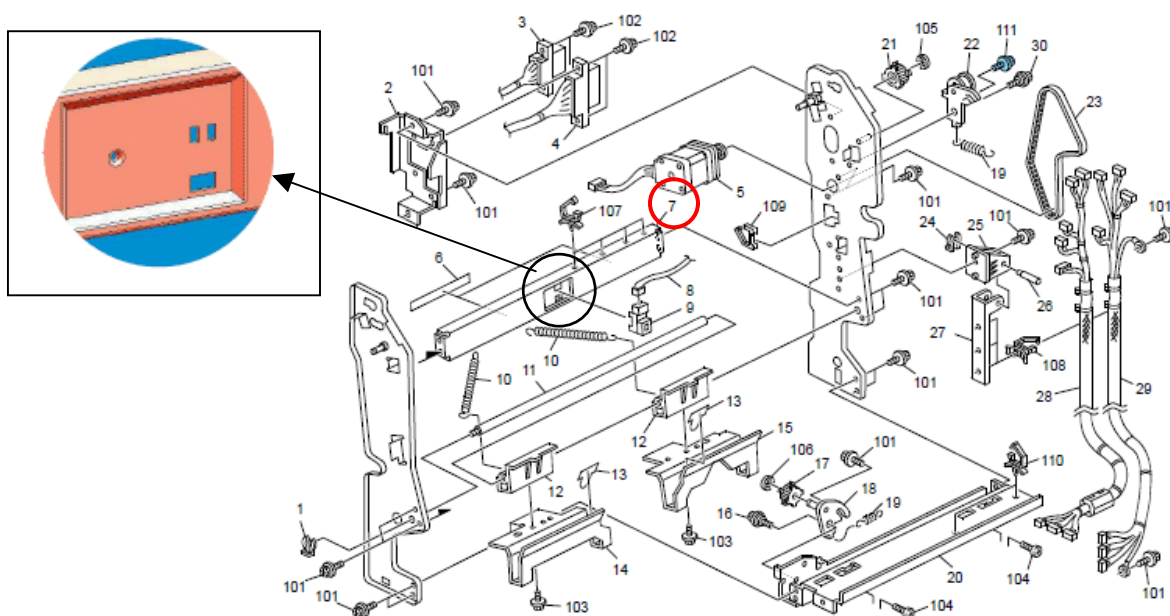
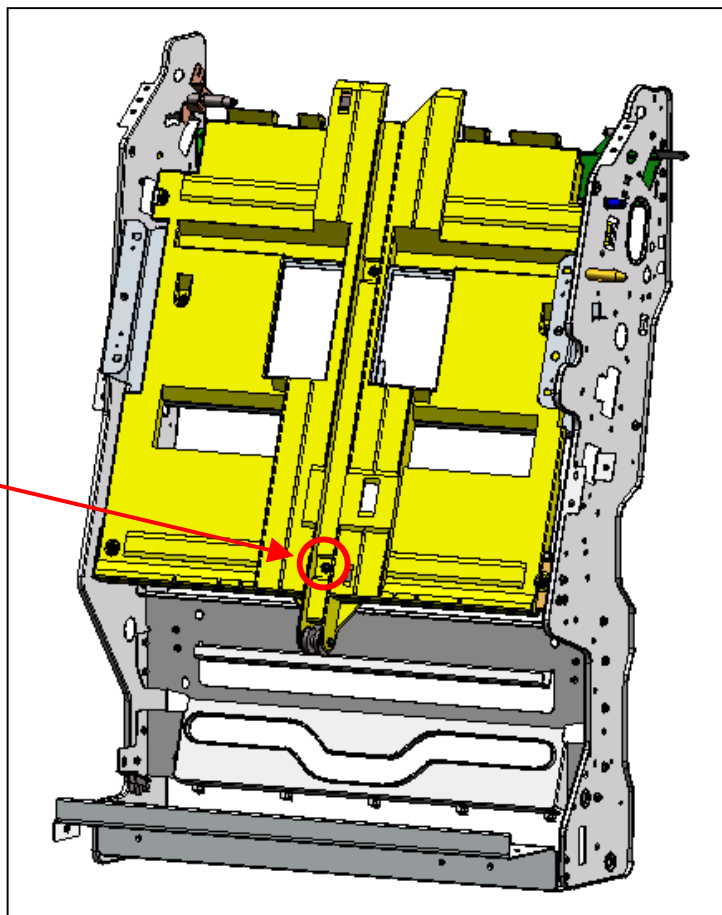
Stay: Lower: Positioning Sensor

*Use the M3x6
tapping screw here.*

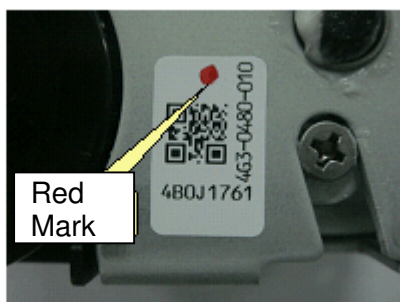
Important: Stapler units on some of these affected finishers have already been replaced with the normal ones. If there is a **red dot** on the stapler unit's label (see the photo below), you **do not need to replace** these units.

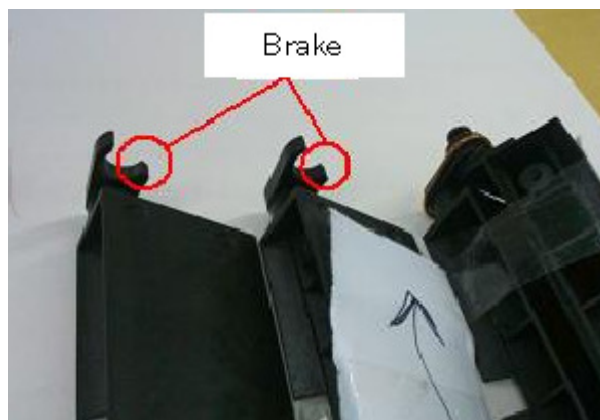
The gate pawl on the proof tray breaks.

The part was assembled incorrectly.

Assemble the part in the correct way, as shown in the procedure below.
