Model: Booklet Finisher SR3160/SR3170	Date: 12-Nov-13	No.: RD688002b
---------------------------------------	-----------------	----------------

Subject: Staple misalignment (3 mm or more) occurs		Prepared by: Yuji Urushihara	
From: 1st Tech Service Sect. MFP/P Tech Service Dept.			
Classification:	<input checked="" type="checkbox"/> Troubleshooting	<input type="checkbox"/> Part information	<input type="checkbox"/> Action required
	<input type="checkbox"/> Mechanical	<input type="checkbox"/> Electrical	<input type="checkbox"/> Service manual revision
	<input type="checkbox"/> Paper path	<input type="checkbox"/> Transmit/receive	<input type="checkbox"/> Retrofit information
	<input type="checkbox"/> Product Safety	<input type="checkbox"/> Other ()	<input type="checkbox"/> Tier 2

Subject: JAM 157		Prepared by: Y. Urushihara	
From: 1st Tech Service Sect., MFP/P Tech Service Dept.			
Classification:	<input checked="" type="checkbox"/> Troubleshooting	<input type="checkbox"/> Part information	<input type="checkbox"/> Action required
	<input type="checkbox"/> Mechanical	<input type="checkbox"/> Electrical	<input type="checkbox"/> Service manual revision
	<input type="checkbox"/> Paper p

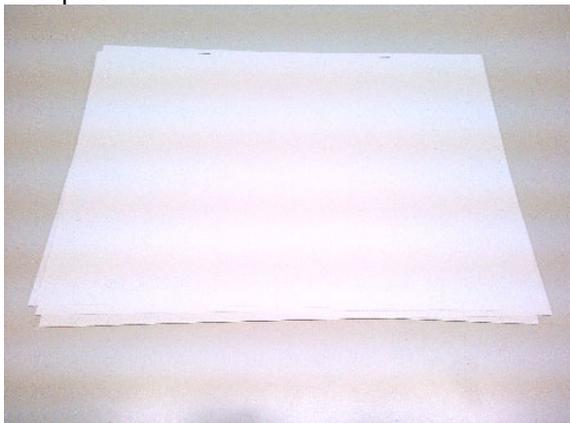
Staple misalignment (3mm or more) occurs.

The paper contacts the jogger fence and skews inside the staple tray during standby.

The side to side registration is not aligned when the paper is being transported from the mainframe to the finisher.

Update the firmware to Ver. **02.000.10** or newer to increase the width of the jogger fences when in standby mode from 7mm to **10mm**.

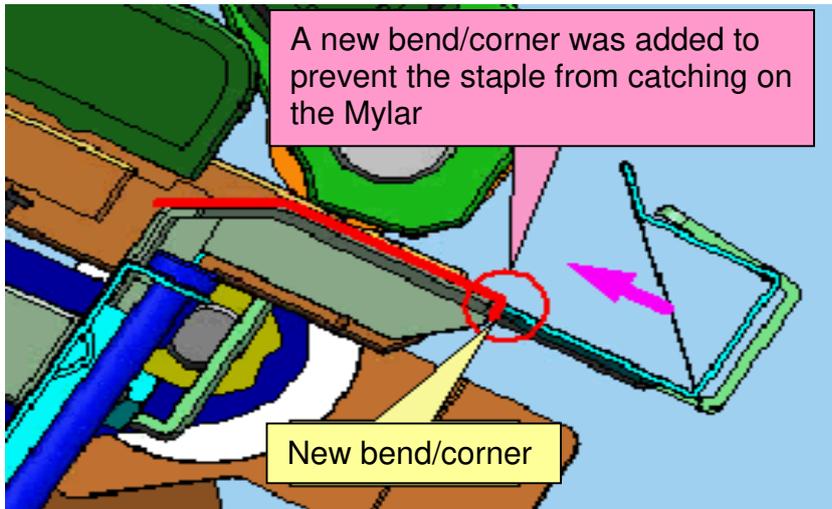
The staple of a stapled set catches on the guide Mylar attached to the jogger fence when the paper is output to the tray.

Push down the mylar to prevent the staple from catching on the mylar

Replace the Mylar with the modified one

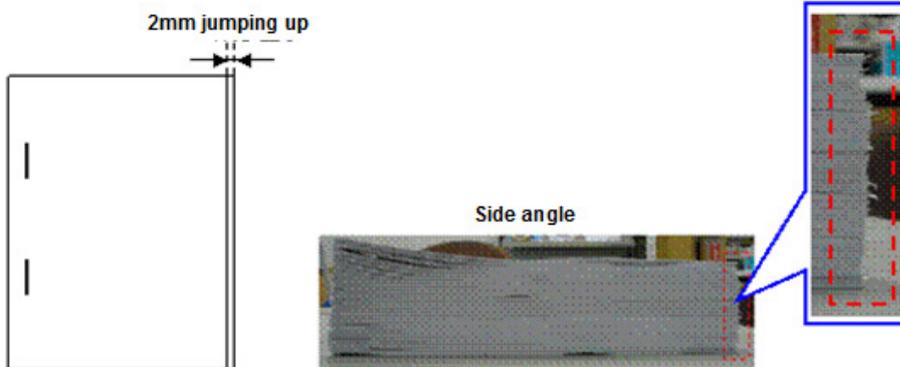
One or more sheets in a stapled set is shifted up to 2mm along the paper feed direction with respect to the other sheets in the set.

Sometimes, the width of the jogger fences during stacking is narrower than expected. As a result, one or more of the sheets juts out from the stack when the jogger fences close.

1. Set **SP6107** ([JogPosAdj(CrnStplr):2K/3K FIN]) to a higher value within the setting range of **1.0mm – 1.5mm**.
2. Make some test printouts and check the alignment of the paper.

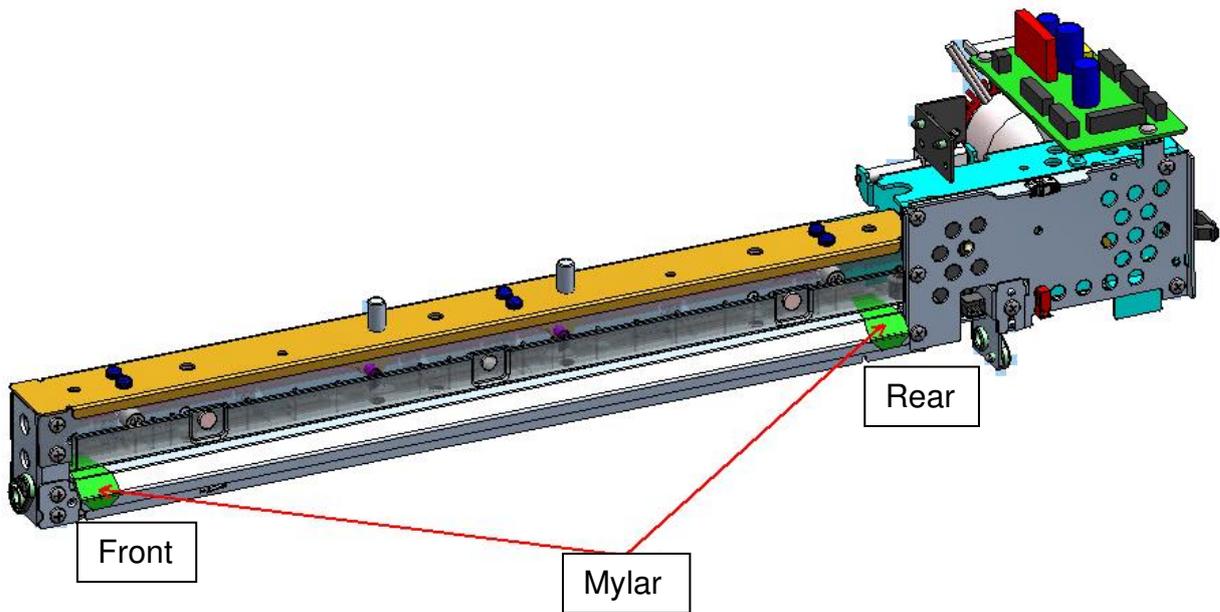
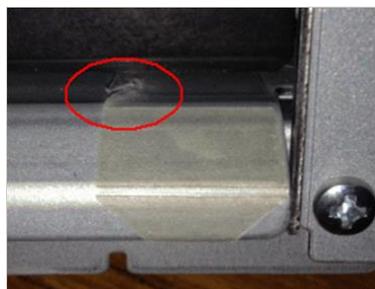
The paper may catch on the Mylar along the paper path inside the punch unit.

- Remove the punch unit from the machine
- Remove the two Mylars inside the punch unit (two different locations)

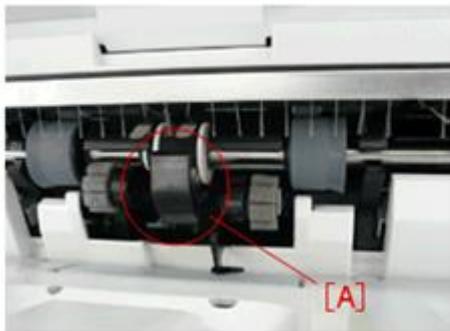
Incorrect Condition

A previous jam or other force places a load on the exit pawls [A], causing the timing belt [B] to slip along the gear teeth. As a result, the home position [C] of the exit pawl is shifted and the pawl blocks part of the paper path [D].

1. Make sure the exit pawl is at its HP (home position).
Note: The pawl moves to its HP after the finisher initialization is performed.
2. Measure the distance between the exit bracket [A] and rear tip of the exit pawl [B] using a scale/ruler [C].
 - If this distance [D] is **NOT 51.2±2mm**, continue this procedure from Step 3 to adjust the position of the pawl manually.

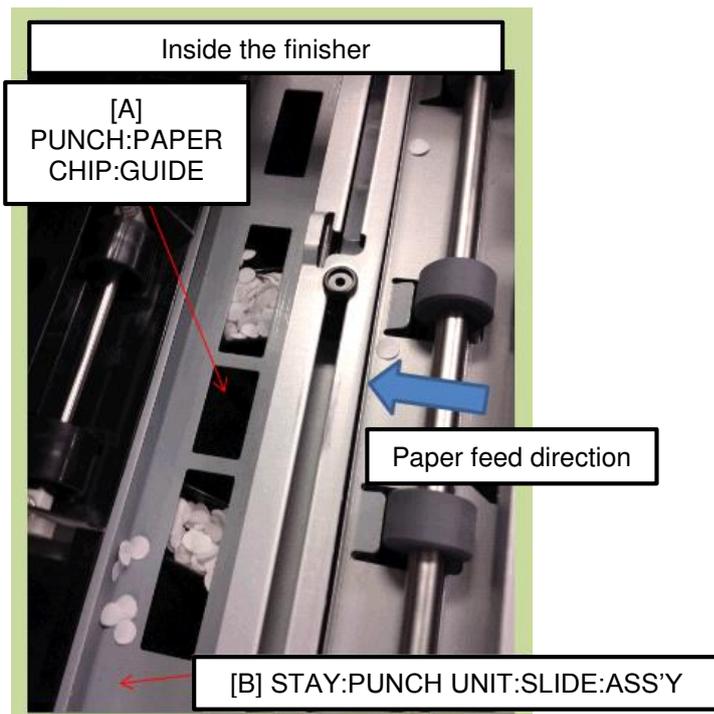
The chads stick to the punch guide [A] and then overflow into the transport path.

Replace the stay, the punch unit, and hopper. **See Replacement Procedure below.**

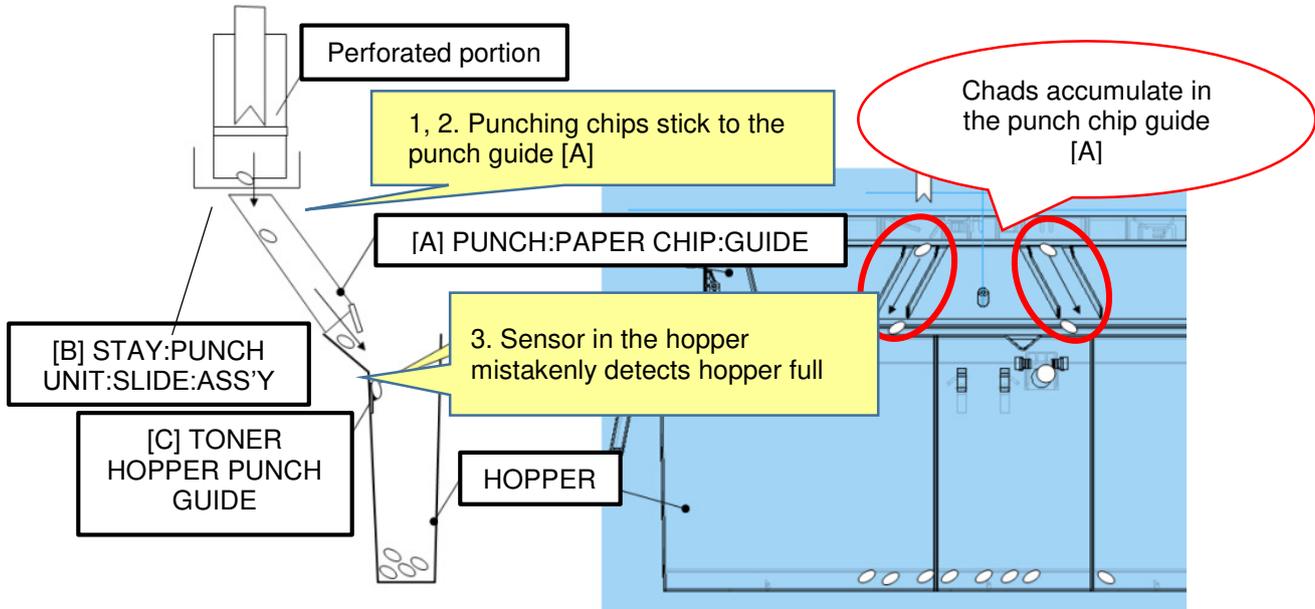
The chads stick to the toner hopper punch guide [C], causing the sensor to mistakenly detect the hopper full condition.

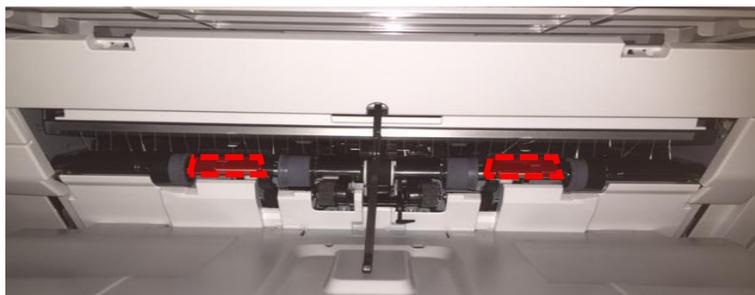
Location of the Mylar:

The Mylar is damaged after repeated contact with the paper. As a result, a crack forms and gradually expands.

Replace the Mylar (modified P/N D6884119).

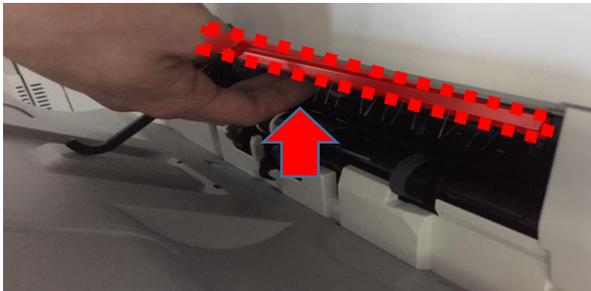
1. Lift up the guide plate and check whether or not the Mylar is damaged.

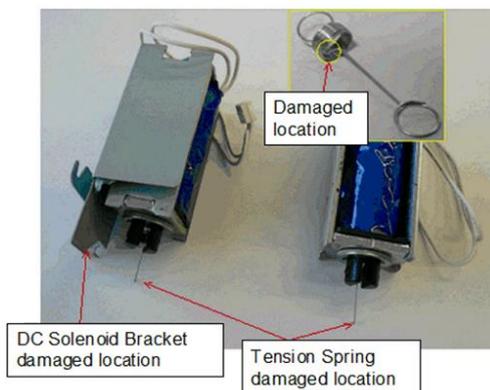
The spring connected to the solenoid breaks (see the photo).

Replace the solenoid (P/N D6882248: DC SOLENOID:GATE PAWL:PROOF TRAY:ASS'Y).

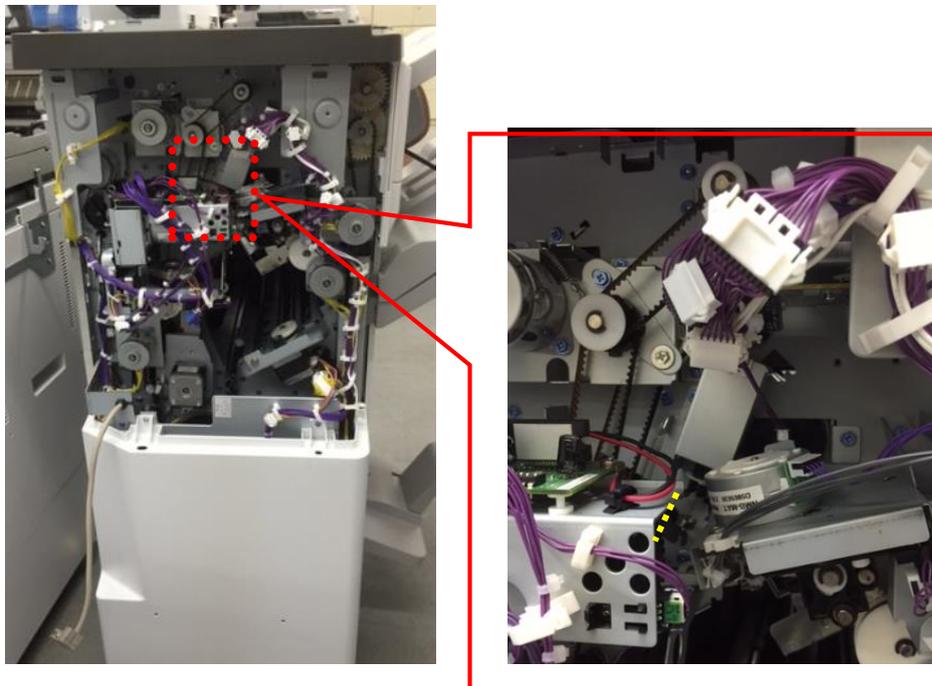
2. Check whether or not the spring shown by the yellow line connected to the solenoid is broken.

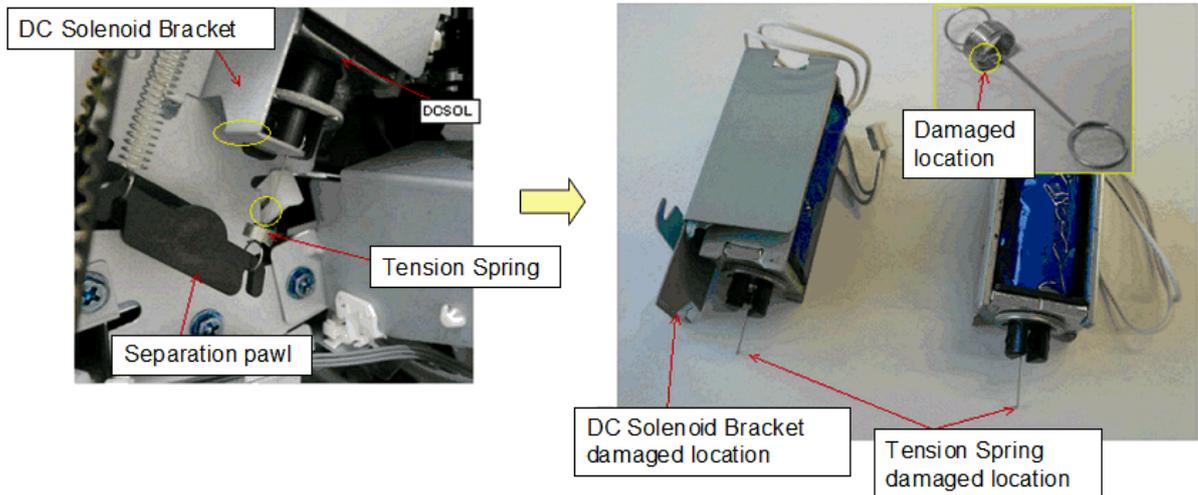
- 1. The spring and bracket for the gate solenoid break.

Replace the solenoid (P/N D6882115)

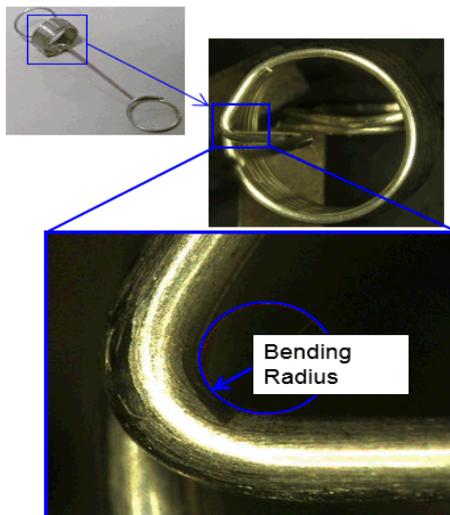
The small bend radius causes stress to concentrate on the spring.

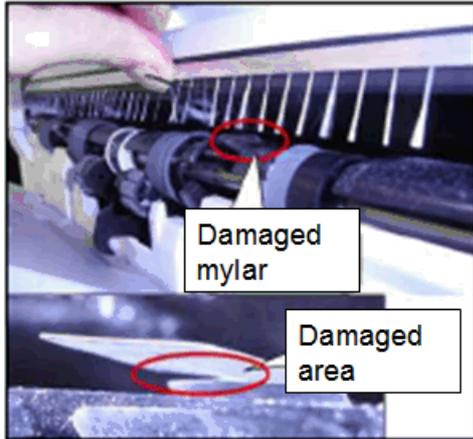
2. The Mylar is worn down by contact with the paper and eventually breaks.

The Mylar is gradually worn down by sliding friction produced by contact with the transported paper. This friction and the resulting stress are concentrated along the edge of the bending part of the Mylar.

Replace the Mylar (P/N D6884119)
