Model: Finisher_SR4090_SR4100	Date: 7-Oct-13	No.: RD703002
-------------------------------	----------------	---------------

Subject: SR4100: Troubleshooting Creases and Jam in stapler unit		Prepared by: Hiroaki H Matsui	
From: 1st PP Tech Service Sec., PP Tech Service Dept.			
Classification:	<input checked="" type="checkbox"/> Troubleshooting	<input type="checkbox"/> Part information	<input type="checkbox"/> Action required
	<input type="checkbox"/> Mechanical	<input type="checkbox"/> Electrical	<input type="checkbox"/> Service manual revision
	<input type="checkbox"/> Paper path	<input type="checkbox"/> Transmit/receive	<input type="checkbox"/> Retrofit information
	<input type="checkbox"/> Product Safety	<input type="checkbox"/> Other ()	<input type="checkbox"/> Tier 2

Model: Finisher_SR4090_SR4100		Date: 11-Oct-13	No.: RD703004
Subject: SR4090/SR4100: Shift tray stalls causing paper jam		Prepared by: H. Matsui	
From: PP Tech Service Dept., 1st PP Tech Service Sect.			
Classification:	<input checked="" type="checkbox"/> Troubleshooting	<input type="checkbox"/> Part information	<input type="checkbox"/> Action required
	<input type="checkbox"/> Mechanical	<input type="checkbox"/

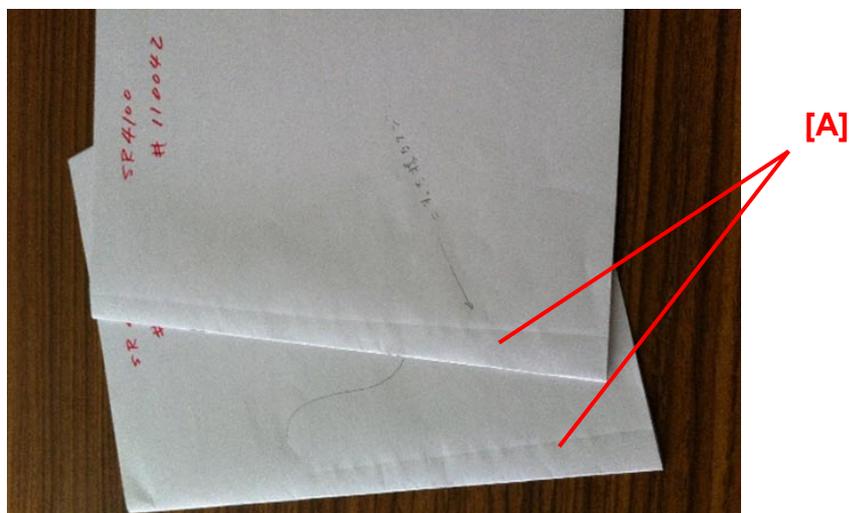
1. Crease [A] appears along the folded edge of a stapled booklet.
2. Paper jam occurs in the booklet stapler unit.

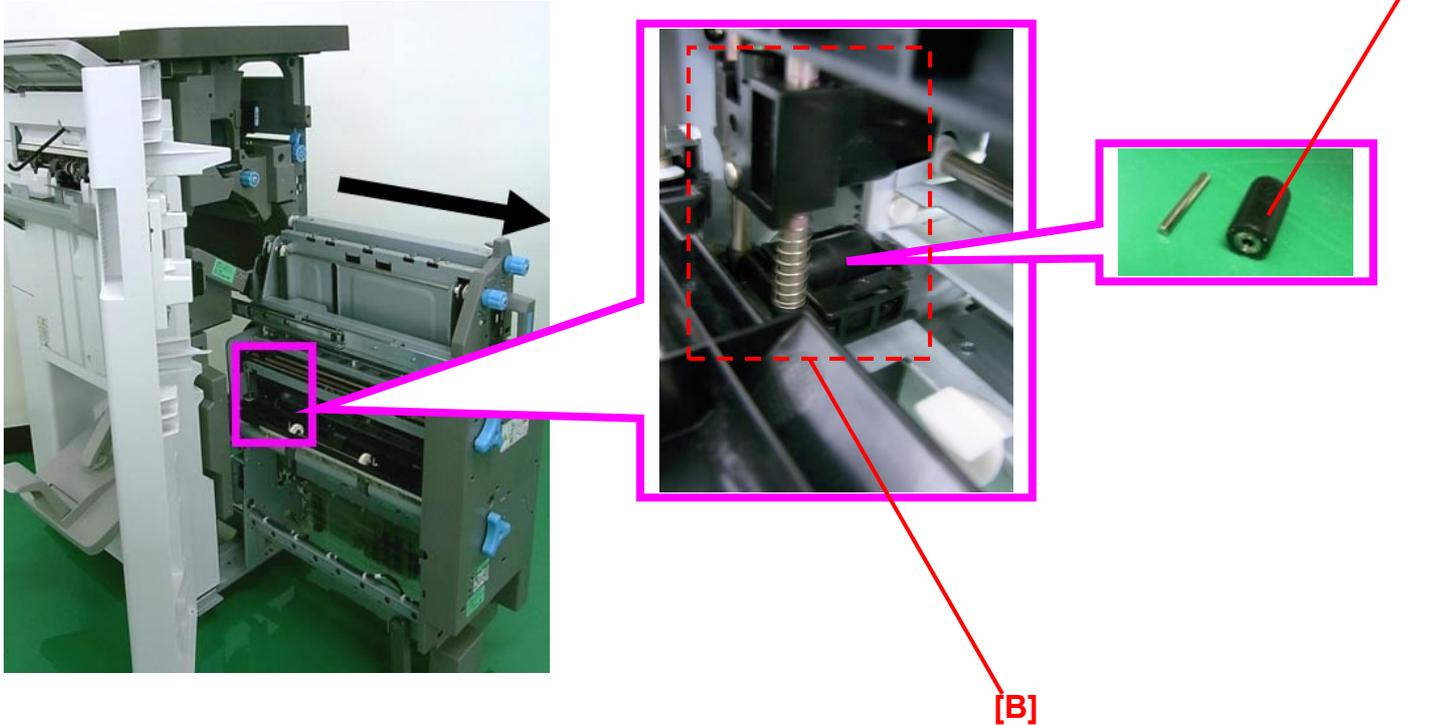
The lower flat fold roller [A], installed in the flat fold roller unit [B] is not set in the correct position, possibly due to the shock when pulling out/pushing in the stapler unit.

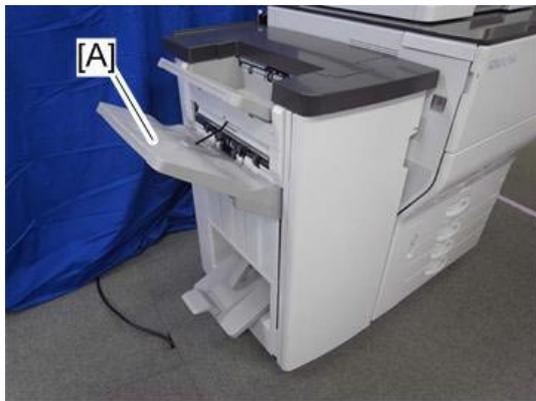
d135a0064

The shift tray [A] unexpectedly stalls at its highest or lowest positions and causes paper jams.

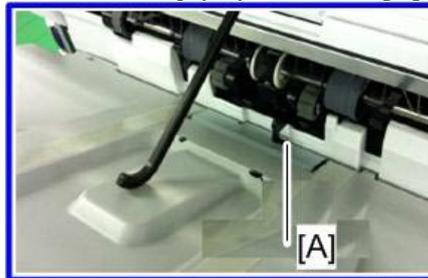
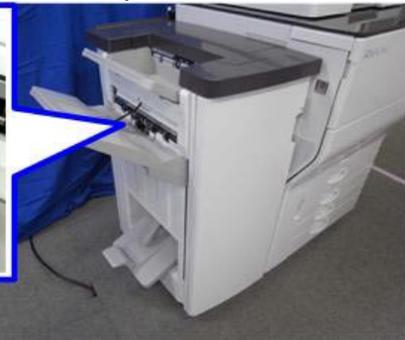
d135a0065

The shift tray paper feeler [A] is out of position.

The problem occurs if the Shift Auxiliary Tray [A] included with the finisher is set incorrectly. In this condition, the feeler gets caught between the auxiliary tray and shift tray when the shift tray moves up and is displaced.

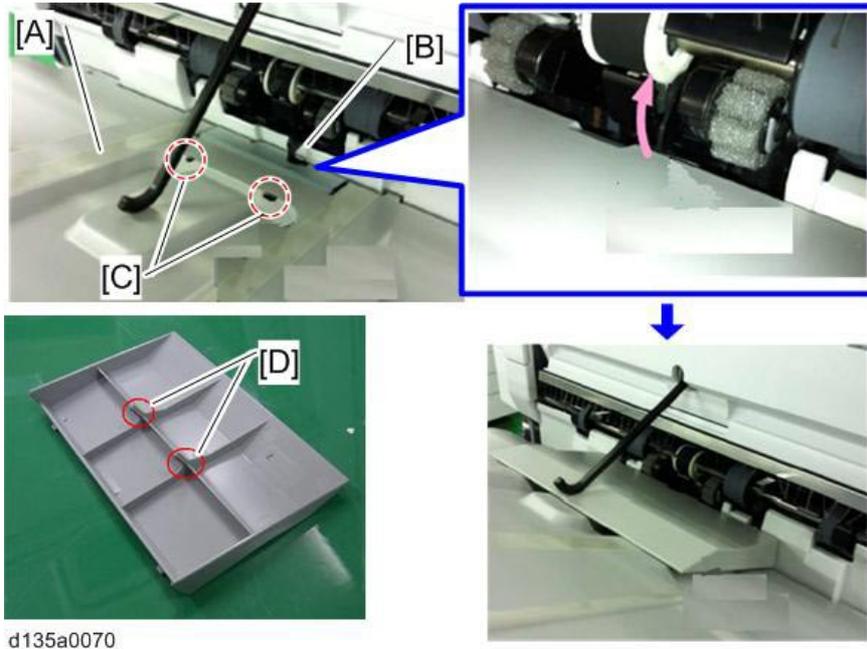
d135a0070

Good	Bad
<p>There is no space between the Shift Auxiliary Tray [A] and shift tray [B].</p>	<p>The Shift Auxiliary Tray [A] is positioned above the feeler, creating a space between the Shift Auxiliary Tray and shift tray [B].</p>

Start the finisher initialization process to raise the shift tray [A]. As you lift up and hold the shift tray paper feeler [B] up, insert the two bosses [D] on the back of the Shift Auxiliary Tray into the two holes [C] in the shift tray.

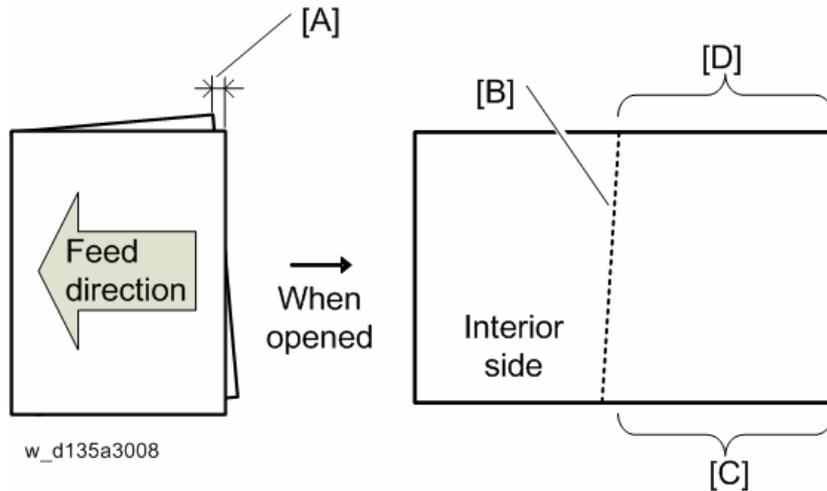
When sheets are center-folded, the fold line [B] is slanted, causing the front side [C] to be longer than the rear side [D], resulting in a misalignment [A].

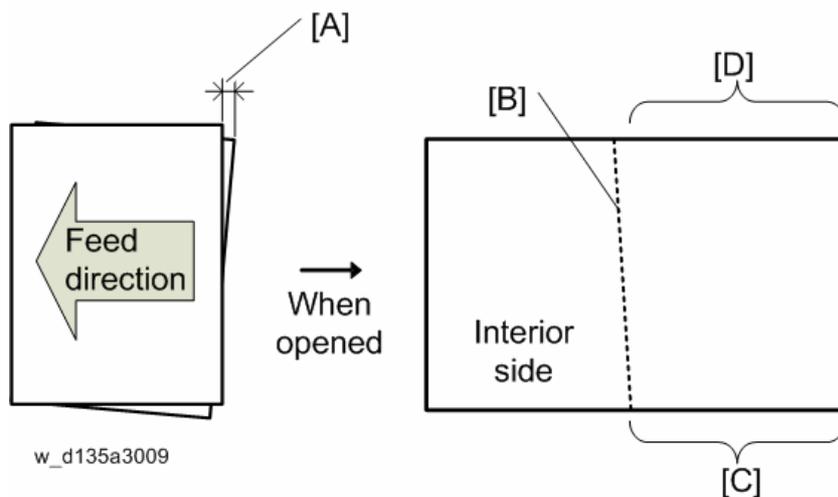
When sheets are center-folded, the fold line [B] is slanted, causing the front side [C] to be shorter than the rear side [D], resulting in a misalignment [A].

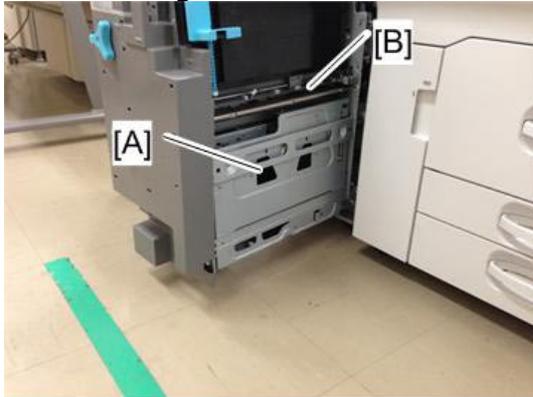
d135a0083

Incorrect angle between the bottom fence [A] and folding plate [B]

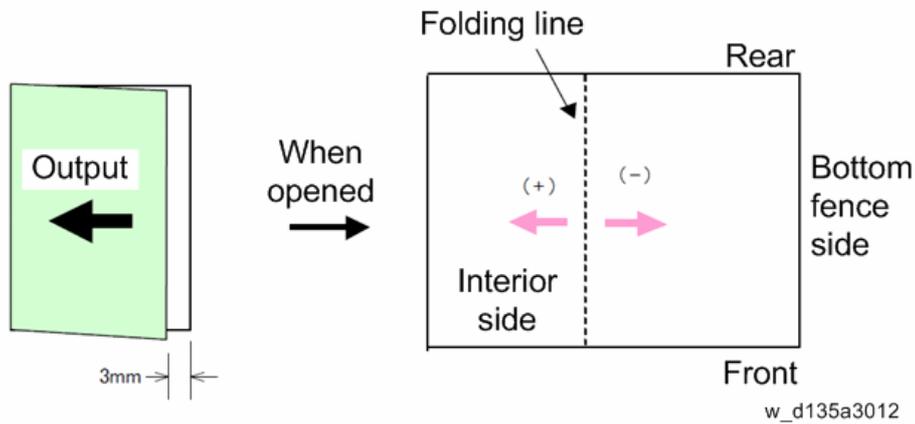
Example: If the folding line appears as below with a misalignment gap of 3mm, shift the folding line "-1.5mm" in the (-) direction.

4. If the adjustment up to this point has caused the folding position to shift to either left or right, make corrections in SP6-113 ([BookletFolderPosAdj:2K/3K FIN]).

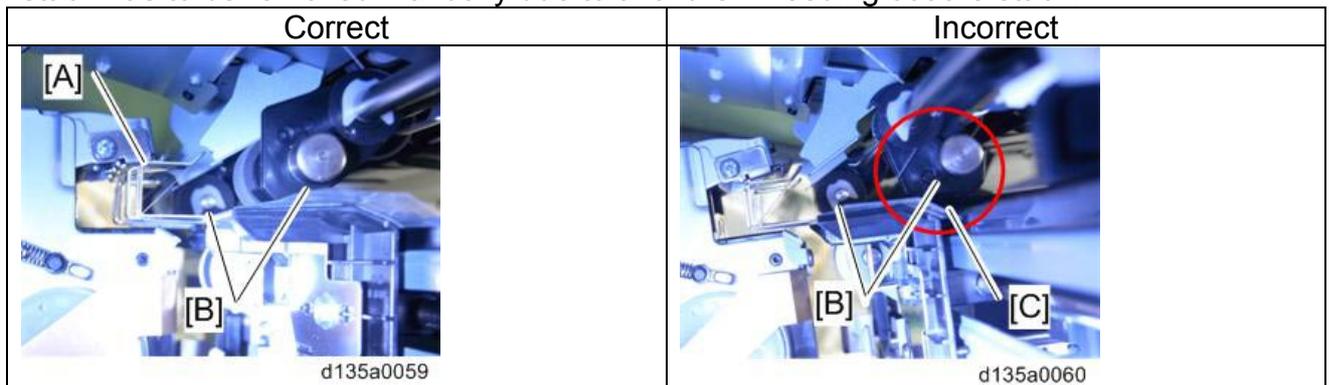
Stacking and stapling is disabled because the drag rollers [B] are stuck on top of the staple tray [C]. This could happen when the trailing edge of the stacked sheets are curled, because curled sheets tend to pull the drag rollers. Another causing factor is when the stack has to be removed manually due to a failure in feeding out the stack.

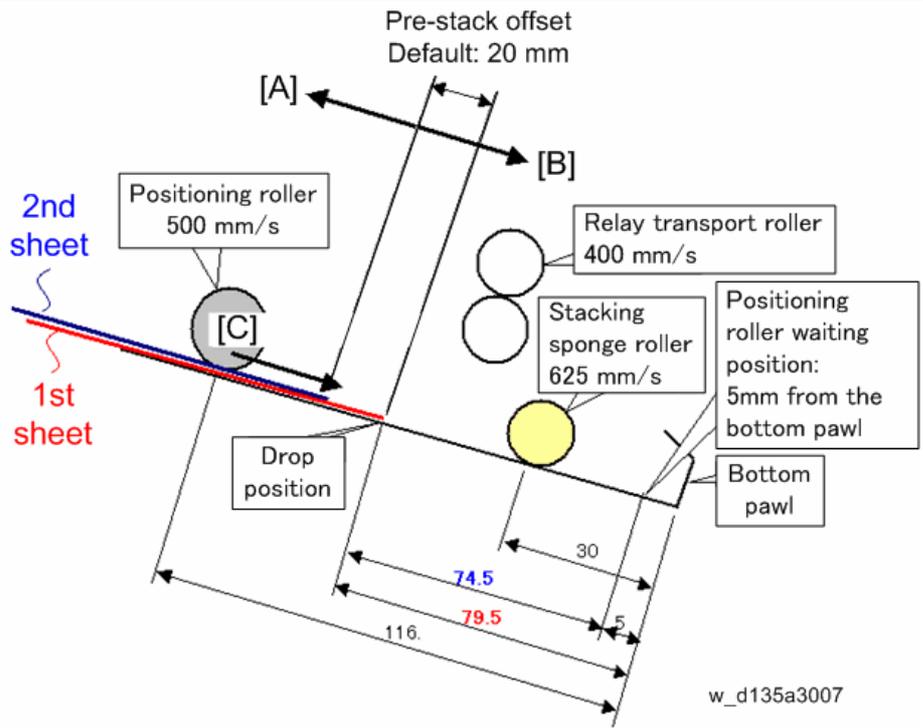
- [CrnrStplrPrstkOffsAdj:2K/3KFIN] (range: ±16 mm, step: 2 mm)
When adjusted in the + direction, pre-stack offset increases in the [A] direction.
When adjusted in the - direction, pre-stack offset decreases in the [B] direction.
- [CrnStpPosExFeedAmtAdj:2K/3KFIN] (range: 0 to 30 mm, step: 10 mm)
Increasing this value shifts the sheet toward direction [C].

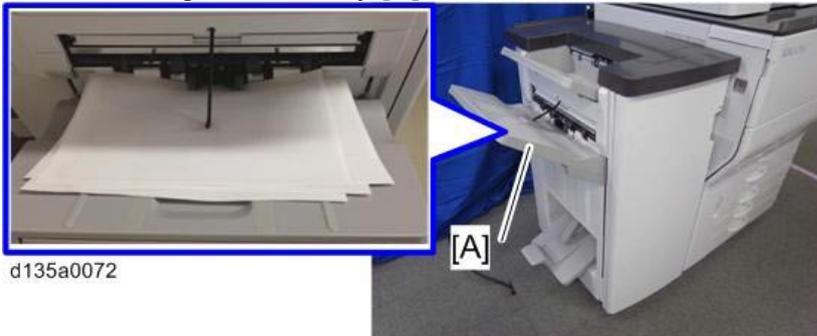
Poor stacking on shift tray [A]

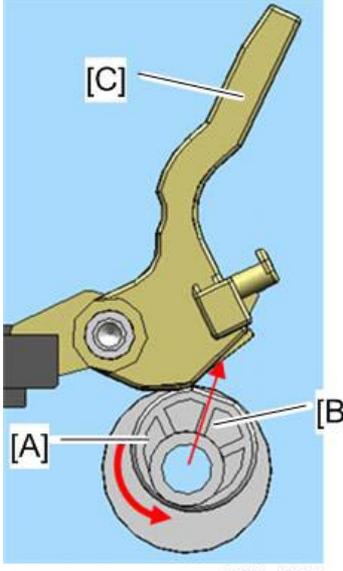
<p>d135a0077</p>

Correct	Incorrect
<p>The center rib [B] of the cam [A] is facing straight up and the paper stacking holder [C] is in contact with the flat surface of the cam [A].</p>	<p>The center rib [B] of the cam [A] is slanted and the paper stacking holder [C] is not in contact with the flat surface of the cam [A].</p>

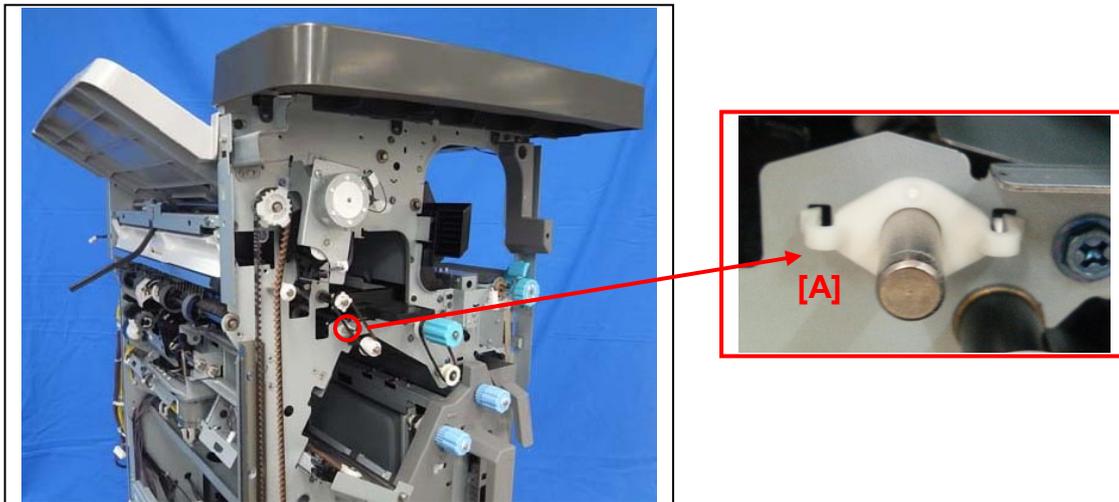
Bushing [A] is not set correctly and slipped from the machine during our factory assembly procedure. As a result, the shift motor shaft cannot rotate correctly.

The affected bushing is attached in the final assembly procedure. In addition, to ensure that the position of the bushings is correct, a visual inspection has been added to the production procedure in the factory. Please refer to the cut-in serial numbers below.

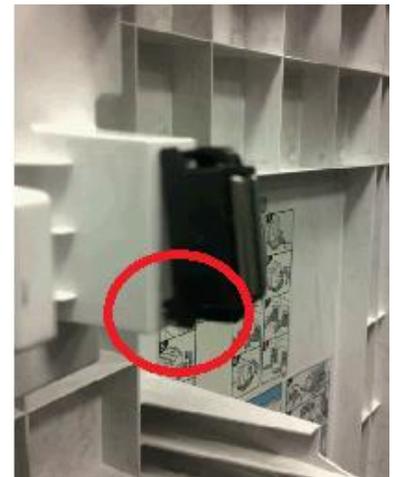
The magnet attached to the magnetic door catch is loose and the front cover does not completely close, displaying a front cover open error message on the operation panel.

- 1) If the magnet is loose, reattach it.
If the magnet cannot be reattached properly, procure the modified magnetic door catch (p/n: D6886124).
- 2) A check procedure to confirm proper attachment of the magnet was added at the factory.

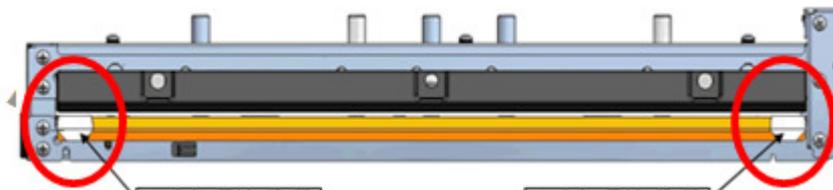
The paper contacts the Mylar on the punch unit (circled in red below).
