| Model: Katana | | Date:14-Jul-06 | No.: RB234015 |
| Subject: Service Manual Revision | | Prepared by: S. Ishizu | |

| Model: Katana (Bellini-C3) | | Date: 2-Aug-07 | No.: RB234036 |
| Subject: SR5000 Staple Rear Fence Broken | | Prepared by: M. Matsuda | |

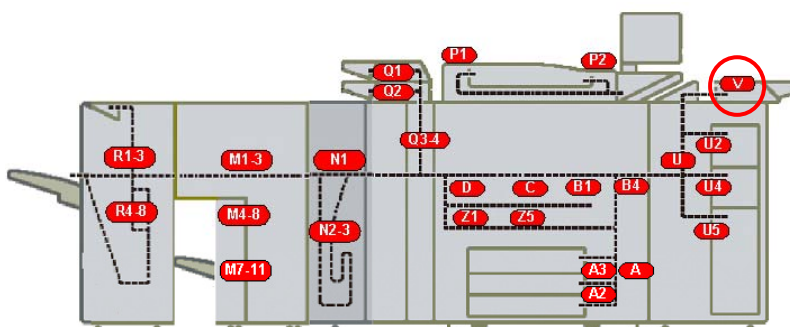
B234T050.WMF

**5. Corrected the label "Y" to "V". <Page: 4-5>**

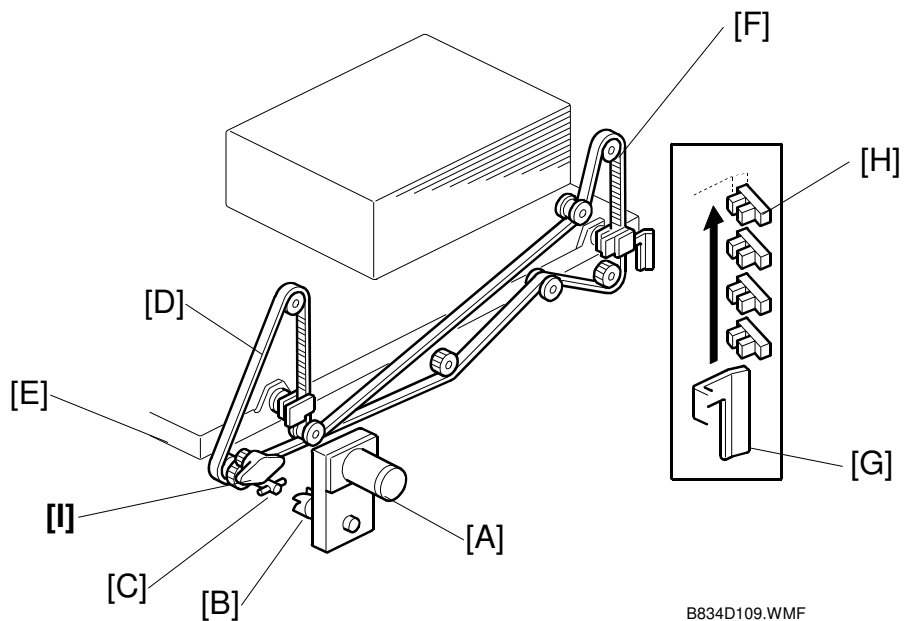
**10. Moved callout “[I]” to correct position. <Page: B834-24>**

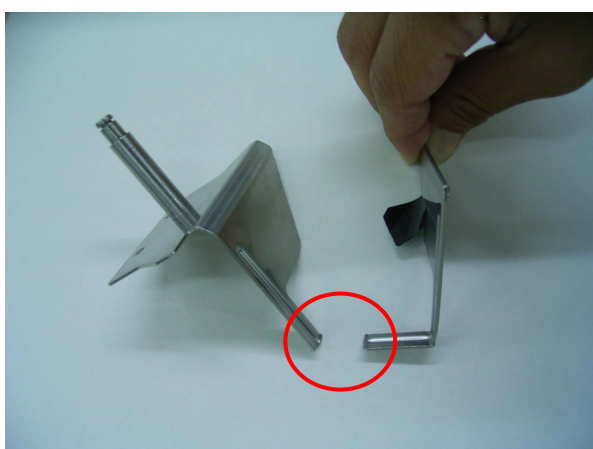
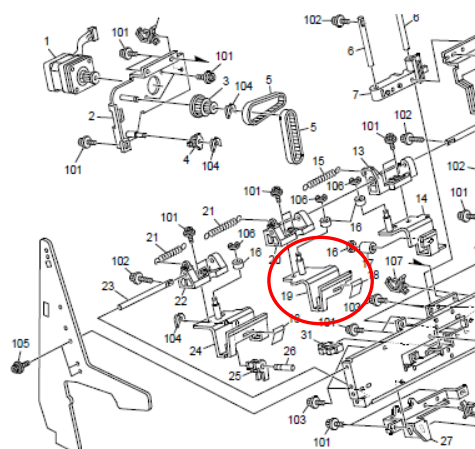
The rear fence for the SR5000 staple tray (P/N: B8304521) breaks, as shown below.

The bending angle of the rear fence was incorrect from the time of production. As a result, the stapler head may hit the rear fence repeatedly during stapling.

- The part of the rear fence that can contact the stapler head will be removed.
- A new factory inspection will be added for the rear fence.

Check the rear fence at the next service visit, and replace the rear fence with a inspected rear fence (P/N **B2349905**, FOC) under these conditions:

- If there is a mark on the rear fence where the stapler head has hit it
- If this symptom has occurred

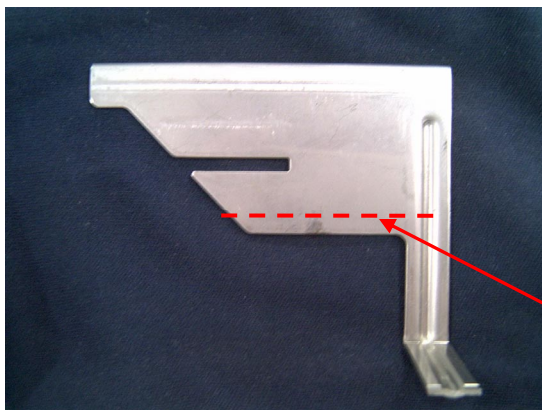
This area  
will be  
removed

**Applied from:** September 2007 production (new P/N and S/N to be announced by MB).

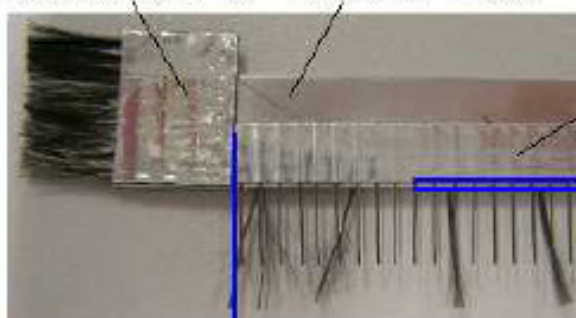
When stacking the papers in the stack unit, a few sheets don't get adjusted correctly so some sheets don't get stapled.

Paper sticks together because of static electricity.

5. Attach "B3011216" (discharge brush for individual support) as shown in the photo below, then fasten it with the bracket to the paper exit guide plate.  
*Attaching Position of the Discharge Brush (for individual support)*

Set flush with  
A6972131  
(Space to be  
within 1 mm)

Space to be  
within 1 mm

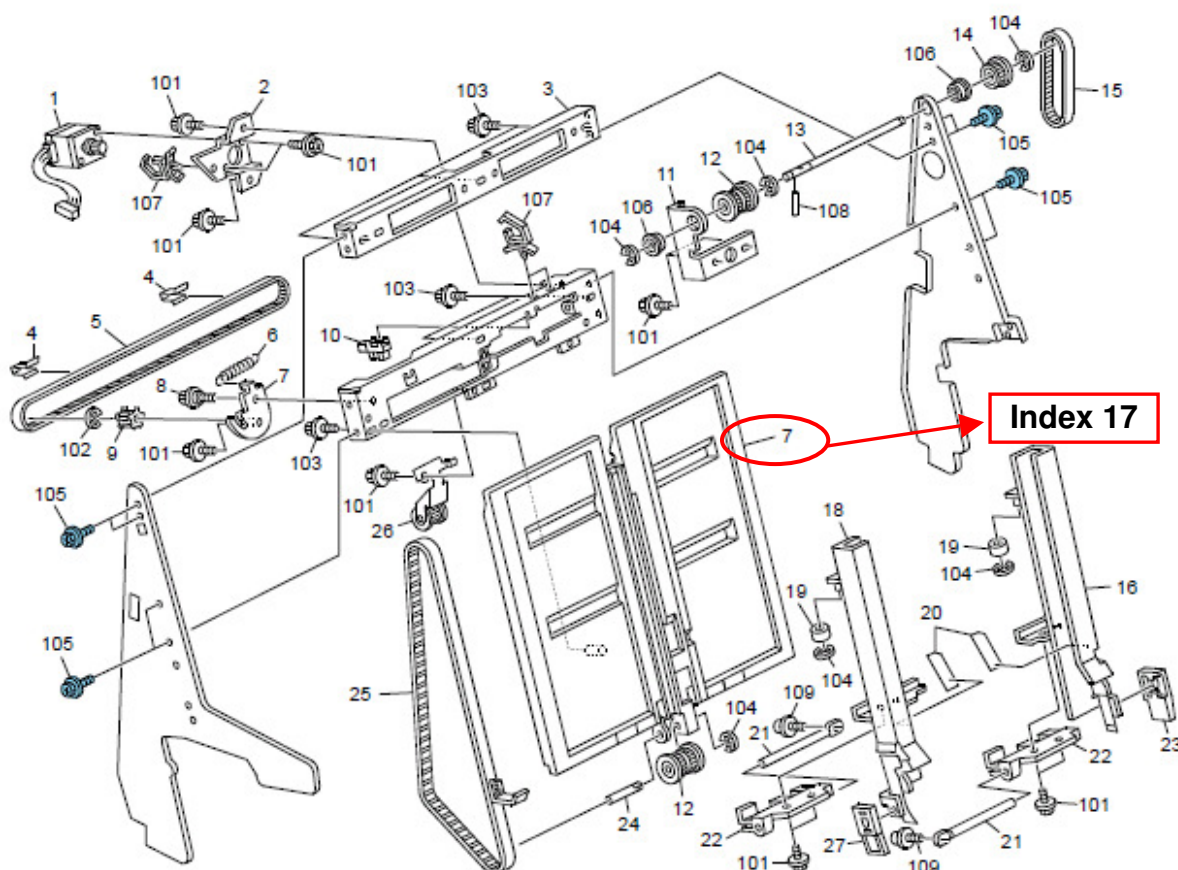
### 3. Staple Tray 2 (B830)

B8304711 (Guide Plate-Stapler Tray) was falsely indexed as #7 in the diagram.  
The correct index number for this part is #17.
