Subject: Firmware Release Note: Finisher_COLUMBIA		Prepared by: T. Tadokoro	
From: PPBG QA/Service Planning Dept.			
Classification:	<input type="checkbox"/> Troubleshooting <input type="checkbox"/> Mechanical <input type="checkbox"/> Paper path <input type="checkbox"/> Product Safety	<input type="checkbox"/> Part information <input type="checkbox"/> Electrical <input type="checkbox"/> Transmit/receive <input checked="" type="checkbox"/> Other (     )	<input type="checkbox"/> Action required <input type="checkbox"/> Service manual revision <input type="checkbox"/> Retrofit information <input type="checkbox"/> Tier 2

Model: B-C4		Date: 06-Apr-09	No.: RD059019
Subject: Booklet Finisher SR5020 staple position adjustment		Prepared by: T.Tadokoro	
From: PPBG QA/Service Planning Dept.			
Classification:	<input type="checkbox"/> Troubleshooting <input type="checkbox"/> Mechanical <input type="checkbox"/> Paper path <input type="checkbox"/> Product Safety	<input type="checkbox"/> Part information <input type="checkbox"/> Electrical <input type="checkbox"/> Transmit/receive <input type="checkbox"/> Other (     )	<input checked="" type="checkbox"/> Action required <input type="checkbox"/> S

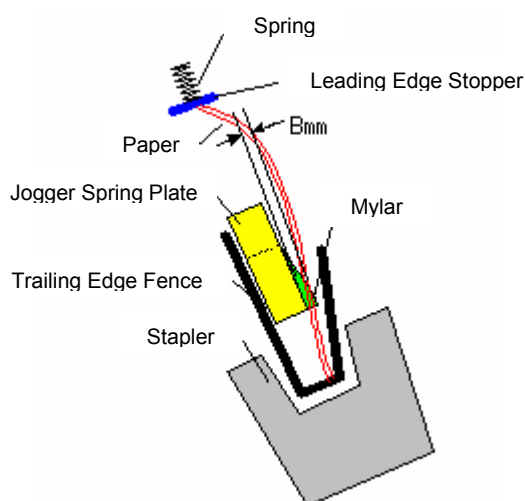
Staple positioning could be misaligned on the SR5020 when stapling 2-4 sheets in “rear-oblique” mode with a paper size of A4 short-edge feed or smaller.

Misaligned stapling is caused by the shifting of the stacked paper when the stapler clinches. A portion of the trailing edge of the stack of paper interferes with (is caught by) the Jogger Spring Plate as it is bent when jogged by the Spring, which causes the shift.

If this problem is reported from the field, please follow the instructions of SP 6208 or Adjustment Settings for Operators.

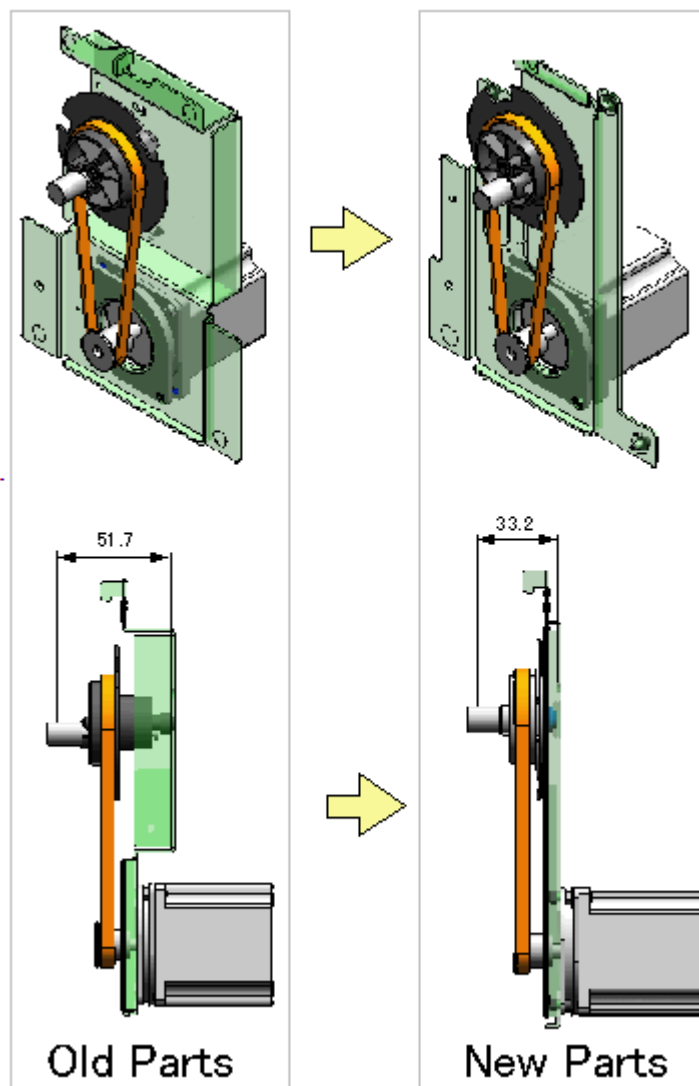
Fig.1

Failure occurs in the tray shift behavior when exceeding 2500 outputs to the shift tray when applying paper types that are relatively heavy considering the thickness such as coated paper.

Excess load to the component causes the timing belt and the gear to disengage.

Replace with the modified parts described in the table below.

Refer to Fig. 1 to identify whether the machine is installed with either old or new parts.

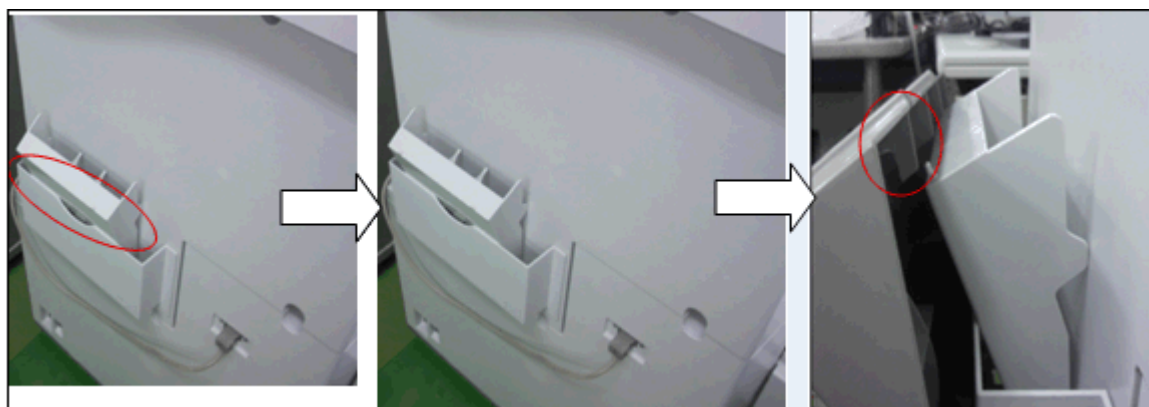
This tray should be used when stacking coated thin paper (less than 90gsm). It prevents sheets sticking together because a space is generated between the stacked sheets. Also, when not using this tray, it can be stored as shown below.

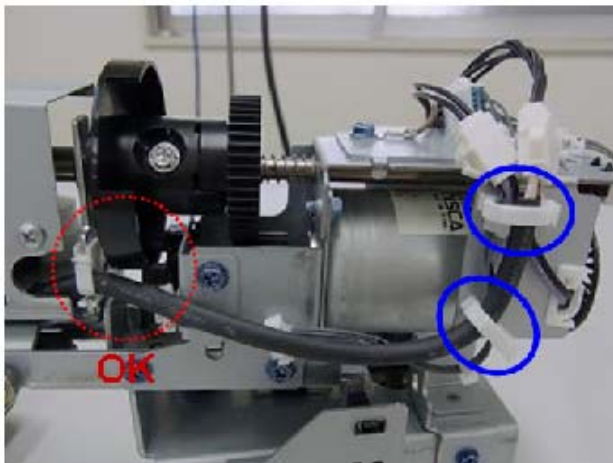
The harness cable must be routed through the clamps as shown in the photo below.

Route the harness cable correctly as described in the following section of the field service manual:

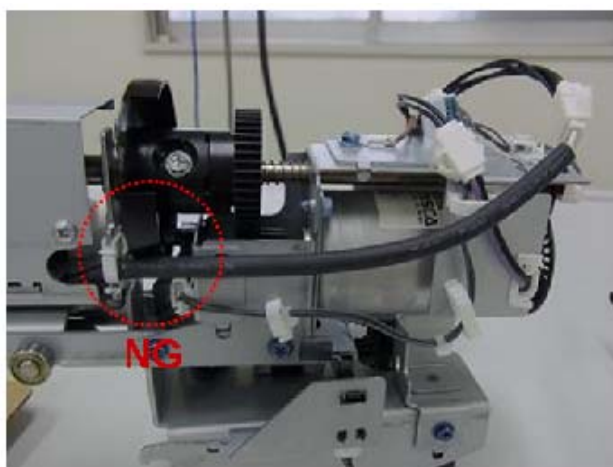
Harness cable of the punch unit is set incorrectly and is interfering with the ratchet (indexed 28), preventing the ratchet from retrieving its home position.

In the photo below, the harness cable is not routed through the clamps and is interfering with the ratchet.

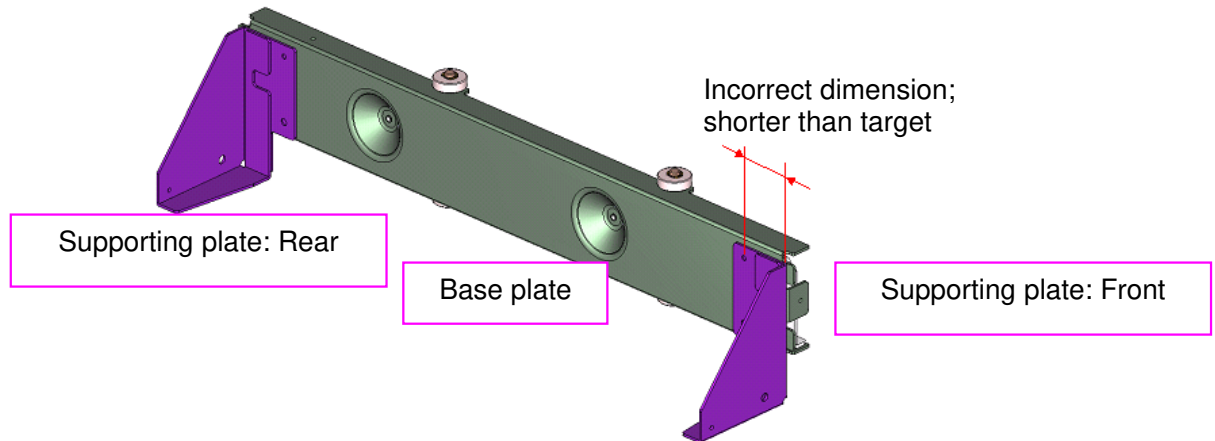
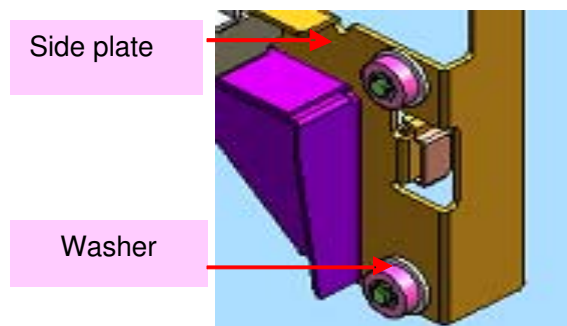
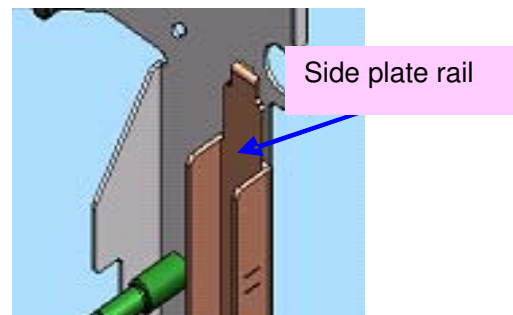
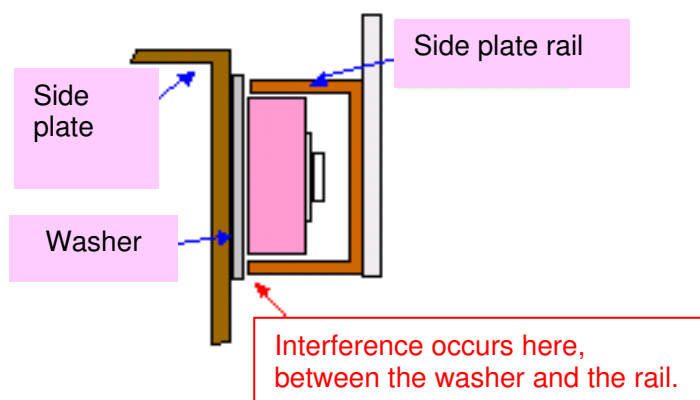
The front and rear supporting plates, which are bent and welded to the base plate, were bent in incorrect dimensions due to a fault in the manufacturing process. This causes the washer installed on the side plate to interfere with the side plate rail, preventing the shift tray from descending.

No data available at RCL. However, the occurrence rate is expected to be low based on the reports in Japan in which 4 units were found with the stated problem among 100 affected units.

When encountering SC750, verify if the cause of the SC is due to the fault in the supporting plates as described above by following the check procedure below.
