Model: Finisher SR5040/SR5030 (D512/D513)	Date: 20-Jun-11	No.:RD512001a
---	-----------------	---------------

Model: Finisher SR5040/SR5030 (D512/D513)		Date: 16-Dec-11	No.: RD512002
Subject: Finisher SR5030 Exit Roller damage by End Fence.		Prepared by: Hiroaki H Matsui	
From: PP Service Planning Department 1G			
Classification:	<input checked="" type="checkbox"/> Troubleshooting <input type="checkbox"/> Mechanical <input type="checkbox"/> Paper path <input type="checkbox"/> Product Safety	<input type="checkbox"/> Part information <input type="checkbox"/> Electrical <input type="checkbox"/> Transmit/receive <input type="checkbox"/> Other ()	<input type="checkbox"/> Action required <input type="checkbox"/> Service manual revision <input type="checkbox"/> Retrofit information <input type="checkbox"/> Tier 2

Subject: Modification for smooth Shift Tray motion		Prepared by: K. Tsutsui	
From: 1 st PP Tech Service Sec., PP Tech Service Dept.			
Classification:	<input type="checkbox"/> Troubleshooting <input type="checkbox"/> Mechanical <input type="checkbox"/> Paper path <input type="checkbox"/> Product Safety	<input type="checkbox"/> Part information <input type="checkbox"/> Electrica

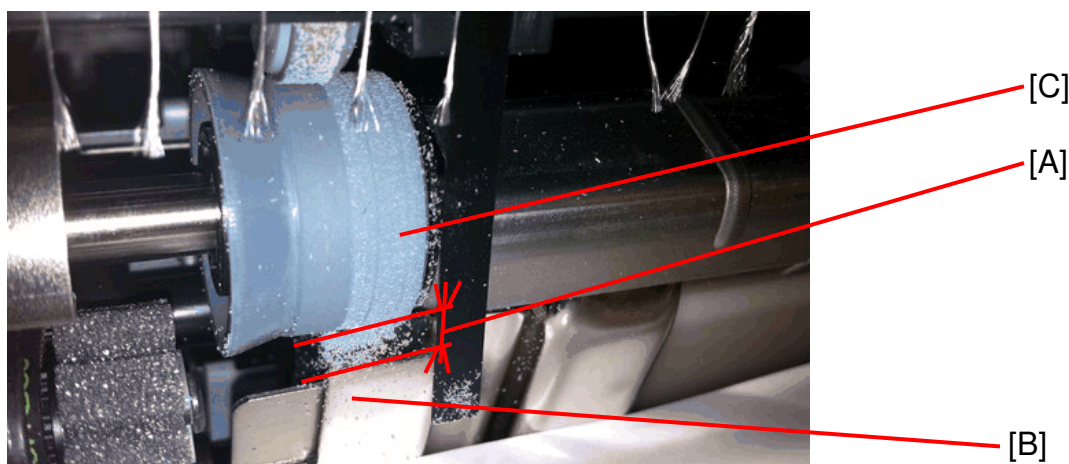
If a sufficient gap [A] is not secured between the End Fence [B] and the Exit Roller [C], the tip of the End Fence [B] could abrade the Exit Roller [C] in the worst case.

A sufficient gap is not secured between the exit roller [C] and the tip of the end fence [B] due to the inaccurate dimensions of the End Fence.

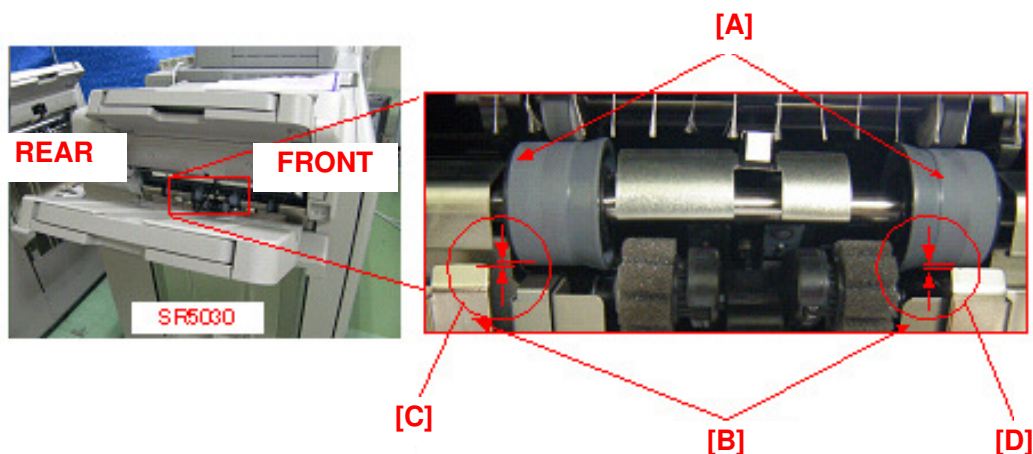
- [A]: Exit Rollers
- [B]: End Fences,
- [C]: Gap at Rear Side
- [D]: Gap at Front Side

2. If the measurements of the 2 locations [C] and [D] are 2.5 mm (approximately 0.1 inch) or smaller, replace the End Fence and the Exit Rollers with the countermeasure parts as a set.

NOTE: Countermeasure parts are supplied as P/N D0749902 (End Fence Kit).

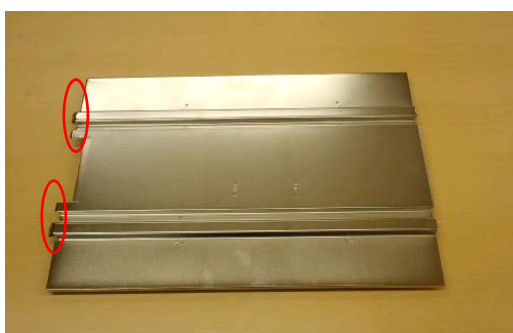
Countermeasure End Fence
(Length of the end fence edges has been shortened to prevent contact with the roller.)

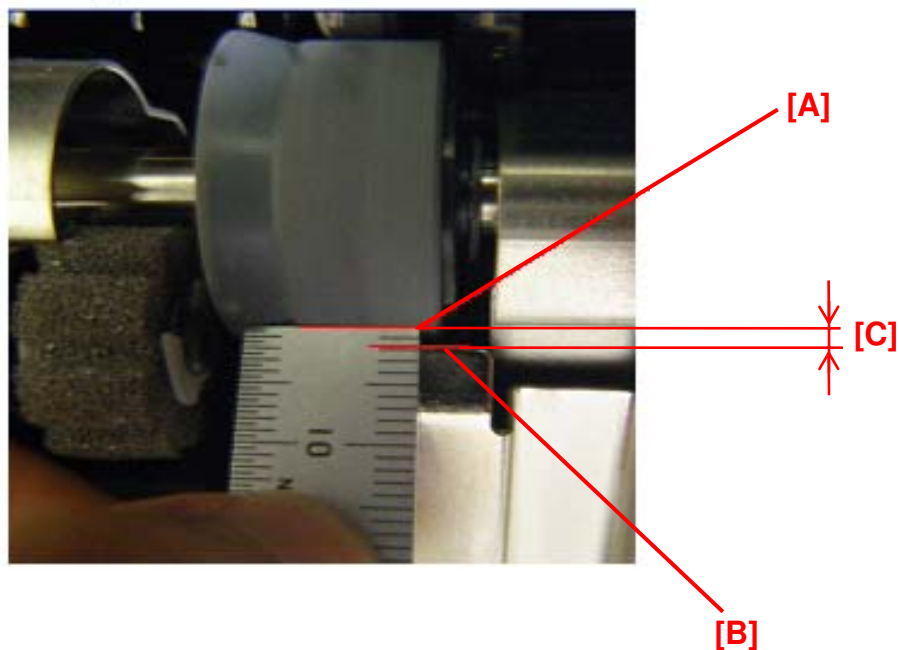
- Place the edge of the ruler [A] flush with the surface of the exit roller and measure the gap [C] between the roller and the tip of the end fence [B].

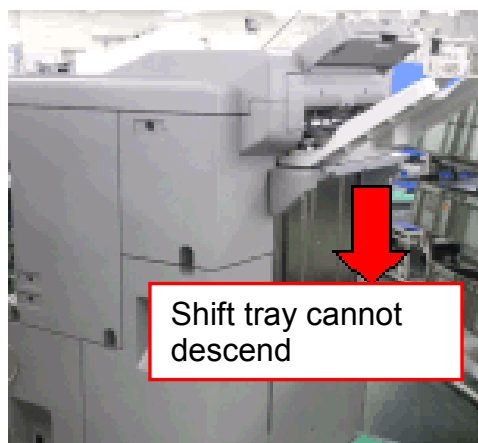
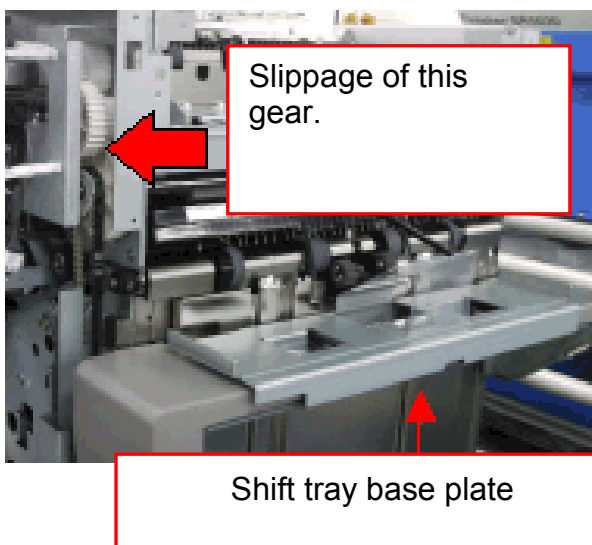
- SC750
- Shift tray cannot descend
- Slippage of the shift tray gear

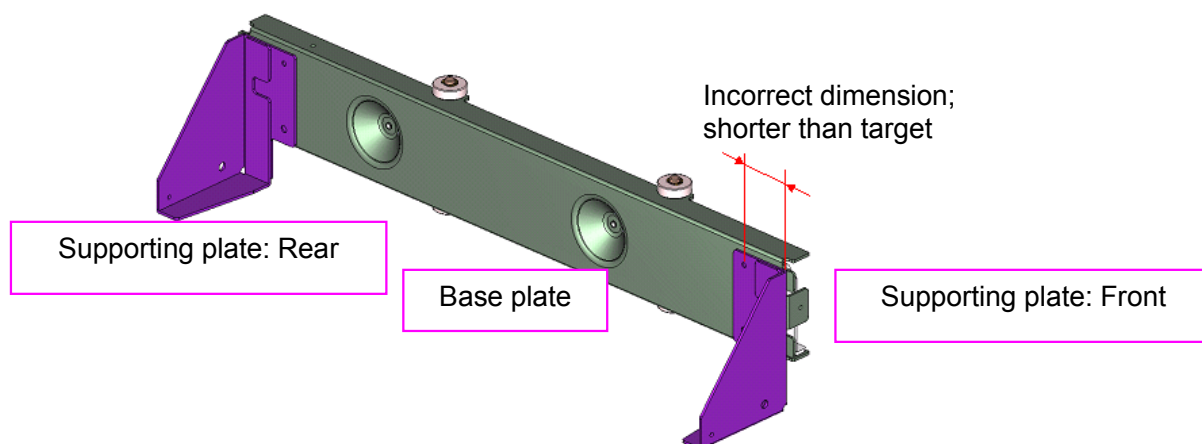
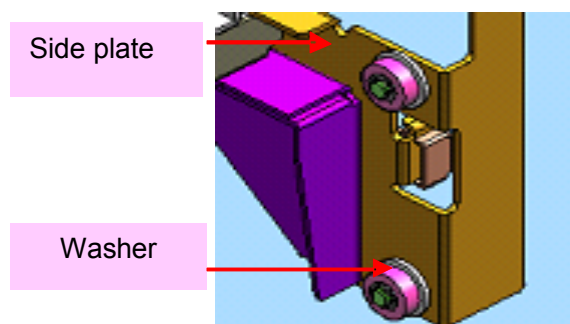
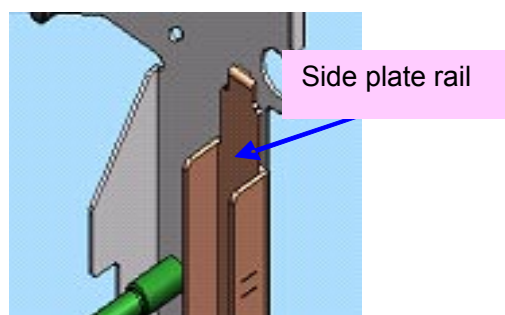
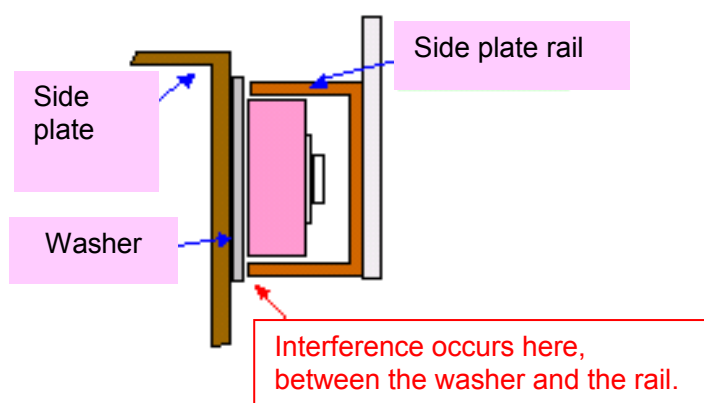
The front and rear supporting plates, which are bent and welded to the base plate, were bent in incorrect dimensions due to a fault in the manufacturing process. This causes the washer installed on the side plate to interfere with the side plate rail, stopping the shift tray from descending.
