| Model: Booklet Finisher SR5060 (D734) | Date: 7-May-15 | No.: RD734001 |

| Subject: Part change – Modified exit roller to prevent roller marks in saddle-stitched booklets | | Prepared by: T. Suzuki | |

| Subject: Request for rework to prevent Jam109 | | Prepared by: Shinnosuke Sasaki | |

| Subject: Booklet Finisher SR5060: Creases on the Leading Edges of Saddle-Stitched Sheets | | Prepared by: Hiroaki H Matsui | |

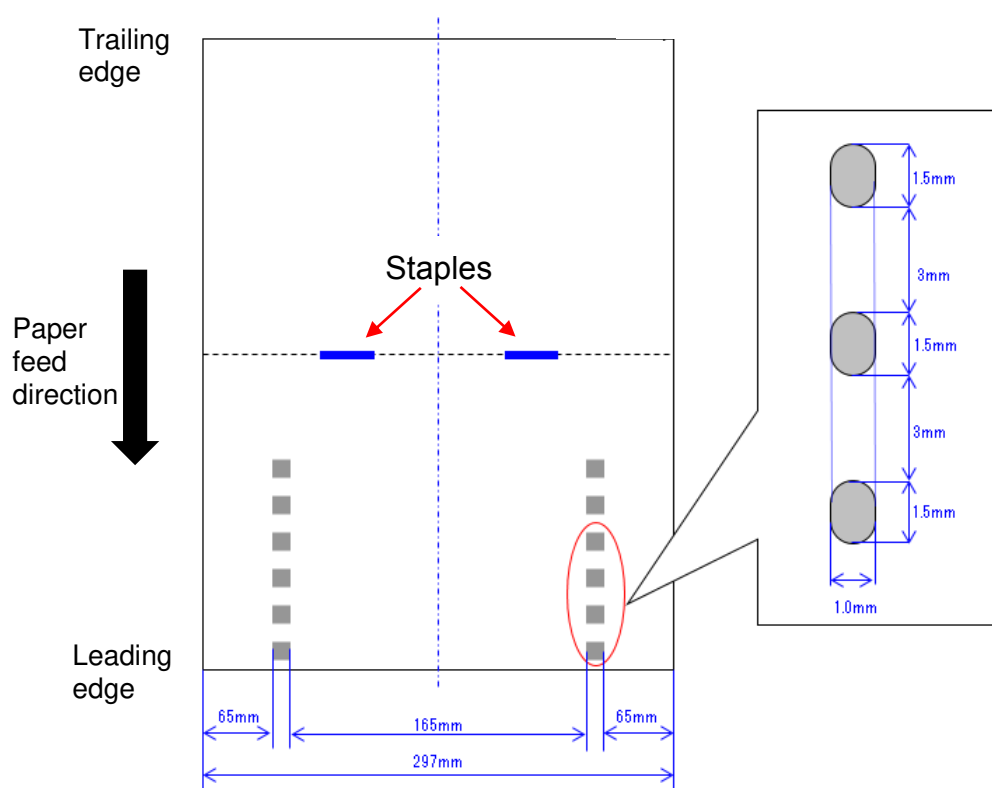
Roller marks appear along the feed direction until about halfway down from the leading edge in saddle-stitched booklets.

The flanges of the exit roller press the paper.

The exit roller was modified. The new exit roller does not have the flange.

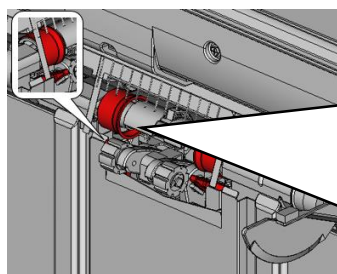
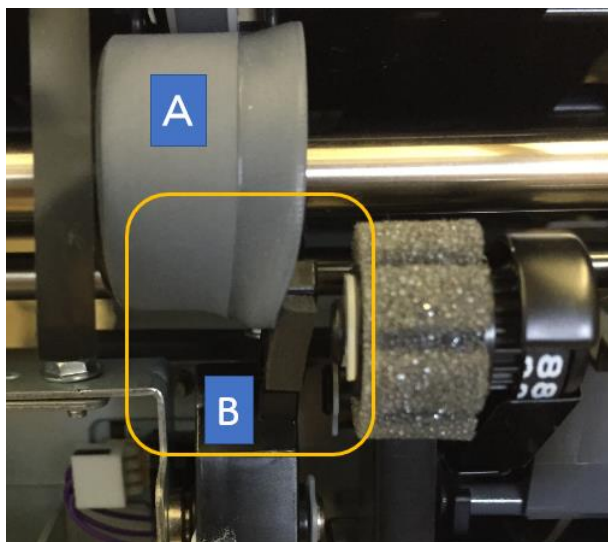
[A] Exit roller  
[B] Press-down lever

Jam109 occurs when printing on coated paper 364.1mm or longer.

The press-down lever interferes with the exit roller, because sufficient clearance is not secured between these components due to fluctuations in the dimensions of the lever.

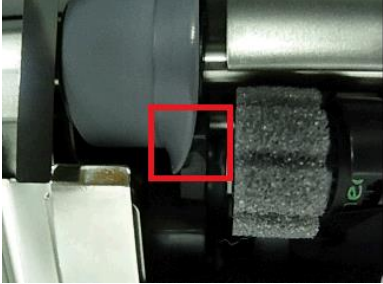
| Model: Booklet Finisher SR5060 (D734) | Date: 31-Jul-15 | No.: RD734005 |
|---|---|---|
| <p>4</p> <p>Parts manufacturing error</p> <p>The exit roller and press down lever interfere with each other's movement.</p> | <p>Replace the lever brackets.<br/>(See RTB #RD734003 for details).</p> | |

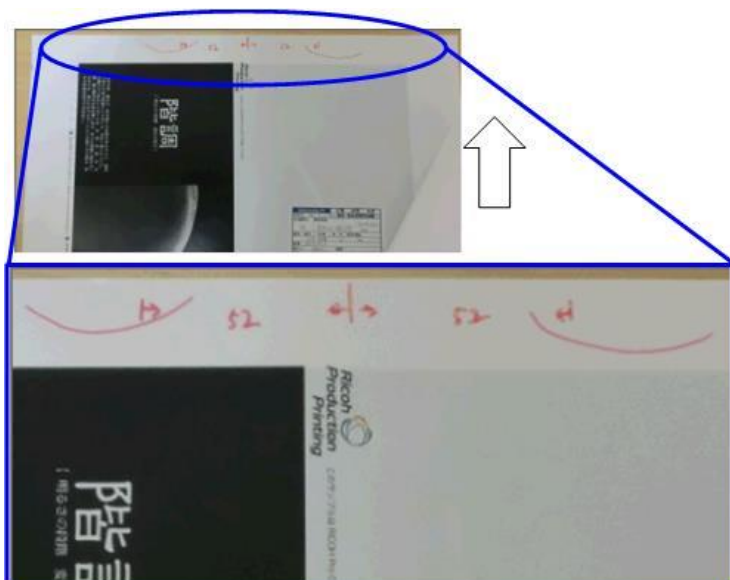
Two creases appear on the leading edge.  
 (The arrow indicates the paper feed direction.)

Excessive pressure is applied to the paper when aligning the pages against the guide plate in the booklet unit.

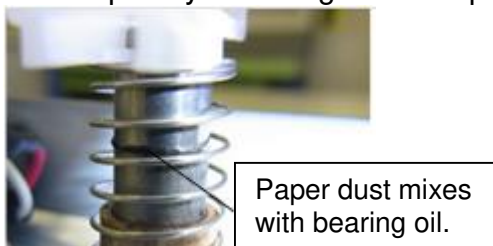
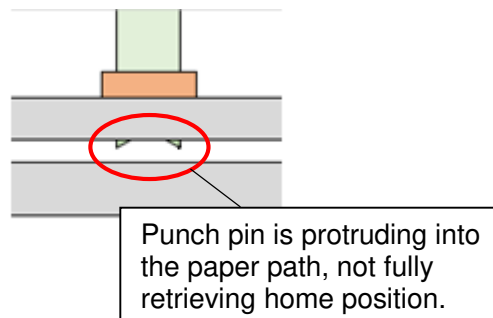
Paper dust mixed with bearing oil builds up over time and hinders smooth movement of the pins. In this condition, the punch motor stops earlier than expected and prevents the pins from completely returning to home position.

Firmware was modified to delay the time that the punch motor stops, to allow enough time for the pins to completely return to home position.

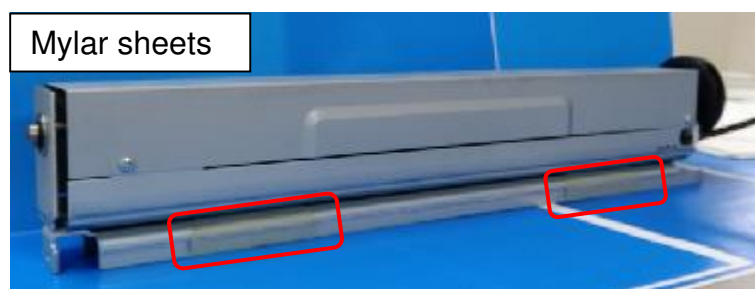
p/n: D4491231  
GUIDE: PUNCH UNIT

Printing frequently on paper containing abundant calcium carbonate abrasives and eventually damages the Mylar sheets attached to the guide plate of the punch unit, and causes Jam 125 and SC720-25.

Check the condition of the Mylar sheets at every 2,000k pages (total counter of the printer/copier mainframe) and replace, if worn/damaged.

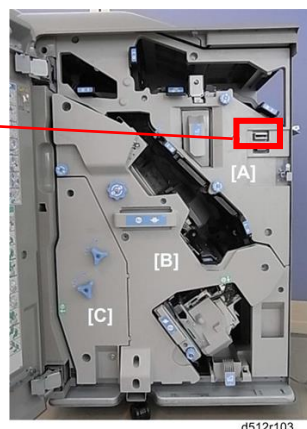
The contact surfaces of the interlock switch on the finisher door were covered by small insulating impurities during the plating process. As a result, a contact failure may occur in the switch.

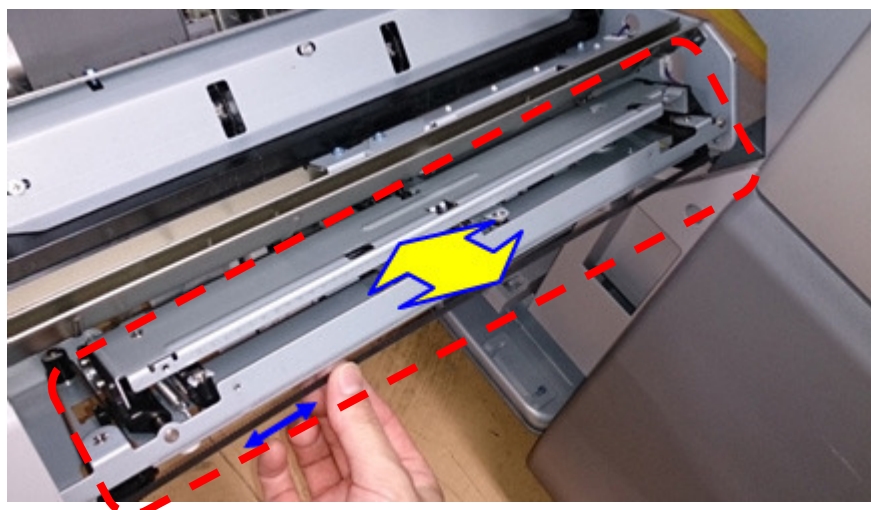
The corner stapler unit does not move properly and/or smoothly.

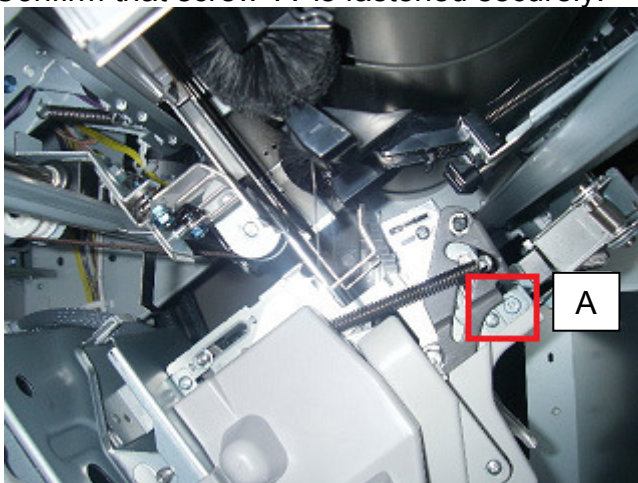
2. Confirm that screw 'A' is fastened securely.

**IMPORTANT:** If the screw is **loose** or lost, then tighten it (or replace with an M3 x 6 screw).

**Note:** Screw originally attached are fastened with an anti-loosening agent, so that, change the screw to M3 x 6 and tighten it, when it is loosened once, since fastening force decreased.

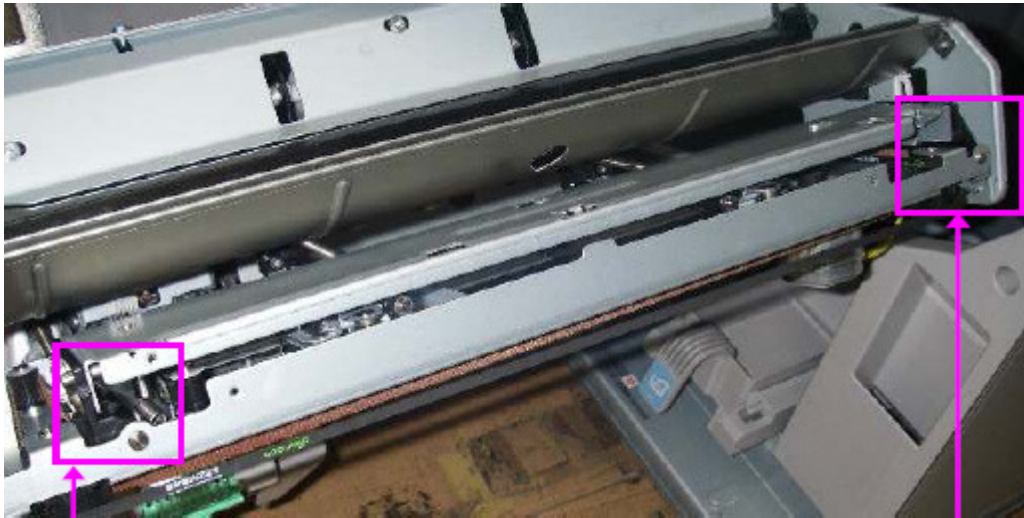
\* The gap should be approximately 2.6mm +/- 0.8mm at both the front and rear sides.

**Note:** If the difference in the gap between the front and rear is larger than 2.0mm, an excess load could be put on the corner stapler stack unit, causing the SC.

Do 'Adjustment **A**' if the gap **at the front is larger** than at the rear.  
Do 'Adjustment **B**' if the gap **at the rear is larger** than at the front.

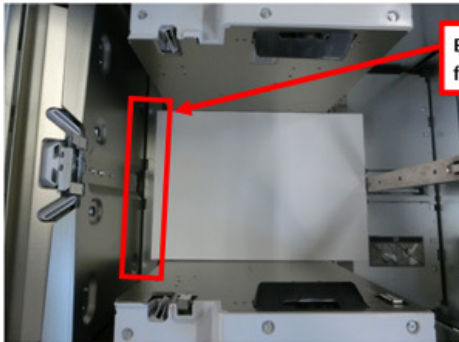
Bad example 1

Excess space is observed between the face plate and leading edge of the paper.

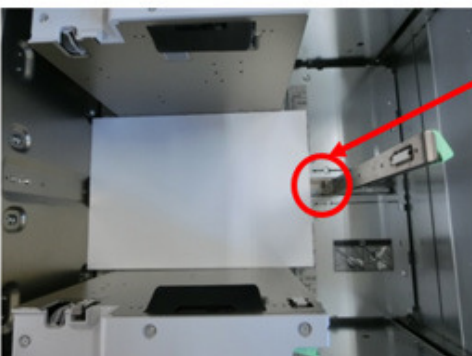
Bad example 2

Excess space is observed between the end fence and trailing edge of the paper.

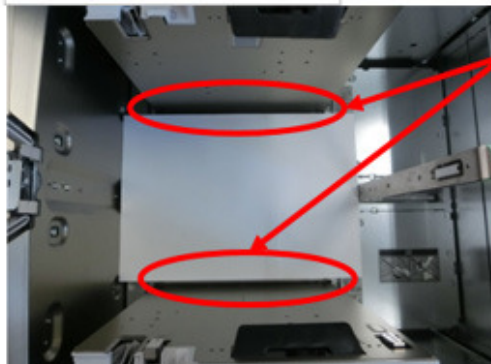
Bad example 3

Excess space is observed between the side fences and edge of the paper.

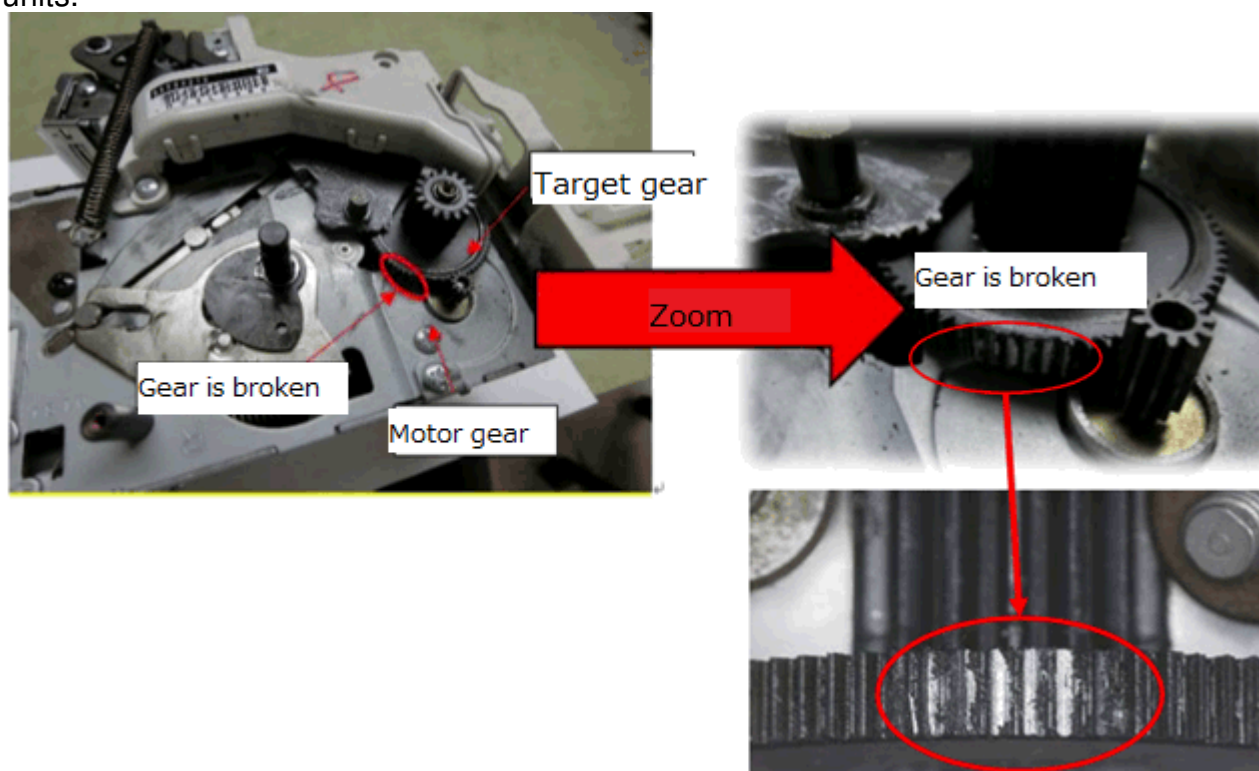
The gear on staple unit gets damage since defective gear is contained in some of staple units.
