Model: Finisher for the AD3		Date: 31-July-97	No: 1
Subject: ROM modification for Main Control Board		Prepared by: E. Fukuyama	
From: QAC 2nd Field Information Dept.			
Classification:	<input type="checkbox"/> Troubleshooting	<input type="checkbox"/> Part information	<input type="checkbox"/> Action required
	<input type="checkbox"/> Mechanical	<input type="checkbox"/> Electrical	<input type="checkbox"/> Service manual revision
	<input type="checkbox"/> Paper path	<input type="checkbox"/> Transmit/receive	<input type="checkbox"/> Retrofit information
	<input type="checkbox"/> Other ()

Model: Finisher for the AD3		Date: 30-Sep-97	No: 18
Subject: SC101		Prepared by: E.Fukuyama	
From: QAC 2nd Field Information Dept.			
Classification:	<input checked="" type="checkbox"/> Troubleshooting	<input type="checkbox"/> Part information	<input type="checkbox"/> Action required
	<input type="checkbox"/> Mechanical	<input type="checkbox"/> Electrical	<input type="checkbox"/> Service manual revision
	<input type="checkbox"/> Paper path	<input type="checkbox"/> Transmit/receive	<input type="checkbox"/> Retrofit information
	<input type="checkbox"/> Other ()

Entrance Guide Installation Procedure

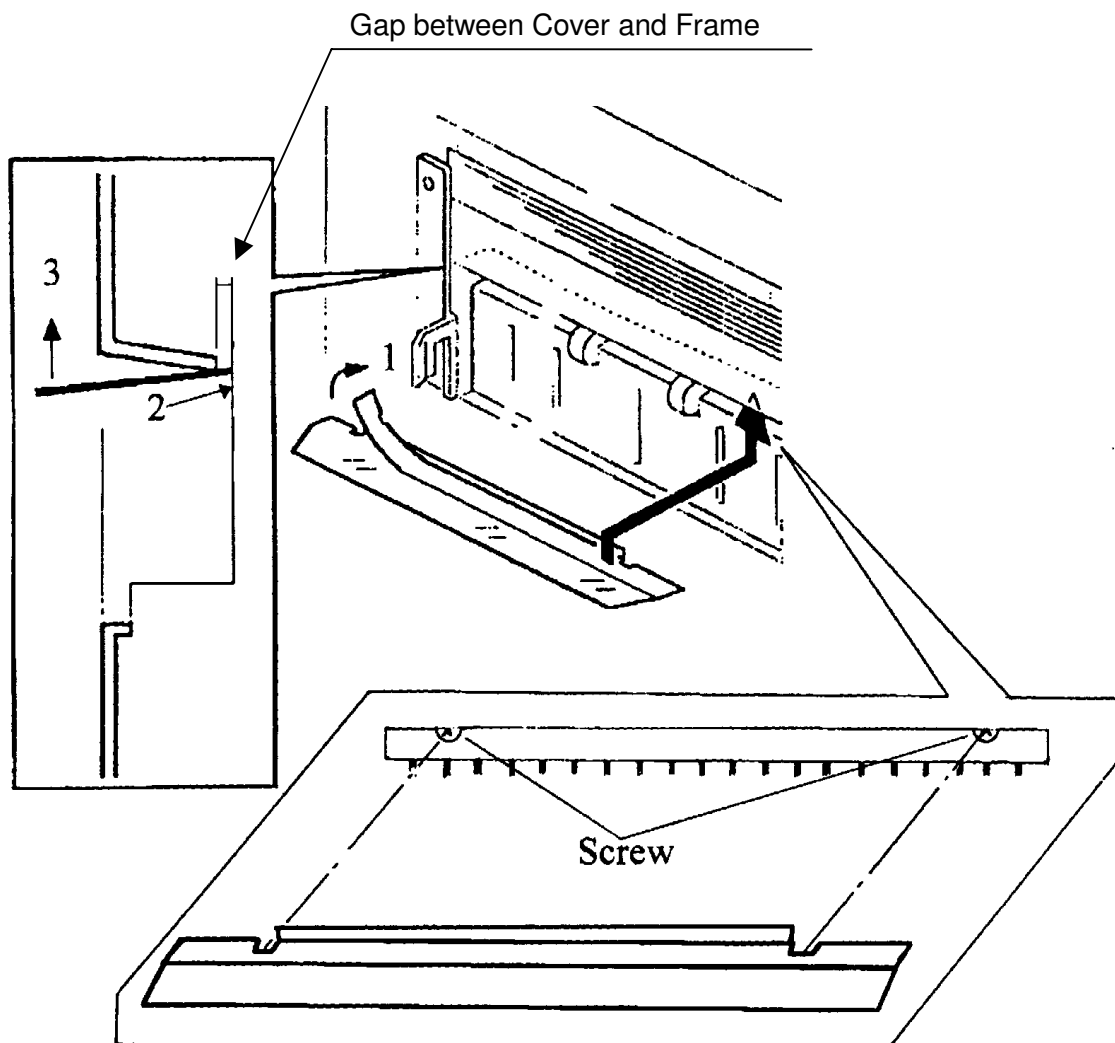
New Entrance Guide

If the Entrance Guide is not installed in the proper position, a gap may develop between the Cover and the Main Frame through which the heat and humidity generated by the paper may enter and lead to high temperature/high humidity around the lamp stabilizer.

During the set-up of a Finisher manufactured after May 1997, please install the Entrance Guide in a manner that will prevent a gap from developing between the Cover and the Main Frame. Please refer to the attached page for this procedure.

In the event of an SC101 on a Finisher manufactured before April 1997, please replace the Entrance Guide with part number A6122333.

1. Peel off the tape seal for the Entrance Guide
2. Place the Entrance Guide on the Main Frame.
3. Attach the Entrance Guide to the Cover
