| Model: NAD 30S/30/40 (3000-sheet Finisher) | | Date: 30-Jun-98 | No: 7 |
| Subject: Paper rolled-up on the shift tray | | Prepared by: M.Mimura | |
| From: QAC Field Information Dept. | | | |

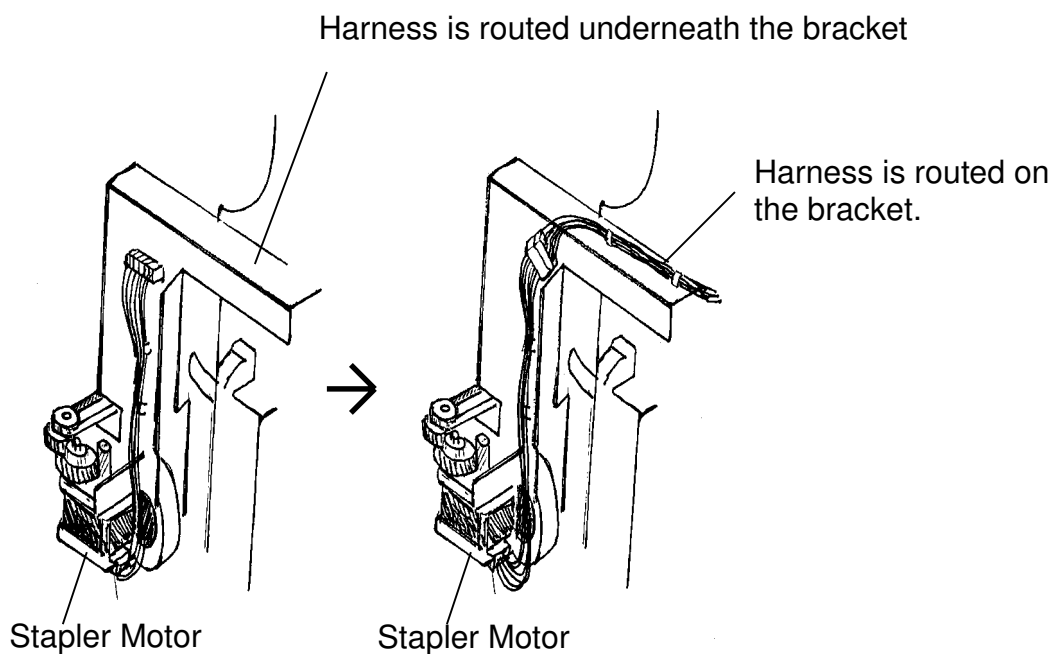
To prevent the stapler motor harness from being damaged, the harness route has been changed as shown in the illustration below:

Cut-in serial number for the harness route change:

- A697 - 15 : 1B59030221~
- 17 : A7779030001~
- 22 : AR39030001~
- 26 : 3R10390001~
- 55 : L0329032032~

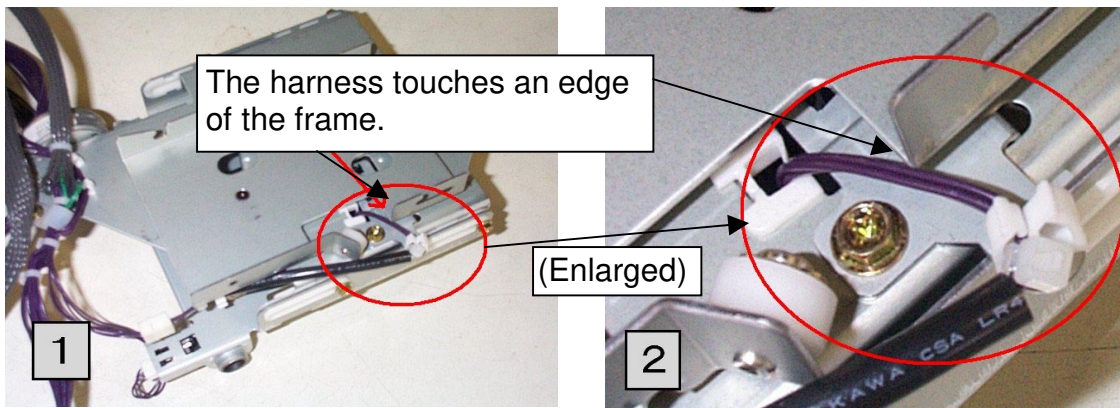
SC621 is generated during copy cycle.

The stapler rotation HP sensor harness shorts to the frame
