| Model: Bellini | | Date: 30-May-00 | No.: RA294014 |
| Subject: Finisher ROM History | | Prepared by: H.K. | |

| Subject: Finisher - Punch Waste Full Condition | | Prepared by: H.K. | |

| Subject: Finisher: Poor Front Cover Sheet Positioning | | Prepared by: H.K. | |

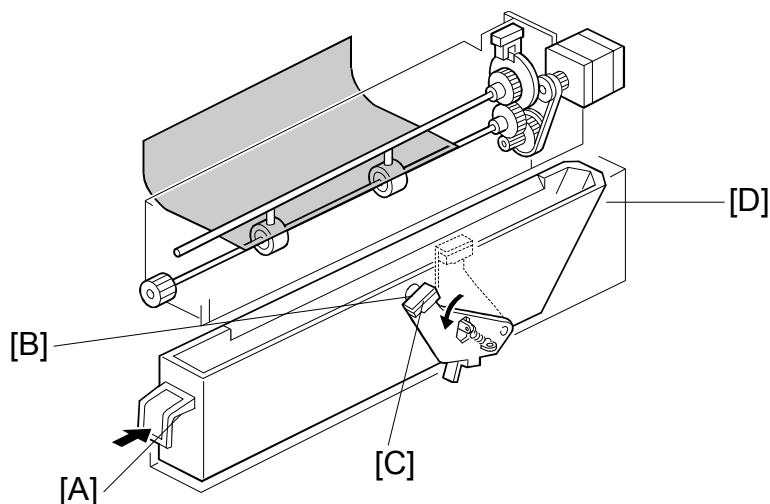
B302D002.WMF

The punch waste is collected in the punch waste hopper [A], which is under the punch unit.

*When the punch waste covers the hole [B] in the hopper, the punch waste hopper sensor [C] turns on and a message will be displayed after the copy job finishes.*

*When the punch waste covers the hole [B] in the hopper, the punch waste hopper sensor [C] turns on and a message will be displayed in the operation panel LCD. Then, the copy job will be stopped. After emptying the punch waste and returning the punch waste hopper [A] to the finisher, the copy job will be resumed.*

We have found an incorrect description of the punch waste full condition on page B302-18 in the finisher service manual. Please correct the service manual as follows:

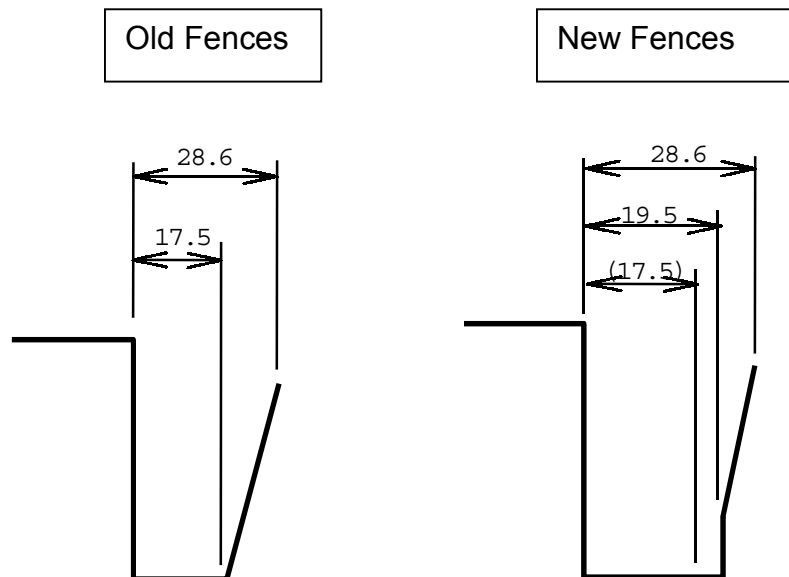
The widths of the positioning fences (front, middle and rear) have been increased as shown below.

Note 1: When replacing either of the old fences in the field, install all three new parts as a set.

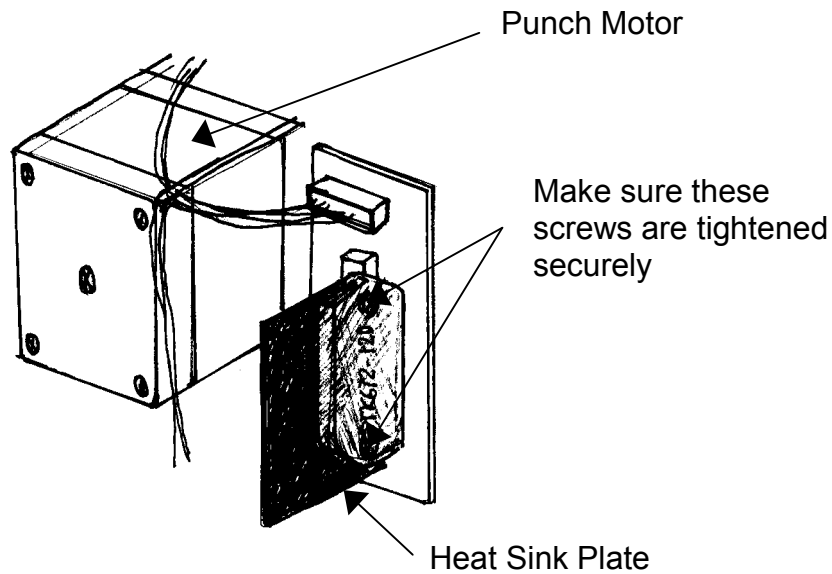
1. Electrical noise generated by the drive motor affects the initial check routine of the punch drive board firmware, so that the motor reset signal is constantly sent out. The only units on which the symptom may occur are the USA two-punch-hole and European fourpunch-hole units.
2. The two screws securing the heat resistor to the IC on the punch drive board come loose. As a result, the temperature of the IC becomes too high.

3-1 Please check the two heat resistor screws when visiting the machine site and tighten them if they are loose.

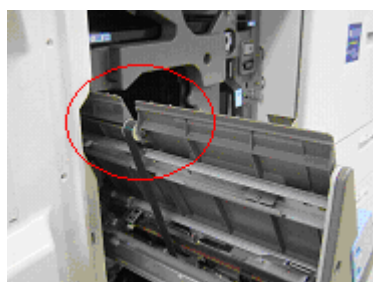
Stapler tray

Excessive force was placed on the shaft bearing (stapler tray rib shown below), damaging the area.

If the symptom occurs, attach the new shaft bracket (B8304783) and modified shaft (B7064785).

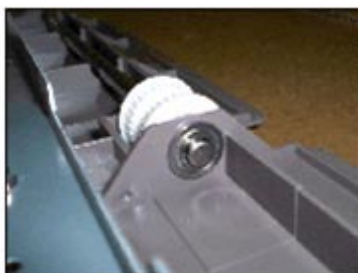
Before damage

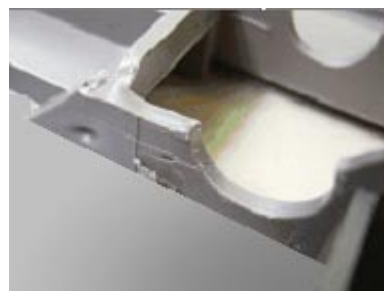
After damage

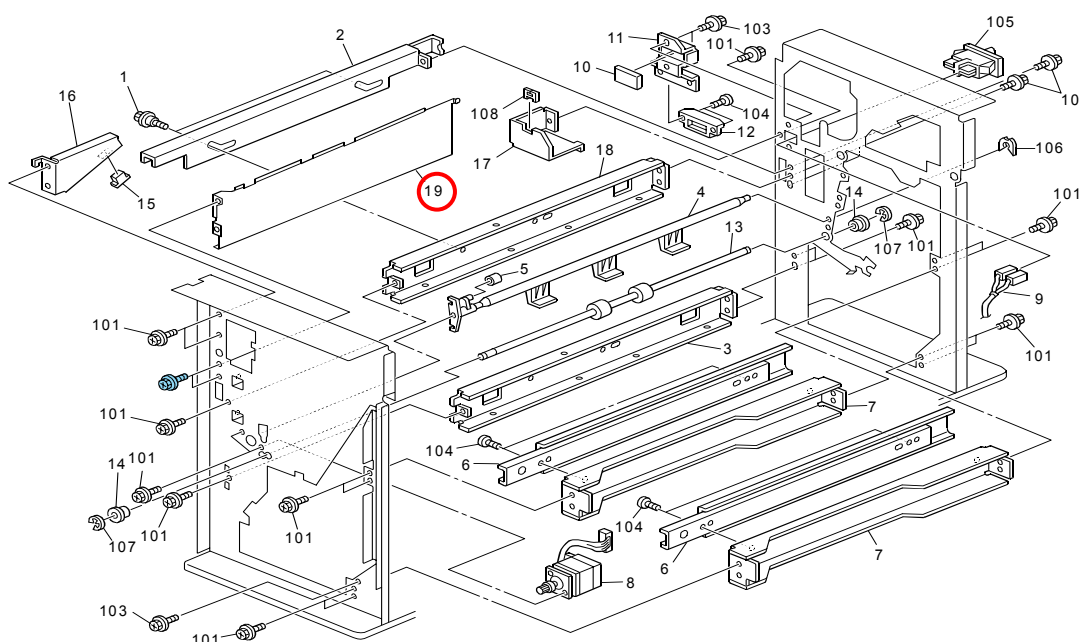
- 1) ***A cover for the door switch harness was added.***
- 2) ***In accordance with this change, a screw hole was added to the safety switch cover and a tapping screw added.***

***Reason: To further protect the harness from physical contact.***

***Important: The newly-added door switch harness cover (D4601146) cannot be installed on machines produced before the cut-in serial numbers. On these machines, be careful not to touch the harness when you service the machines.***
