Model: Martini-C1

Subject: Jogger Fence Adjustment		Prepared by: Y.Urushihara	
From: 1st Tech. Support Sec. Service Support Dept.			
Classification:	<input type="checkbox"/> Troubleshooting <input type="checkbox"/> Mechanical <input type="checkbox"/> Paper path <input type="checkbox"/> Other ()	<input type="checkbox"/> Part information <input type="checkbox"/> Electrical <input type="checkbox"/> Transmit/receive	<input type="checkbox"/> Action required <input checked="" type="checkbox"/> Service manual revision <input type="checkbox"/> Retrofit information

Model: Martini-C1		Date: 4-Oct-02	No.: RB064005
Subject: Finisher screw detaches from slide rail bracket		Prepared by: K. Miura	
From: Technical Services sec. Service Planning Dept.			
Classification:	<input checked="" type="checkbox"/> Troubleshooting <input type="checkbox"/> Mechanical <input type="checkbox"/> Paper path <input type="checkbox"/> Other ()	<input type="checkbox"/> Part information <input type="checkbox"/> Electrical <input type="checkbox"/> Transmit/receive	<input type="checkbox"/> Action required <input type="checkbox"/> Service manual revision <input type="checkbox"/> Retrofit information

Model: Martini-C1

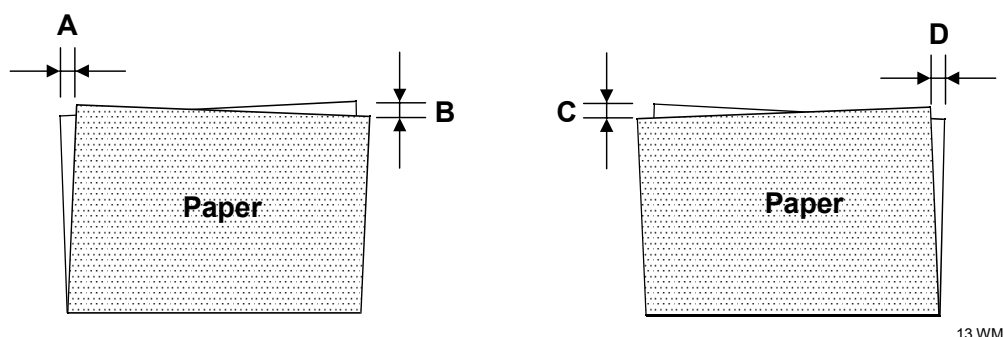
All distances shown below (A, B, C, D): **2mm or less.**

13. If A, B, C or D is **over 2mm**, perform the following.

- Open the finisher front door, then insert a driver or other tool into the door switch to create the door-closed condition. Also, make sure to push in the stapler unit.
- Print out 3 Booklet sets (2-3 sheets each) using the exposure glass (not the DF).
- Once the paper is fed into the stapler unit and the machine stops operation, pull out the stapler unit.
- Press the “#” key on the operation panel, and then pull out the driver from the door switch as soon as the jogger fences close in to the paper edges from the standby position (10mm outside the paper width).
- Check to see that the paper/fence gaps on both sides are:
Paper/fence gap (top + bottom) = **0 - 0.5mm.**
If the fences are positioned too wide or too narrow, adjust the gap to 0 – 0.5mm for the given paper size using **SP6120.**

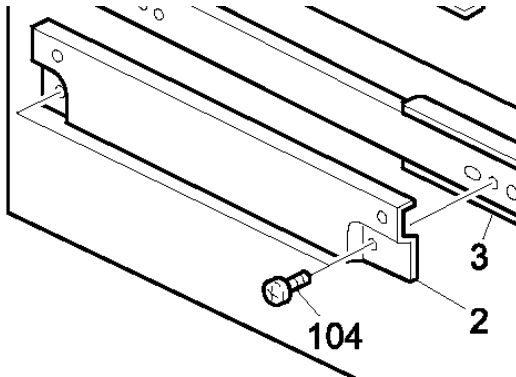
The screw shown below (Frame section 20, P/N #04533006B, pg. 45 #104) comes loose and detaches from the slide rail bracket.

Vibration during transport.

As a permanent solution, the screws have been equipped with spring-washers. As a temporary solution in the field, please perform the procedure below.

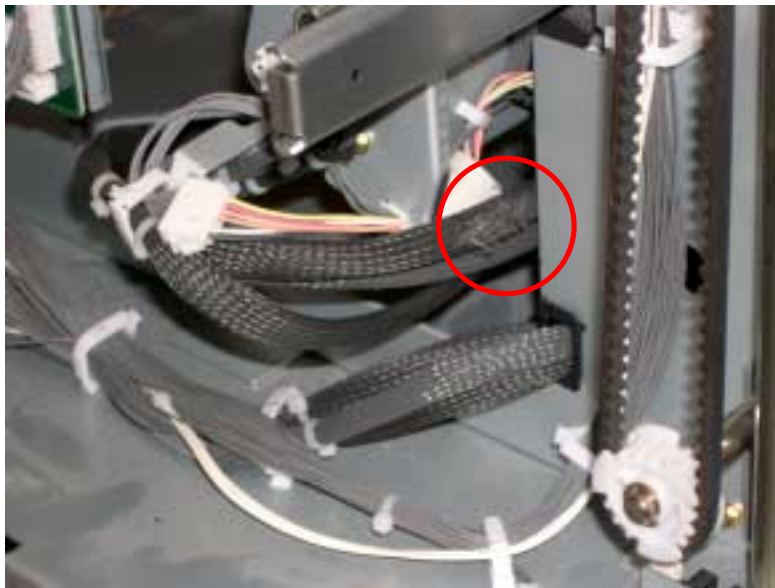
The outside of the stapler harness is damaged in the area shown in the photo. In some cases, a short circuit occurs in the damaged area.

The stapler harness rubs against the finisher rear plate when the stapler unit is pulled out or pushed in.

The shape of the rear plate has been changed so that it does not touch the stapler harness (the cut-in serial number is in the table below).
