Model: Model Sh-MF1 PFU option		Date: 24-Feb-12	No.: RM375001
Subject: Part catalog correction		Prepared by: T.Hirai	
From: 3rd Tech Service Sect., MFP/P Tech Service Dept.			
Classification:	<input type="checkbox"/> Troubleshooting <input type="checkbox"/> Mechanical <input type="checkbox"/> Paper path <input type="checkbox"/> Product Safety	<input checked="" type="checkbox"/> Part information <input type="checkbox"/> Electrical <input type="checkbox"/> Transmit/receive <input type="checkbox"/> Other ()	<input type="checkbox"/> Action required <input type="checkbox"/> Service manual revision <input type="checkbox"/> Retrofit information <input type="checkbox"/> Tier 2

Model: Model Sh-MF1 (PFU)		Date: 28-Mar-12	No.: RM375002
Subject: Check points at installation (Tray side fences or Paper end sensor were detached)			Prepared by: T.Hirai
From: 3rd Tech Service Sect., MFP/P Tech Service Dept.			
Classification:	<input type="checkbox"/> Troubleshooting <input type="checkbox"/> Mechanical <input type="checkbox"/> Paper path <input type="checkbox"/> Product Safety	<input type="checkbox"/> Part information <input type="checkbox"/> Electrical <input type="checkbox"/> Transmit/receive <in

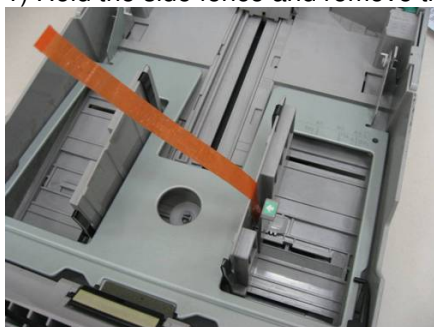
1. During transportation.
Remove the side fences together when removing orange tapes at installation.
2. Orange tape pushed and detached the paper end sensor.

- 1) Hold the side fence and remove the orange tapes one by one.

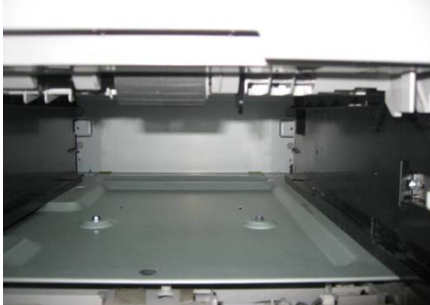
Correct position (can see)

Check whether you can see the paper end sensor or not.

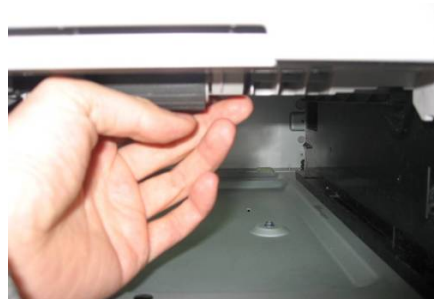
Incorrect position (cannot see)

1. Side fences are detached
2. Paper end sensor is detached.

If the paper end sensor is in an incorrect position (cannot see), please reattach as follows.

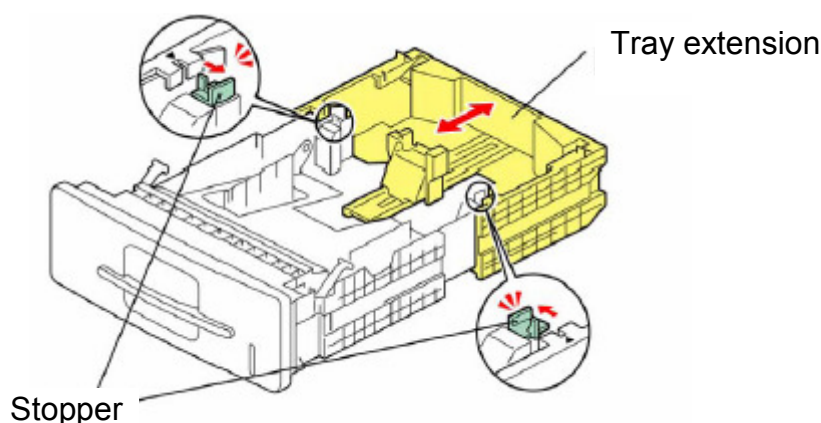
A paper feed jam or non-feed occurs when feeding the paper from a mainframe paper tray.

The stopper breaks and the tray extension extends out too far, causing the end fence to retract.

The shape of the stopper was changed, and four screw holes were added so that the extension tray can be fixed in place for LT/A4 and LG paper sizes.

- If the user always uses the same paper size, fasten the extension tray in place with screws.
- ***For all other users, fix the extension in place for LG sized paper.***

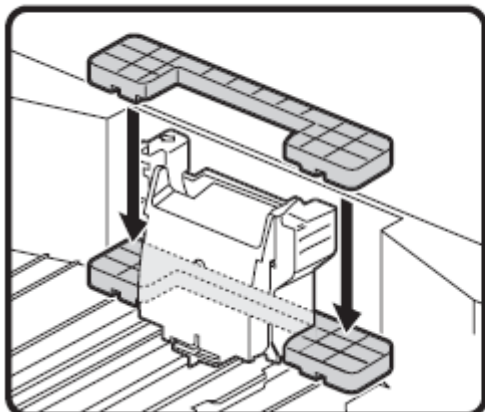
A4/Legal

A paper feed jam or non-feed occurs when feeding the paper from optional paper trays.

End fence is not set correctly.

Attach the following parts (***P/N: M0212570***) behind the end fence, as shown, using double-sided tape.
