Technical Bulletin

Model: Model Sh-P1 (PFU)			Date: 08-May-1	12	No.: RM386002
Subject: Check	Prepai	red by: T.Hirai			
(Tray side fenc					
From: 3rd Tech S					
Classification:	Troubleshooting	☐ Part info	rmation	Action	required
	☐ Mechanical	☐ Electrica	al [] Service	e manual revision
	☐ Paper path	Transmi	t/receive	Retrofi	it information
	☐ Product Safety	Other () [Tier 2

Model: Sh-P1 PFU Option	Date: 15-Mar-13	No.: RM386004a

Subject: Breakage of Stoppers for Tray Extension				ed by: T. Nihei
From: 3rd Tech Service Sect., MFP/P Tech Service Dept.				
Classification:		☐ Part information	n	Action required
	☐ Mechanical	☐ Electrical		☐ Service manual revision
	☐ Paper path	☐ Transmit/recei	ve	☐ Retrofit information
	☐ Product Safety	☐ Other ()		⊠ Tier 2

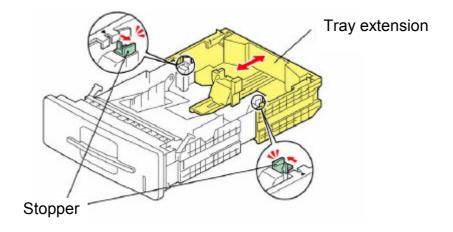
A paper feed jam or non-feed occurs when feeding the paper from a mainframe paper tray.

The stopper breaks and the tray extension extends out too far, causing the end fence to retract.

The shape of the stopper was changed, and four screw holes were added so that the extension tray can be fixed in place for LT/A4 and LG paper sizes.

- If the user always uses the same paper size, fasten the extension tray in place with screws.
- For all other users, fix the extension in place for LG sized paper.
