Model: Paper Feed Unit for Model Ti-P1		Date: 05-Sep-13	No.: RM406001
Subject: Upper Left Cover & Frame		Prepared by: H.K.	
From: 3rd Tech Service Sect., MFP/P Tech Service Dept.			
Classification:	<input type="checkbox"/> Troubleshooting <input type="checkbox"/> Mechanical <input type="checkbox"/> Paper path <input type="checkbox"/> Product Safety	<input checked="" type="checkbox"/> Part information <input type="checkbox"/> Electrical <input type="checkbox"/> Transmit/receive <input type="checkbox"/> Other ()	<input type="checkbox"/> Action required <input type="checkbox"/> Service manual revision <input type="checkbox"/> Retrofit information <input type="checkbox"/> Tier 2

Model: Paper Feed Unit for Model Ti-P1		Date: 18-Oct-13	No.: RM406002
Subject: RUBBER FOOT		Prepared by: H.K.	
From: 3rd Tech Service Sect., MFP/P Tech Service Dept.			
Classification:	<input type="checkbox"/> Troubleshooting <input type="checkbox"/> Mechanical <input type="checkbox"/> Paper path <input type="checkbox"/> Product Safety	<input checked="" type="checkbox"/> Part information <input type="checkbox"/> Electrical <input type="checkbox"/> Transmit/receive <input type="checkbox"/> Other ()	<input type=

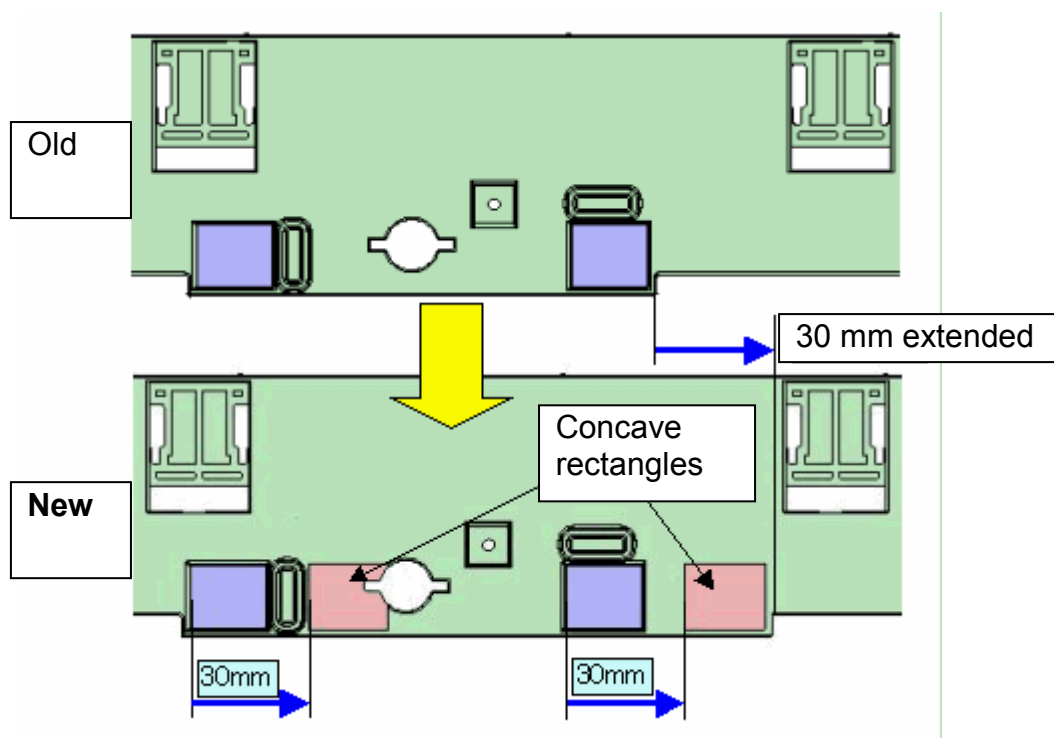
Left upper cover:

Change: The shapes of the left upper cover and left side frame (non service parts) were changed.

Reason: To standardize these parts with future models

1. The two concave rectangles were added.
2. The length of the cover was increased by 30 mm.

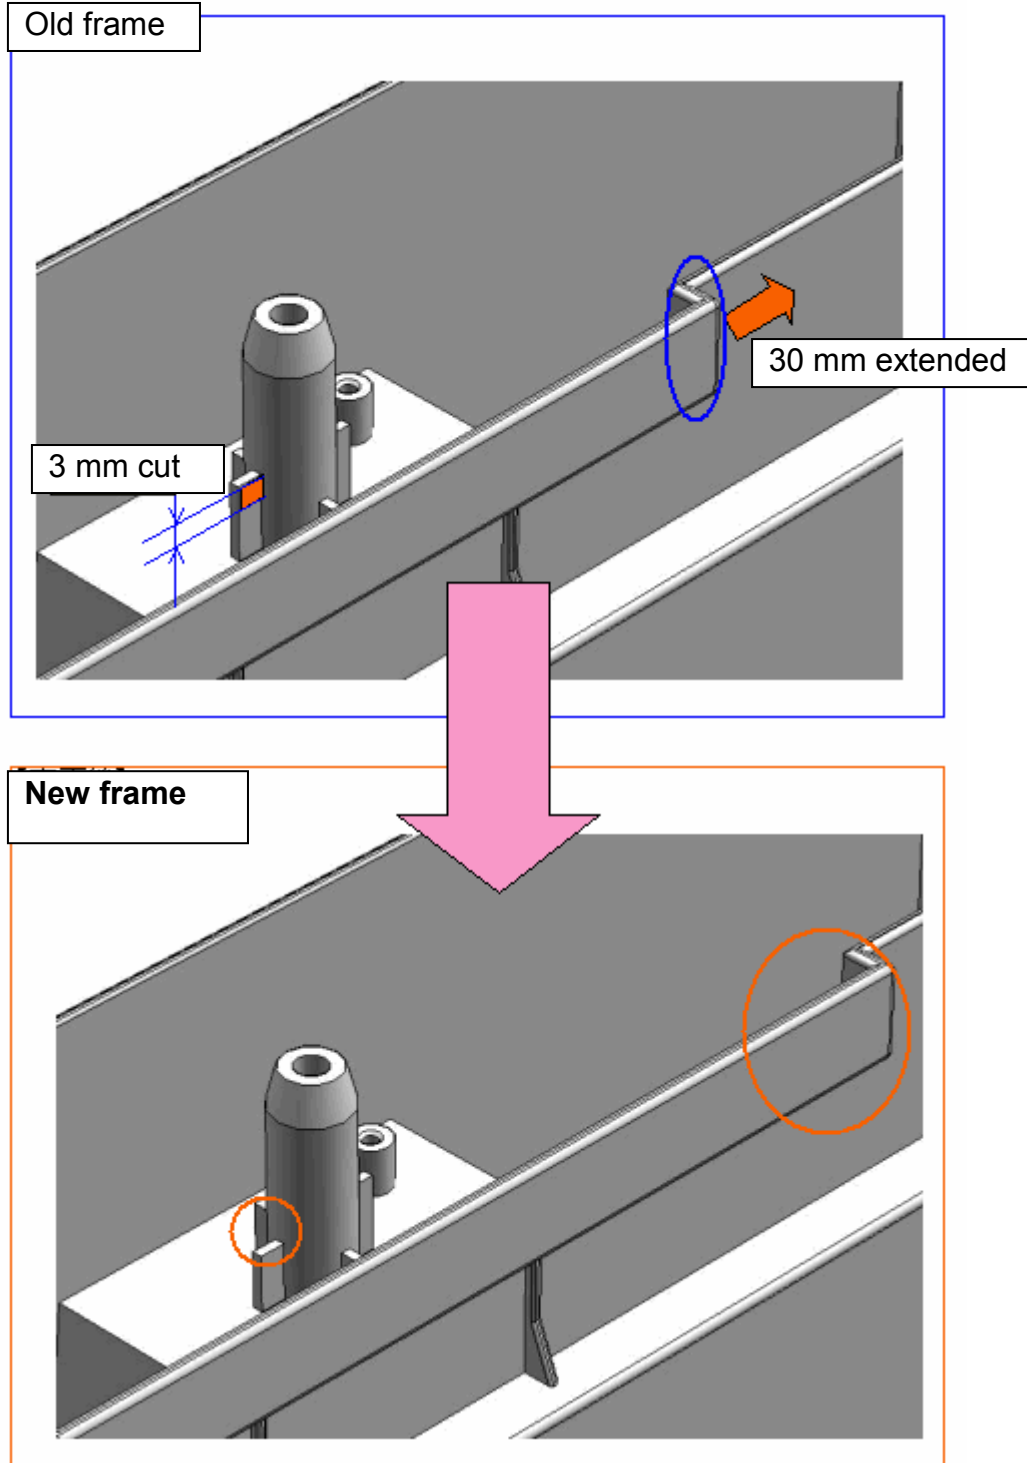
Left side frame

1. A 3 mm section was cut from the area of the rib shown.
2. The length of the frame was increased by 30 mm.

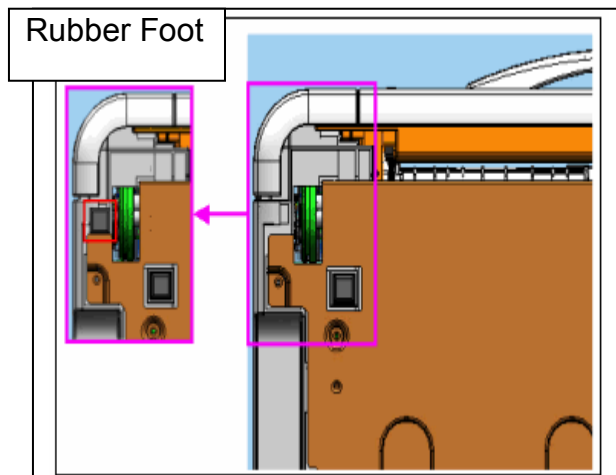
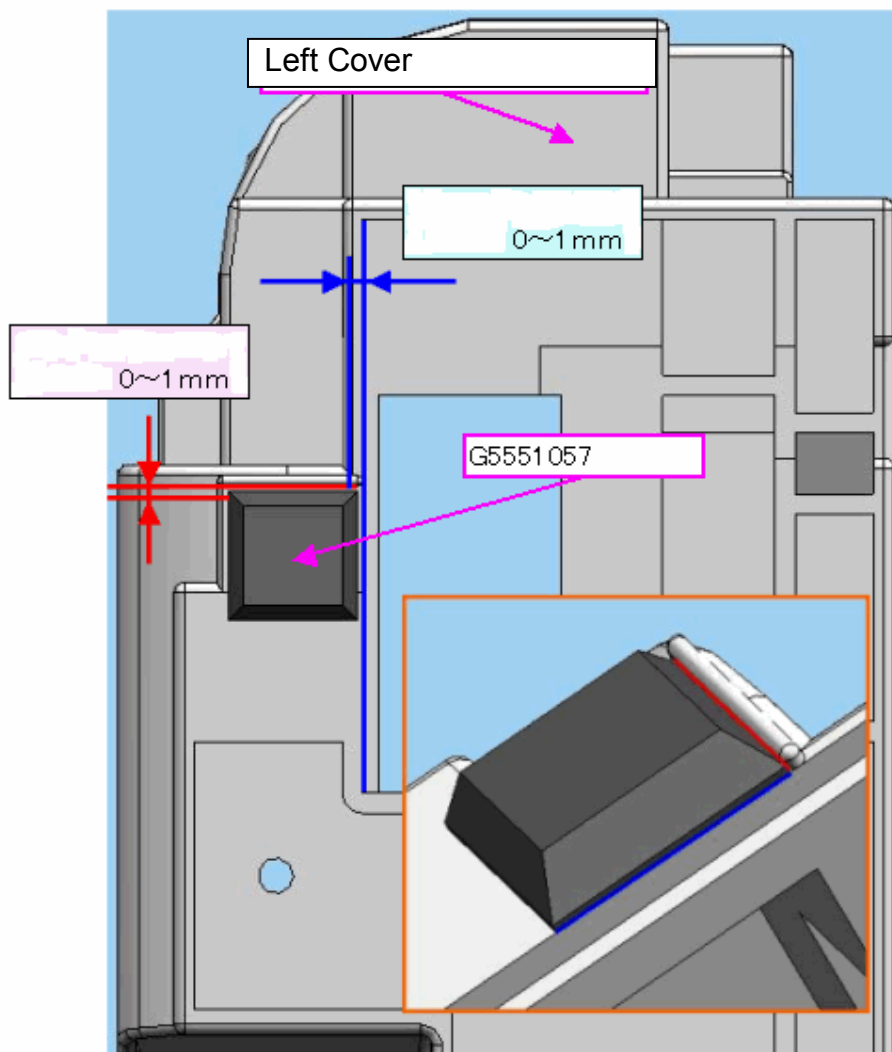
Change: The quantity for this part was increased from 2 to 3.

Reason: To further improve the stability of the tray when placed on a desk or table.

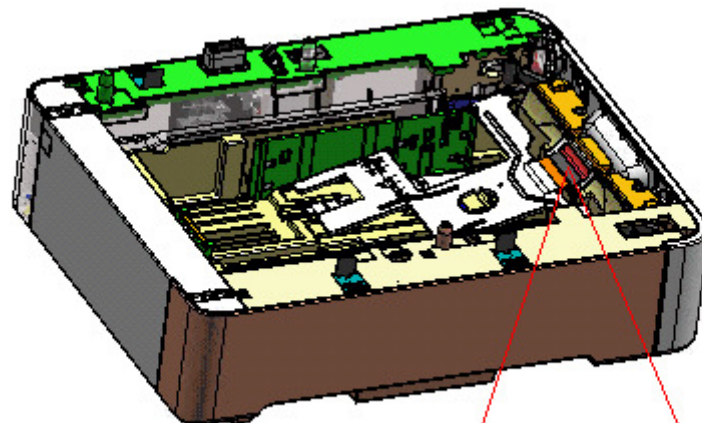
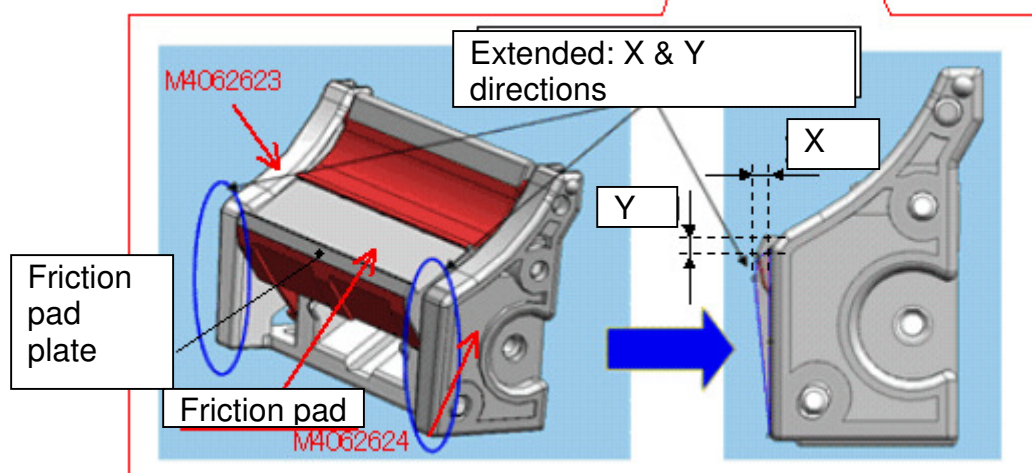
A non-feed jam occurs when feeding thick paper types (164g or more).

The friction between sheets of paper is high, causing one or more extra sheets to be fed together with the top sheet. The sheets hit the friction pad plate, and the plate lowers. As a result, the top sheet is held in place by the plate and is not fed.

The shapes of the friction pad holder and cover were changed.

1. This modification enables the holder and cover to stop ***the friction pad plate from lowering. (Modification 1)***
2. ***The paper tray holder sheet was eliminated on the modified machines since it was no longer necessary to prevent non-feed jams, but it is still available as a Service part for older machines. (Modification 2)***

IMPORTANT: If you need to replace the old friction pad holder or cover in the field, make sure to install the new parts **together as a set**.

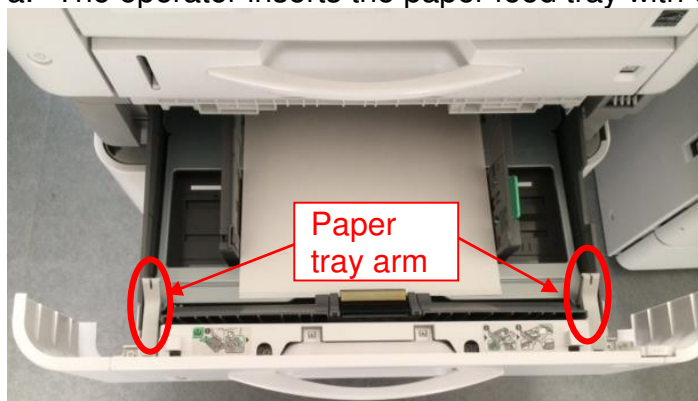
1. The spring is deformed

The spring is deformed and the paper feed pressure is lowered. Deformation of the spring is caused by the states below (a. and b.).

a. The operator inserts the paper feed tray with one side tilted (see the photo).

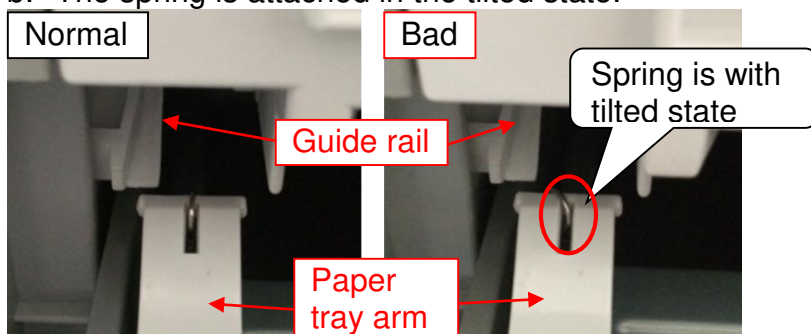
b. The spring is attached in the tilted state.

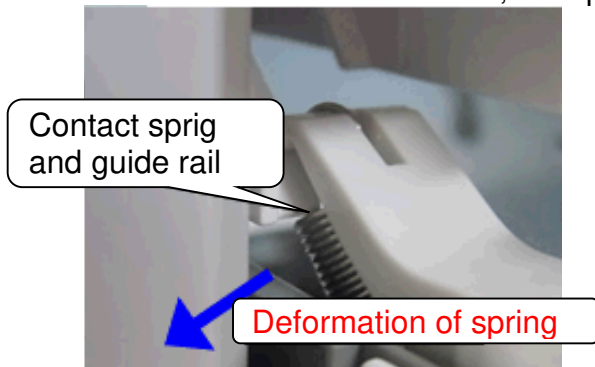
As a result of the above state, the spring contacts the guide rail and is deformed.

1. The height of the rib (see the photo) was increased on both sides.

Note: This is to prevent contact between the spring and guiderail. The lengthening of these ribs minimizes the rattling of the tray.

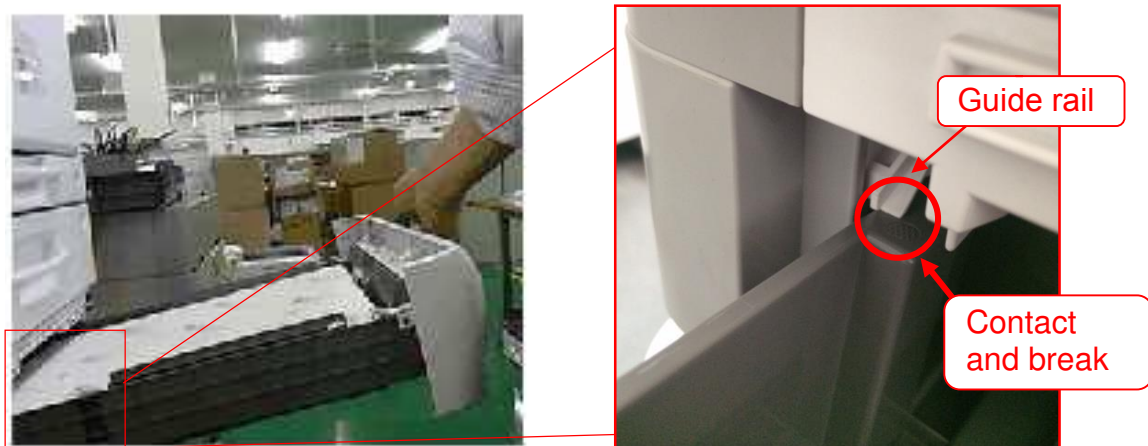
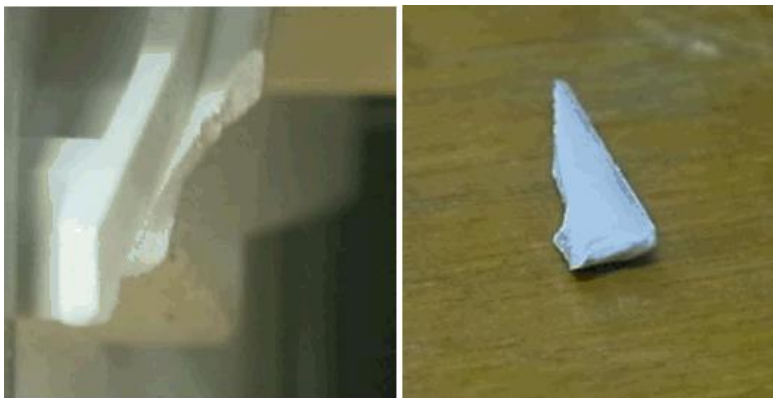
2. The guide rail for the paper feed arm breaks

The operator lifts up the paper tray (see the photos) when pulling out the tray. This causes the guide rail to be broken by contact with the tray (see the photos). As a result, the paper tray base plate cannot lift up to the position of the paper.

2. The guide rail was strengthened

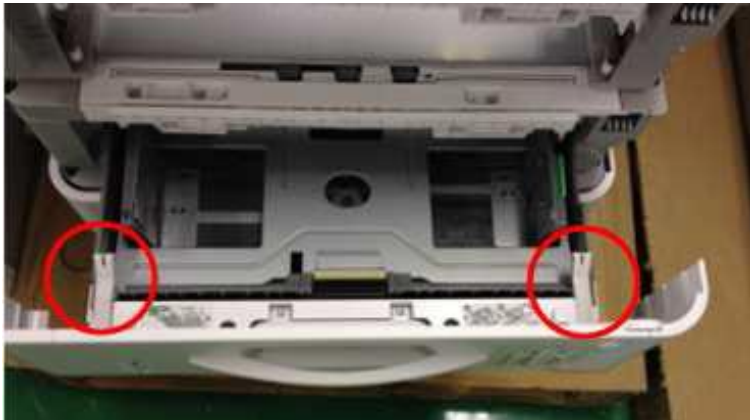
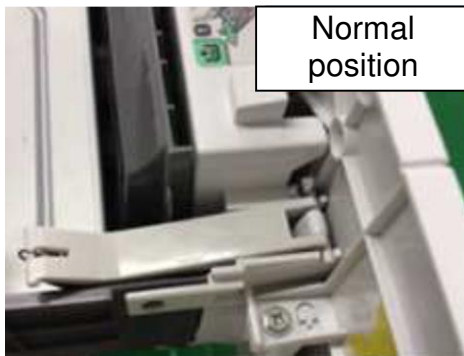
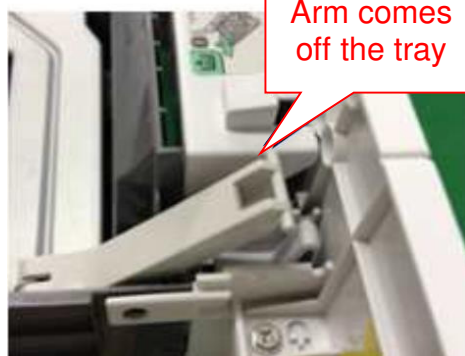
A jam occurs in the additional paper feed tray.

The paper tray arm detaches easily.
