Technical Bulletin

Model: Trimmer Unit TR5040 (D520) Date: 14-Jul-11 No.: RD520001

Subject: Firmwar	e Release Note: Trimmer Unit	Prepared	d by: K.Tsutsui	
From: PPBG Service Planning Dept.				
Classification:	Troubleshooting	Part information	tion	Action required
	☐ Mechanical	☐ Electrical		☐ Service manual revision
	☐ Paper path	☐ Transmit/rec	eive	☐ Retrofit information
	☐ Product Safety	Other (Firmv	vare)	☐ Tier 2

Model: Trimmer Unit TR5020 (D455) Dat					t-11	No.: RD455005
Subject: Adjustment of the trim volume					d by: T. K	Komori
From: PP Service						
Classification:	Troubleshooting	⊠ Part inf	orma	tion	☐ Action	required
		☐ Electric	al		Service	ce manual revision
	☐ Paper path ☐ Transmit/r			eive	Retrof	fit information
	☐ Product Safety	Other ()	☐ Tier 2

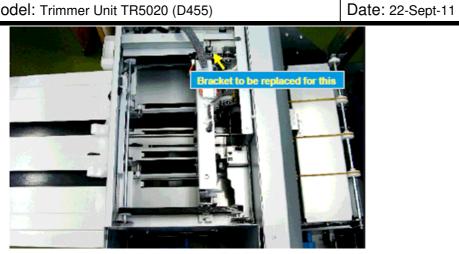
3. Identify the sensor.

4. Move the bracket in the direction of the arrow (decrease in trim volume). Check the trim volume.

DO NOT shift the sensor bracket in the opposite direction (increase in trim volume) as this may cause damage to the machine due to interference with the registration unit.

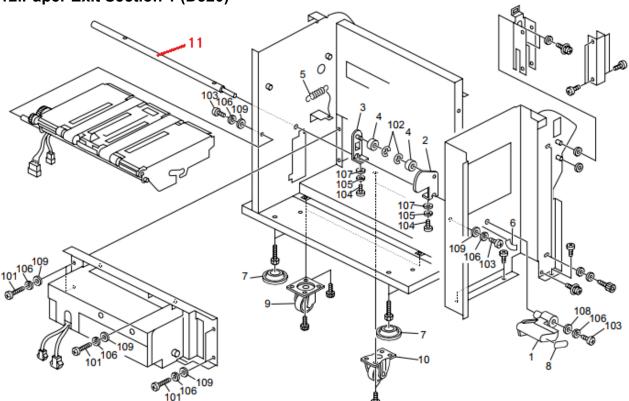
Old part number	New part number	Description		Int	Page	Index	Note
-	D4551286	SHAFT:RELEASE:YZ3-08407011	1	-	25	11	Add

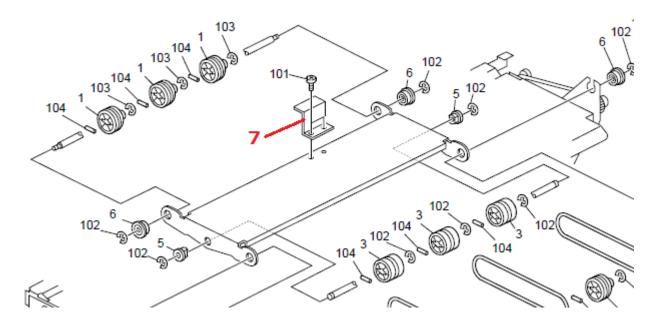
3.Paper Feed Unit 2 (D520)

Old part	New part	Description	Q'ty	Int	Page	Index	Note
number	number						
-	D4551176	STOPPER:ENTRANCE:YZ4-08405302	1	-	7	7	Add

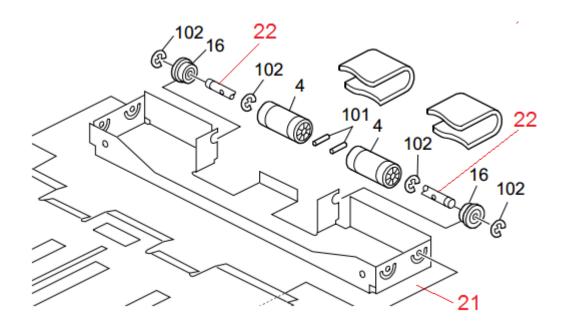
Old part	New part	Description Q		Int	Page	Index	Note
number	number						
-	D4551272	BRACKET:FRONT:YZ3-08407005	1	-	27	21	Add
-	D4551278	SHAFT:ROLLER:FRONT:Z4-08407008	1	-	27	22	Add

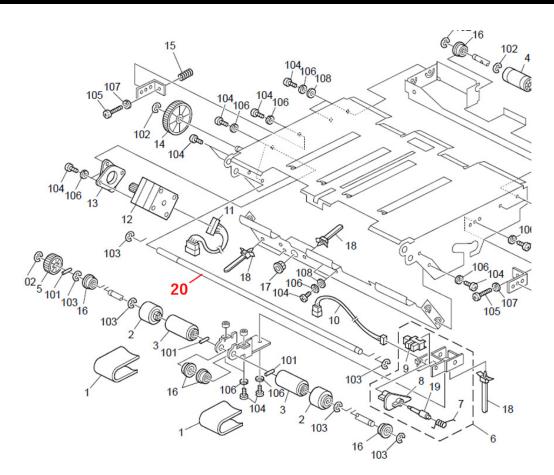
Old part	New part	Description	Q'ty	Int	Page	Index	Note
number	number						
-	D4551268	SHAFT:YZ3-08407001	1	-	27	20	Add
