Model: Pomelo-P3	Date: 06-Nov-01	No.: RG063001a
------------------	-----------------	----------------

## RTB Correction

Subject: Firmware History - MCTL		Prepared by: H.K.	
From: Technical Services Dept., GTS Division			
Classification:	<input type="checkbox"/> Troubleshooting <input type="checkbox"/> Mechanical <input type="checkbox"/> Paper path <input checked="" type="checkbox"/> Other (Firmware History)	<input type="checkbox"/> Part information <input type="checkbox"/> Electrical <input type="checkbox"/> Transmit/receive	<input type="checkbox"/> Action required <input type="checkbox"/> Service manual revision <input type="checkbox"/> Retrofit information

Model: Pomelo-P3		Date: 13-Feb-02	No.: RG063003
Subject: Light Bands at 36-mm Intervals		Prepared by: H.K.	
From: Technical Services Dept., GTS Division			
Classification:	<input checked="" type="checkbox"/> Troubleshooting	<input type="checkbox"/> Part information	<input type="checkbox"/> Action required
	<input type="checkbox"/> Mechanical	<input type="checkbox"/> Electrical	<input type="checkbox"/> Service manual revision
	<input type="checkbox"/> Paper path	<input type="checkbox"/> Transmit/receive	<input type="checkbox"

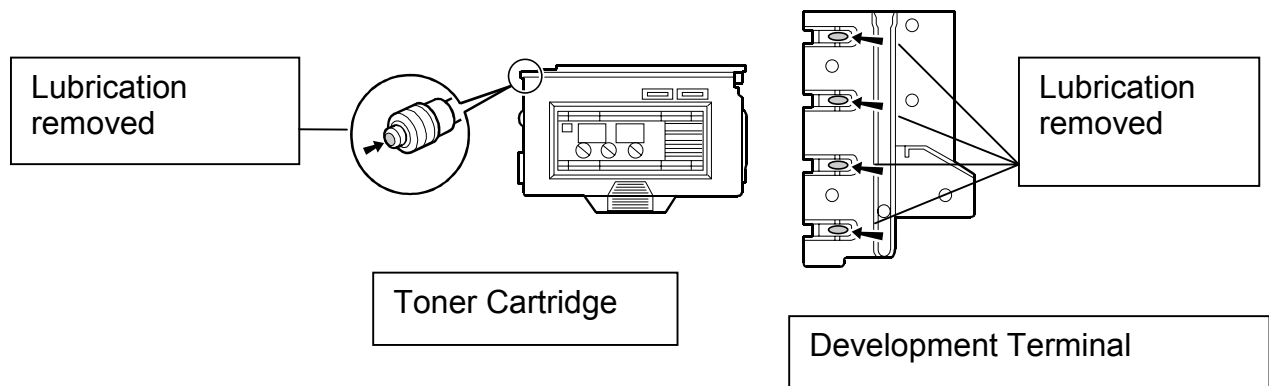
Fig. 1: Grease Removal

Light bands appear in black halftone areas along the main scan direction (at about 36-mm intervals).

Poor electrical connections caused by foreign material caught between the development bias terminal in the printer unit and the toner cartridge terminal.

1. Lubricant (grease) will no longer be applied to the toner cartridge terminal and the development bias terminal (see Fig. 1 on the next page).
2. The shape of the left development unit guide has been changed to minimize the possibility of foreign particles being generated from the guide scratching the toner cartridge (see Fig. 2 on the next page).

Clean the development bias terminal, toner cartridge terminal, and left development unit guide to remove any foreign material.
