Model: Pomelo	Date: 30-Apr-99	No.: RG033001a
---------------	-----------------	----------------

Subject: Detailed Self -diagnostics Error		Prepared by: H. Someya	
From: Technical Service Dept., GTS Division			
Classification:	<input checked="" type="checkbox"/> Troubleshooting	<input type="checkbox"/> Part information	<input type="checkbox"/> Action required
	<input type="checkbox"/> Mechanical	<input type="checkbox"/> Electrical	<input type="checkbox"/> Service manual revision
	<input type="checkbox"/> Paper path	<input type="checkbox"/> Transmit/receive	<input type="checkbox"/> Retrofit information
	<input type="checkbox"/> Other (      )

Model: Pomelo		Date: 15-Aug-99	No.: RG033003
Subject: Uneven or faint image / SC41		Prepared by: H. Someya	
From: Technical Service Dept., GTS Division			
Classification:	<input checked="" type="checkbox"/> Troubleshooting	<input type="checkbox"/> Part information	<input type="checkbox"/> Action required
	<input type="checkbox"/> Mechanical	<input type="checkbox"/> Electrical	<input type="checkbox"/> Service manual revision
	<input type="checkbox"/> Paper path	<input type="checkbox"/> Transmit/receive	<input type="checkbox"/> Retrofit informat

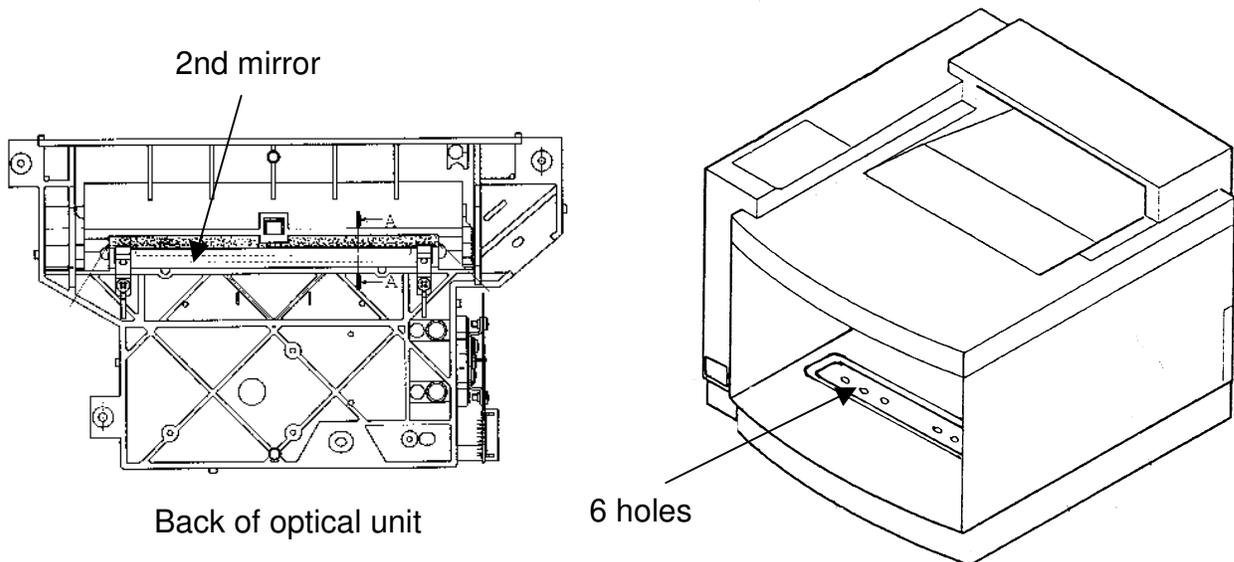
Dust entering from the holes in the base adheres to the 2nd mirror over time.

1. Remove the optical unit and clean the 2nd mirror with an optical cloth.
2. Use tape to block the 6 holes in the base.
3. Reassemble the machine.

Polyester tape has been attached to block the 6 holes in the base (effective as of February production runs).

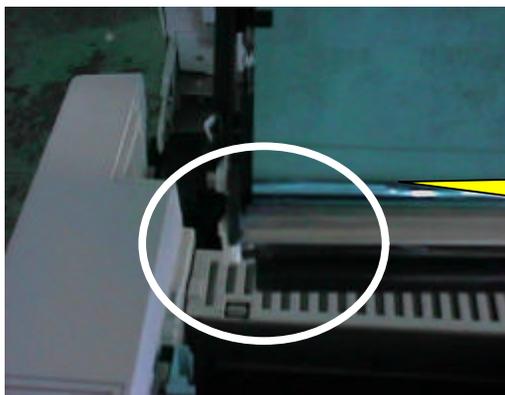
Diagram 1

1. Remove the belt cartridge.
2. Measure the gap L between side plate and OPC belt as shown in diagram 1.
3. Do one of the following actions depending the length of gap L:

Gap L (mm)	Required action
0 – 3	Attach one spacer to the bearing on side A as shown in diagrams 2 & 3.
3 – 7	No action necessary
7 - 10	Attach one spacer on the bearing on side B as shown in diagrams 2 & 3.

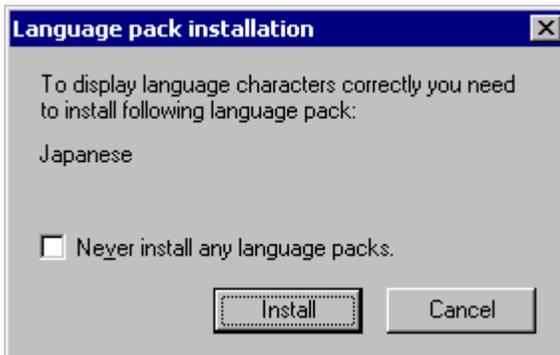
When you browse the Pomelo and FresaWIN printers with Microsoft Internet Explorer 5.x (IE 5.x), IE 5.x requires installing a Japanese font even if the HTML does not have a Japanese font.  
 i.e., if browsing [http://Printer IP Address/en/cgi-bin/sts\\_index.cgi](http://Printer IP Address/en/cgi-bin/sts_index.cgi), the following message appears:

Maybe the message is different because of a minor variation in the IE version or Windows OS. The above message appears when using IE 5.00.2920.0000 with Windows 2000. In this case, IE requires a Japanese font every time.

This line means that HTML declares this file's code is Japanese. Therefore IE 5.x requires installing a Japanese font even if all HTMLs do not have a Japanese font.

If the NIB version is 3.8.7 or earlier, please get the latest Ricoh NIB firmware and install the new one in the NIB.

Install a Japanese font in Windows. There are a few ways to install Japanese fonts.

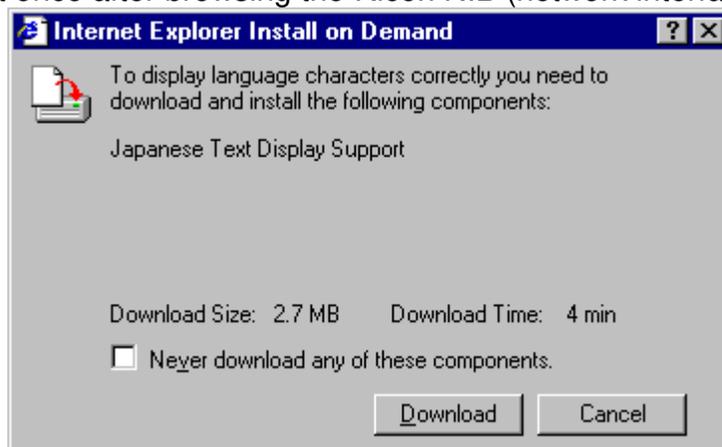
IE 5.00.2314.10003 with Windows NT 4.0 is shown below. In this case, IE requires a Japanese font once after browsing the Ricoh NIB (network interface board).
