Model: Model K-P1		Date: 18-Jan-01	No.: RG058001
Subject: Printer Controller Firmware History		Prepared by: K. Misugi	
From: Technical Services Dept., GTS Division			
Classification:	<input type="checkbox"/> Troubleshooting <input type="checkbox"/> Mechanical <input type="checkbox"/> Paper path <input type="checkbox"/> Other ()	<input type="checkbox"/> Part information <input type="checkbox"/> Electrical <input type="checkbox"/> Transmit/receive	<input checked="" type="checkbox"/> Action required <input type="checkbox"/> Service manual revision <input type="checkbox"/> Retrofit information

Printer controller firmware history for the Kir-P1 (G058/G056 model).

Model: Model K-P1		Date: 09-Apr-01	No.: RG058003
Subject: Dirty Background on Printouts		Prepared by: K. Misugi	
From: Technical Services Dept., GTS Division			
Classification:	<input checked="" type="checkbox"/> Troubleshooting	<input type="checkbox"/> Part information	<input type="checkbox"/> Action required
	<input type="checkbox"/> Mechanical	<input type="checkbox"/> Electrical	<input type="checkbox"/> Service manual revision
	<input type="checkbox"/> Paper path	<input type="checkbox"/> Transmit/receive	<input type="check

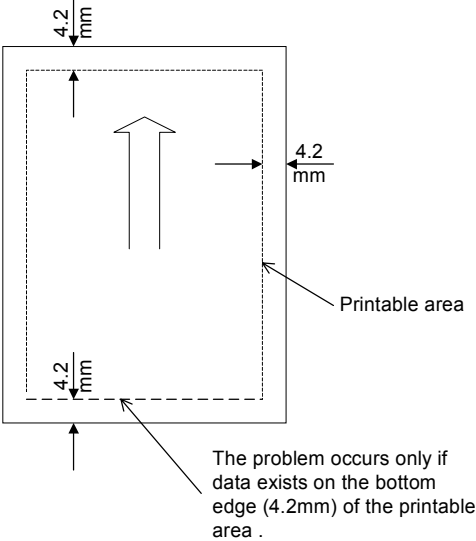
Descriptions	Version
<p>1. Firmware modified to improve print quality when image data is printed using the PCL6 driver. Note: This occurs only in the following condition.</p> <ul style="list-style-type: none"> - When printing image data - When using the PCL6 driver <p>2. New feature added in the user mode. "Curl Prevention" mode is added in the user mode. (Curl Prevention: User mode/ Maintenance) Please note that the function of this mode is the same as "Curl Control" in the printer engine service mode. It lowers the fusing temperature to prevent paper from curling. Advise customers to use this mode when paper jams occur during duplex rear side printing. Note: When this mode is switched on, "Curl Control" in the service mode is also switched on.</p>	
<p>Firmware modified to correct the following problem.</p> <p>Symptom: During PCL printing, if data extends over the bottom edge of the printable area, the machine freezes, displaying "Processing" and operation will no longer be possible.</p> <p>Condition: The printer driver is <u>not</u> being used Print data exists on the <u>bottom edge</u> of the printable area (at 4.2 mm)</p>

<p>Action: Update the controller firmware.</p>	<p>1.05</p>

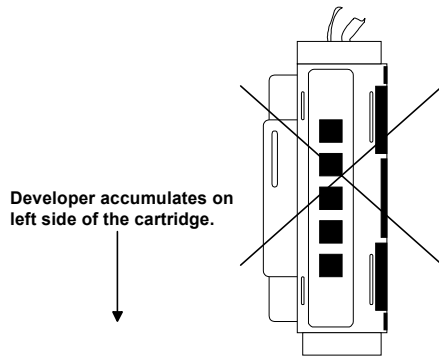
The developer will shift to the left side if the cartridge is tilted as shown below when the sealing tapes are being removed. This causes toner to be over-supplied on the right side of the cartridge, which in turn causes the dirty background on the right side of the printout.

When removing the tape, place the machine on a level surface.

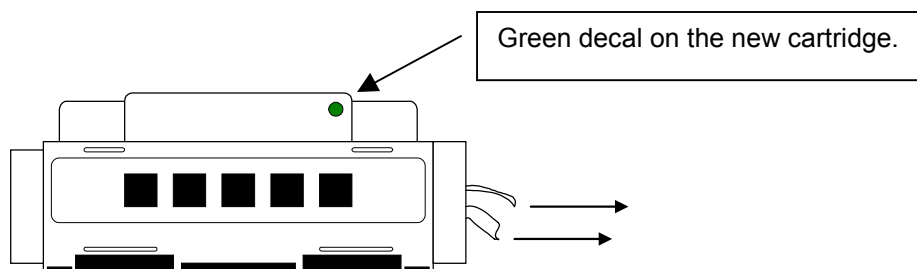
The cartridge has been modified from June production so that dirty background will not occur at installation even when the cartridge is tilted.

A green decal is added so the new cartridge can be distinguished from the old type. The same decal is also placed on the supply cartridge, next to the bar-code label on the box.

- Place the cartridge on a level surface when removing the sealing tapes on the cartridge.
 - Remove the sealing tapes on the cartridge before turning on the main switch.
 - Once the seals have been removed, do not shake the cartridge.
- Note:** This only applies to cartridge installation and replacement.

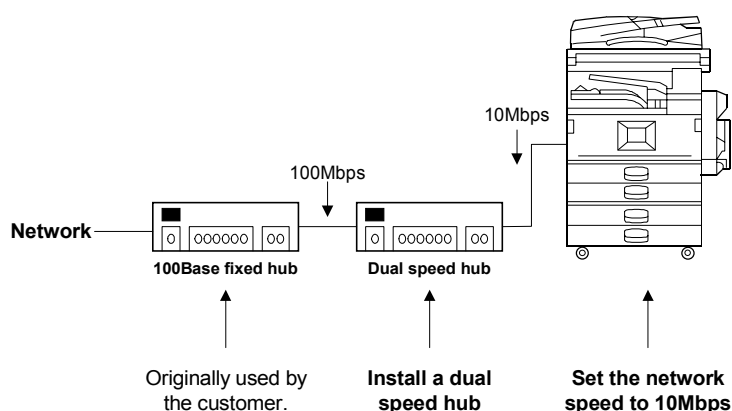
When the data is transferred at 100Mbps, depending on network conditions, the controller ASIC is not able to receive all data packets and a retry procedure occurs. As a result, print jobs from a Macintosh take a long time to print out.

- a) Set the network (ethernet) speed of the machine to 10Mbps.
The default setting of the machine is "Auto." This setting can be changed in the "Network Setup" in the user mode "Host Interface" ("Interface Settings" in the "System Settings" for the Model A-C2).
- b) Install a dual speed hub between the 100Base fixed hub and the machine.

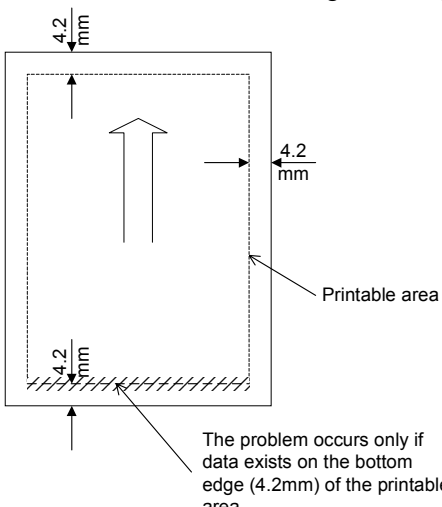
<p>Firmware modified to correct the following problem.</p> <p>Symptom: In PCL printing, if data exists over the bottom edge of the printable area, the machine freezes, displaying "Processing" and operation will no longer be possible.</p> <p>Condition: Printer driver is <u>not</u> being used Print data exists on the <u>bottom edge</u> of the printable area (at 4.2mm)</p>

<p>Action: Update the controller firmware.</p>	1.05
Firmware modified to make corrections in the German wordings.	1.02

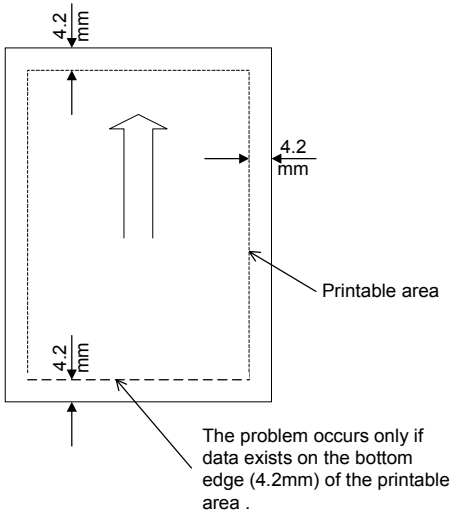
Descriptions	Version
<p>Firmware modified to correct the following problem.</p> <p>Symptom: In PCL printing, if data exists over the bottom edge of the printable area, the machine freezes, displaying "Processing" and operation will no longer be possible.</p> <p>Condition: Printer driver is <u>not</u> being used Print data exists on the <u>bottom edge</u> of the printable area (at 4.2mm)</p>

<p>The problem occurs only if data exists on the bottom edge (4.2mm) of the printable area .</p> <p>Action: Update the controller firmware.</p>	1.05
Firmware modified to make corrections in the German wordings.	1.02
