Model: Model K-P2	Date: 4-Jun-02	No.: RG073001a
-------------------	----------------	----------------

Subject: Printer Controller Firmware History		Prepared by: A. Ishiyama	
From: Technical Services sec. Service Planning Dept.			
Classification:	<input type="checkbox"/> Troubleshooting <input type="checkbox"/> Mechanical <input type="checkbox"/> Paper path <input type="checkbox"/> Other (      )	<input type="checkbox"/> Part information <input type="checkbox"/> Electrical <input type="checkbox"/> Transmit/receive	<input checked="" type="checkbox"/> Action required <input type="checkbox"/> Service manual revision <input type="checkbox"/> Retrofit information

Printer controller firmware history for the Model K-P2 (Kir-P2: G073/G074 model).

Model: Model K-P2		Date: 4-Jun-02	No.: RG073002
Subject: Problems Using "Verify" in the Firmware Update		Prepared by: A. Ishiyama	
From: Technical Services sec. Service Planning Dept.			
Classification:	<input checked="" type="checkbox"/> Troubleshooting <input type="checkbox"/> Part information <input type="checkbox"/> Action required <input type="checkbox"/> Mechanical <input type="checkbox"/> Electrical <input type="checkbox"/> Service manual

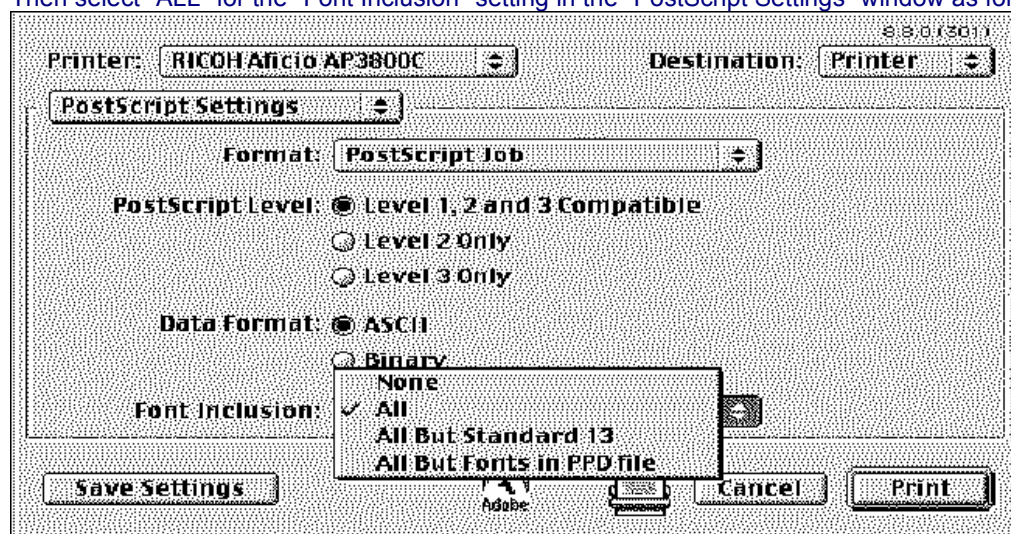
MacOS 9.x / 8.x

If Euro Fonts can't be printed by the PS driver, the following solutions may be effective.

Use the AdobePS 8.8 printer driver.

Then select "ALL" for the "Font Inclusion" setting in the "PostScript Settings" window as follows.
