Model: Russian-P		Date: 29-Mar-00	No.: RG038001
Subject: Hard Disk Compatibility		Prepared by: K. Misugi	
From: Technical Services Dept., GTS Division			
Classification:	<input checked="" type="checkbox"/> Troubleshooting <input type="checkbox"/> Part information <input type="checkbox"/> Action required <input type="checkbox"/> Mechanical <input type="checkbox"/> Electrical <input type="checkbox"/> Service manual revision <input type="checkbox"/> Paper path <input type="checkbox"/> Transmit/receive <input type="checkbox"/> Retrofit information <input type="checkbox"/> Other ()

This RTB informs possible compatibility problems with the Printer Hard Disk Type 185 (model code: G690-06).

Model: Russian-P		Date: 11-Apr-00	No.: RG038002
Subject: NIB NVRAM Backup and Restore		Prepared by: K. Misugi	
From: Technical Services Dept., GTS Division			
Classification:	<input checked="" type="checkbox"/> Troubleshooting <input type="checkbox"/> Part information <input type="checkbox"/> Action required <input type="checkbox"/> Mechanical <input type="checkbox"/> Electrical <input type="checkbox"/> Service manual revision <input type="checkbox"/> Paper path <input type="checkbox"/> Transmit/recei

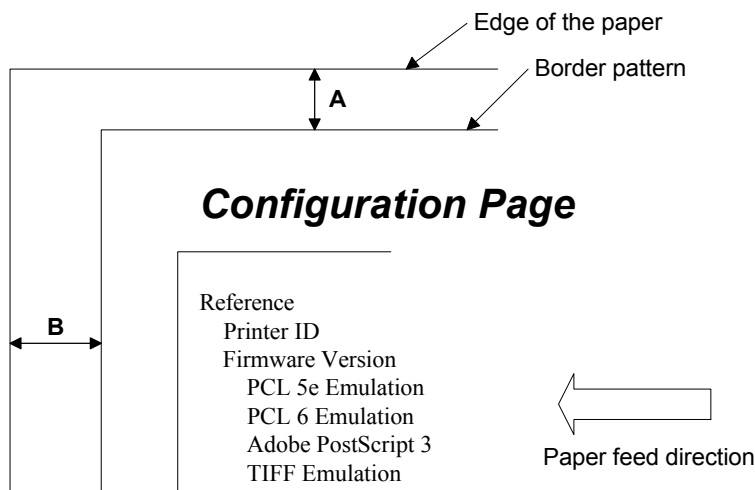
5. Print the Configuration Sheet and notice that the border pattern is printed.

Note: The machine prints the border pattern only for A4 or Letter size paper LEF.

6. Adjust the leading edge and the side-to-side registration using the registration adjustment mode (Service Menu 2: Service regist).

Leading Edge (A)	Side-to-Side (B)
A4 (LEF)	4.2 mm	6.0 mm
Letter (LEF)	4.2 mm	6.4 mm

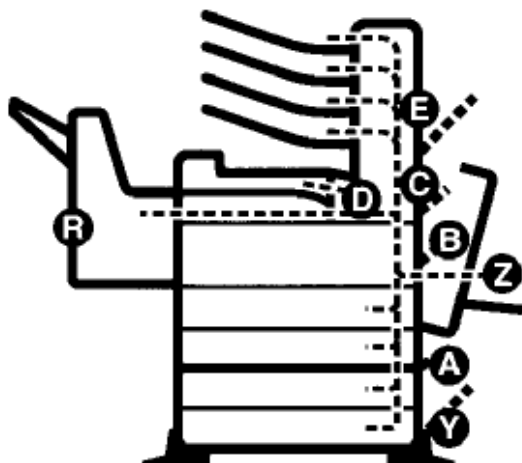
Jam Locations:

ERROR CODES	JAM LOCATION	DESCRIPTIONS
0001h	A (Standard Tray)	Paper does not reach the upper (1st) relay sensor.
0002h	B	Paper does not reach the registration sensor.
0004h	C	Paper does not reach or release from the paper exit sensor.
0040h	D	Paper does not reach or release from the bridge relay sensor.
0008h	Y (Optional Tray)	Paper does not reach the lower (2nd) relay sensor or optional relay sensor.
0010h	E (Mailbox)	Paper does not reach or release from the mailbox vertical transport sensor.
0020h	R (Finisher)	Paper does not reach or release from the finisher entrance sensor, or does not reach or release from the finisher exit sensor.
0100h	Z (Duplex)	Paper does not reach or release from the duplex entrance sensor, or does not reach or release from the duplex exit sensor.
