Model: Russian-P2		Date: 30-Jan-01	No.: RG062001
Subject: Engine Firmware History		Prepared by: S. Tomoe	
From: Technical Services Dept., GTS Division			
Classification:	<input type="checkbox"/> Troubleshooting <input type="checkbox"/> Part information <input type="checkbox"/> Action required <input type="checkbox"/> Mechanical <input type="checkbox"/> Electrical <input type="checkbox"/> Service manual revision <input type="checkbox"/> Paper path <input type="checkbox"/> Transmit/receive <input type="checkbox"/> Retrofit information <input checked="" type="checkbox"/> Other ()

Engine firmware history for the Russian-P2.

Model: Russian-P2		Date: 1-Jun-04	No.: RG062007
Subject: Non-paper feed jam (Bad friction pad)		Prepared by: S.Tomoe	
From: 1st Tech. Support Sec. Service Support Dept.			
Classification:	<input checked="" type="checkbox"/> Troubleshooting <input type="checkbox"/> Mechanical <input type="checkbox"/> Paper path <input type="checkbox"/> Other ()	<input type="checkbox"/> Part information <input type="checkbox"/> Electrical <input type="checkbox"/> Transmit/receive	<input type="checkbox"/> Action required <input type="checkbox"/> Service manual revision <input type="c

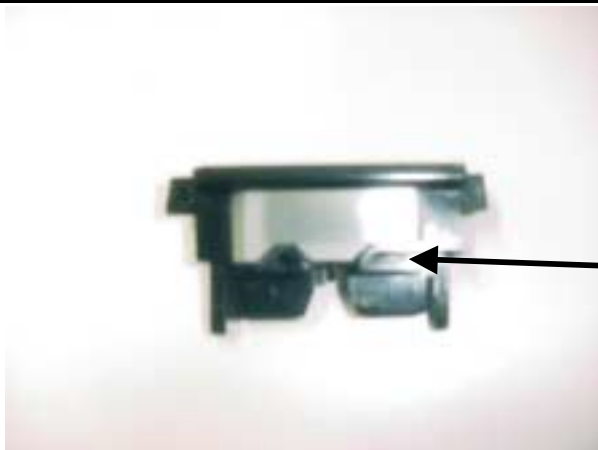
A defect in one of the molds that the manufacturer uses to produce the friction pad left a burr on the pad surface, catching the paper and preventing it from being fed.

Note: Only one of the two molds used to form the friction pad was defective (Cav 2).

Cav number (1 or 2) is visible here.

Cav 1: Normal

Cav 2: May be defective

2. If it is suspected that the non-feed is caused by a defective friction pad, please try the following:

- (1) Replace the friction pad
