Model: K-P1, A-C2, J-P1		Date: 03-Jul-01	No.: RB003008
Subject: Slow Printing from Macintosh		Prepared by: K. Misugi	
From: Technical Services Dept., GTS Division			
Classification:	<input checked="" type="checkbox"/> Troubleshooting <input type="checkbox"/> Part information <input type="checkbox"/> Action required <input type="checkbox"/> Mechanical <input type="checkbox"/> Electrical <input type="checkbox"/> Service manual revision <input type="checkbox"/> Paper path <input type="checkbox"/> Transmit/receive <input type="checkbox"/> Retrofit information <input type="checkbox"/> Other (      )

Model: General (GW Models)		Date: 20-Dec-01	No.: RGene010
Subject: Series Print Mode		Prepared by: K. Misugi	
From: Technical Services Dept., GTS Division			
Classification:	<input checked="" type="checkbox"/> Troubleshooting <input type="checkbox"/> Part information <input type="checkbox"/> Action required <input type="checkbox"/> Mechanical <input type="checkbox"/> Electrical <input type="checkbox"/> Service manual revision <input type="checkbox"/> Paper path <input type="checkbox"/> Transmit/receive <input type="checkbox"/> Retrofit information <input type="checkbox"/> Other (      )

Mo

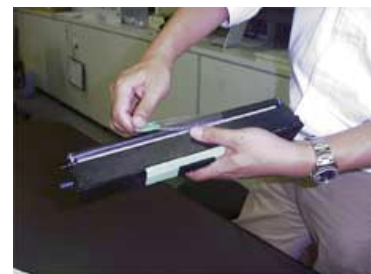
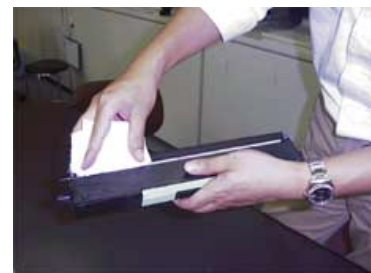
- (3) If excessive oil is soaked, replace the unit.
4. Keep the oil supply unit horizontal and remove the shield tape (with the green ② tab). Check the amount of oil on the oil supply felt. If oil tends to drop from the felt when tilting the unit, replace the unit.

5. If it is difficult to judge whether the condition on the oil supply felt is OK or NG, clean the oil supply felt with a clean cloth to remove any oil on the felt as shown.

6. Make sure that shield tape (with the green ① tab) has been removed, and then install the oil supply unit onto the fusing unit.
7. Make sure that the oil supply unit is properly set and the release (green) lever is moving freely. (If the release lever stops and does not return to the original position after pressing and releasing it, check the cause of it.)

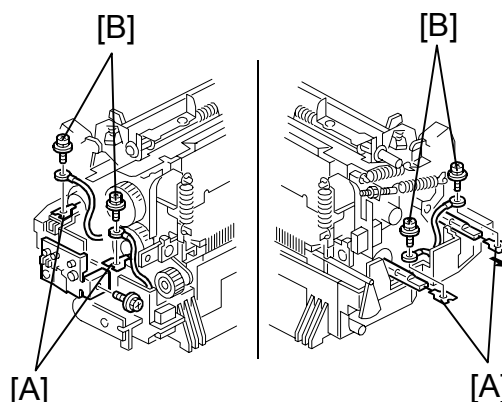
If they are not, there will be too much space between the screw and lamp terminal, causing a short. This can lead to SC543 or SC553, or in the worst case burn marks on the terminal area.

SC543: Heating roller fusing lamp overheat

SC553: Pressure roller fusing lamp overheat

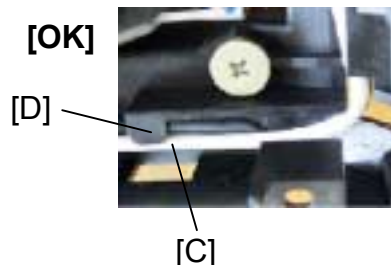
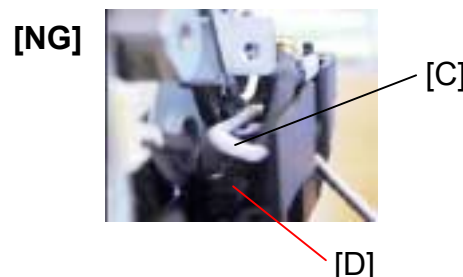
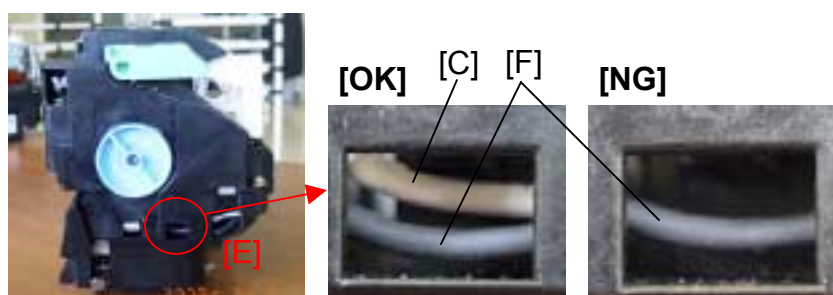
## 2. Wiring the cable of the heating roller fusing lamp

1. This positioning is essential. If the cable is above the projection, the C-ring of the heating roller may contact the cable and damage the protective sleeve. In the worst case, this could lead to an electrical short circuit.
2. If the white cable has been properly led, you will be able to see both it [C] and the gray cable [F] through the window [E] in the fusing unit cover.

When securing the white cable [C] of the heating roller fusing lamp (front side), make sure to lead it underneath the projection [D] as shown.

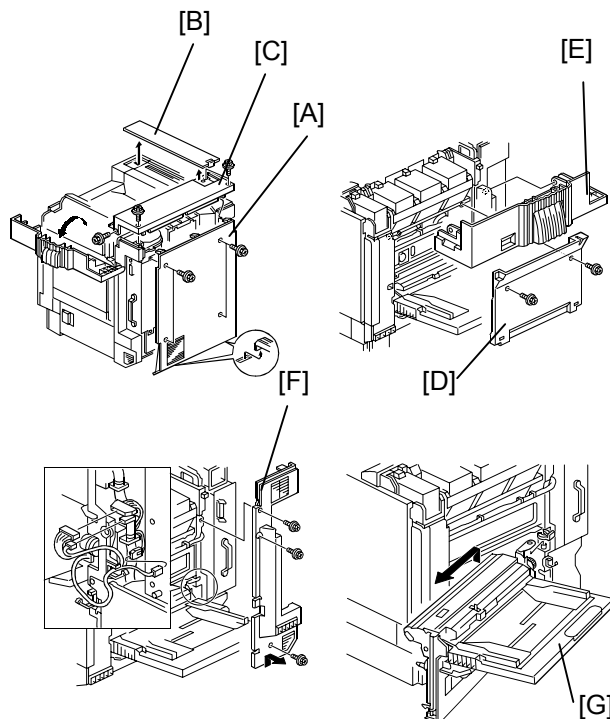
The electrical resistance of the Sheet (#G0602632) attached to the Guide Plate – Middle Registration is out of specification in some machines from July to September '01 production. This may cause the static electricity generated during a multi-print run to charge the Sheet, leading to a jam at the registration area (occasionally a Z-jam).

Replace the Guide Plate with the newly registered “Guide Plate – Middle Registration” assembly (#G0602613):

1. Make sure that the main switch is turned off and the power cord is unplugged.
2. Remove the following parts:
  - Rear Cover [A] (4 screws)
  - Upper Exit Cover [B]
  - Note:** Also remove the Mailbox if installed.
  - Upper Rear Cover [C] (4 screws)
  - Right Cover [D] (2 screws)
  - Upper Right Cover [E]
  - Right Rear Cover [F] (3 screws)
3. Open the Right Door Unit [G] and remove it (3 connectors, 1 snap-ring).

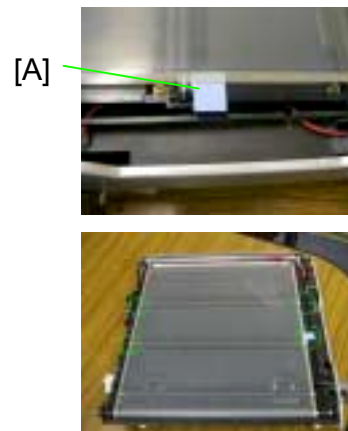
**NOTE:** If the 4 temporary stoppers [A] for the back-up rollers are present in the circled areas, be sure to remove them before installing the unit. Installing the transfer unit with these stoppers may cause noise or image problems.

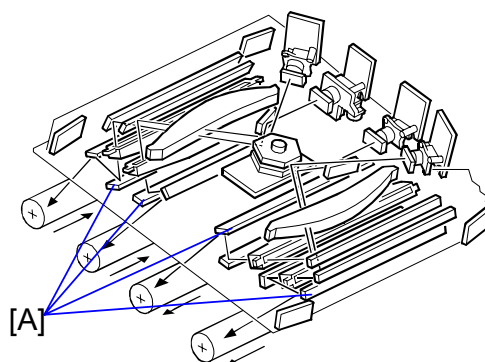
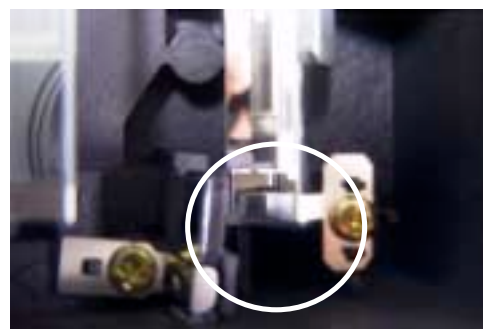
If color(s) is (are) missing on the output, remove the laser optics housing unit and lower cover (10 screws), and reposition the mirror(s) for the missing color(s) once the spring plate is removed.
