Model: Model-J P1c	Date: 4-Jun-02	No.: RG082001a
--------------------	----------------	----------------

## RTB Correction

Subject: Machine Installation & Short Haul Transportation		Prepared by: H. Someya	
From: Technical Services sec. Service Planning Dept.			
Classification:	<input type="checkbox"/> Troubleshooting <input type="checkbox"/> Mechanical <input type="checkbox"/> Paper path <input type="checkbox"/> Other (      )	<input type="checkbox"/> Part information <input type="checkbox"/> Electrical <input type="checkbox"/> Transmit/receive	<input checked="" type="checkbox"/> Action required <input type="checkbox"/> Service manual revision <input type="checkbox"/> Retrofit information

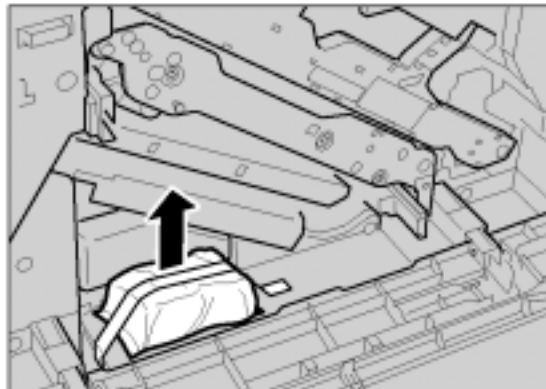
At machine installation, the following types of white lines appear in black halftone areas at the same interval as the drum circumference:

- Horizontal and straight (broken/continous)
- Short, vertical and wavy

Vibrations during transport cause scratches on the black OPC drum, as the image transfer belt is always contacting the black PCU during this time.

Until the permanent solution can be applied, P1c machines are shipped with the transfer belt unit separated from the black PCU. Specifically, the transfer belt unit lever has been detached before shipping to allow the front cover to be closed.

The transfer belt unit lever has been detached and placed inside the machine as shown in the illustration. This lever must then be reattached at installation by the customer or service technician.

The attachment procedure for this lever has been packaged together with the machine.
