Model: Model C-P2c	Date: 17-Feb-05	No.: RG112001a
--------------------	-----------------	----------------

Subject: Controller Firmware Release History (System)		Prepared by: A. Ishiyama	
From: 1st Tech. Support Sec. Service Support Dept.			
Classification:	<input type="checkbox"/> Troubleshooting	<input type="checkbox"/> Part information	<input type="checkbox"/> Action required
	<input type="checkbox"/> Mechanical	<input type="checkbox"/> Electrical	<input type="checkbox"/> Service manual revision
	<input type="checkbox"/> Paper path	<input type="checkbox"/> Transmit/receive	<input type="checkbox"/> Retrofit information
	<input checked="" type="checkbox"/> Other ()

This RTB has been issued to announce the firmware history for the System of the Model C-P2c (G113 model).

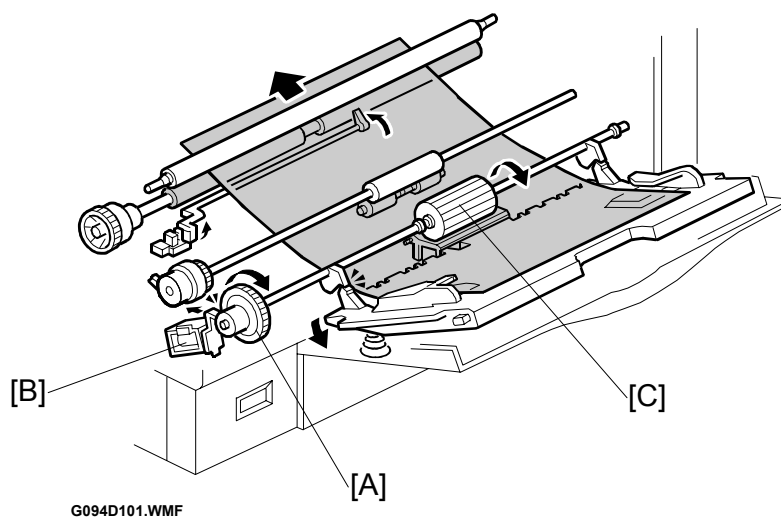
Solenoid System: Same as the C-P1/K-P3 system

- This is the same solenoid system that is used on the C-P1/K-P3.
- This change is for the C-P2b/P2c and K-P4.
- See MB MG112003 for the P/N details.

[A] Bypass feed gear

[B] Solenoid

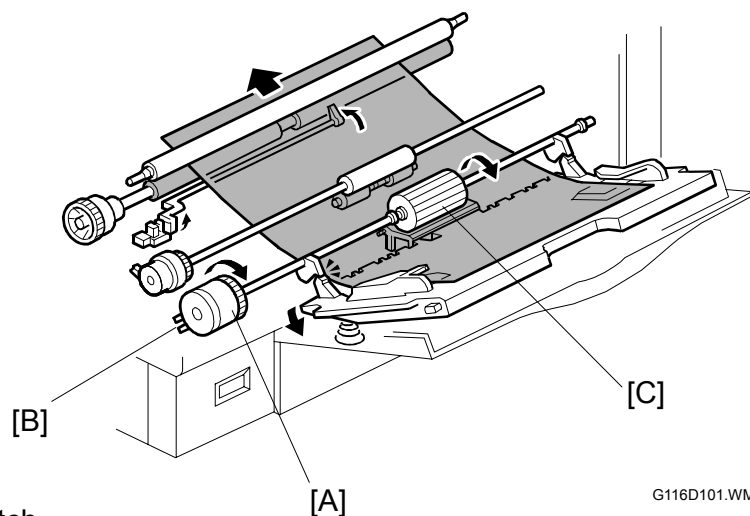
Clutch System: Originally designed for the C-P2/K-P4

[A] Bypass feed clutch

[B] Stopper

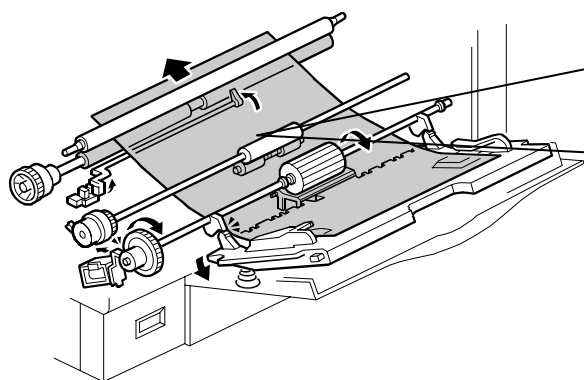
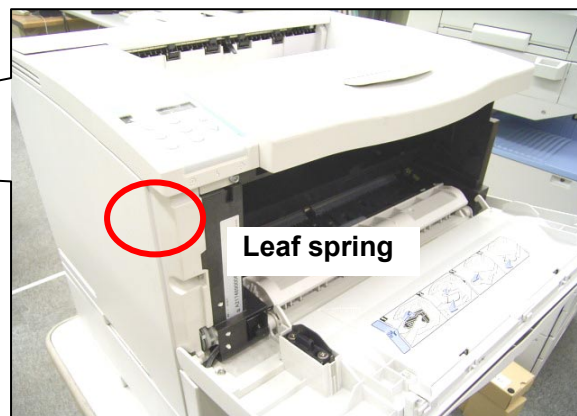
The G0523303 leaf spring is too thin on a small number of machines (about 34).

Replace the leaf spring if the symptom is reported on one of the “**potentially affected machines**”.

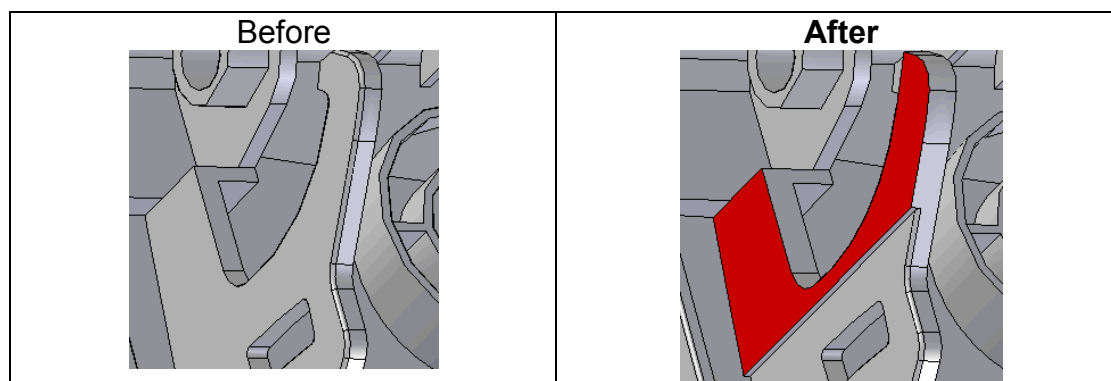
Change: The shape of the hook was changed.

Reason: To improve the durability of the hook.
