Model: Model K-P3		Date: 14-Nov-03	No.: RG091001
Subject: Service Manual Correction		Prepared by: A. Ishiyama	
From: 1st Technical Support sec. Service Support Dept.			
Classification:	<input type="checkbox"/> Troubleshooting <input type="checkbox"/> Mechanical <input type="checkbox"/> Paper path <input type="checkbox"/> Other ()	<input type="checkbox"/> Part information <input type="checkbox"/> Electrical <input type="checkbox"/> Transmit/receive	<input type="checkbox"/> Action required <input checked="" type="checkbox"/> Service manual revision <input type="checkbox"/> Retrofit information

Model: Model K-P3		Date: 26-Apr-04	No.: RG091003
Subject: Engine Board		Prepared by: A. Ishiyama	
From: 1st Technical Support Sec. Service Support Dept.			
Classification:	<input type="checkbox"/> Troubleshooting <input type="checkbox"/> Mechanical <input type="checkbox"/> Paper path <input type="checkbox"/> Other ()	<input type="checkbox"/> Part information <input type="checkbox"/> Electrical <input type="checkbox"/> Transmit/receive	<input checked="" type="checkbox"/> Action required <input type="checkbox"/> Service manual revision <input type="checkbox"/> Retrofit information

Important Not

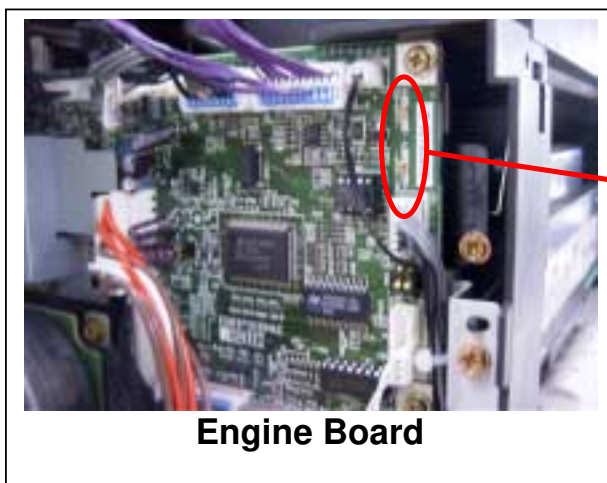
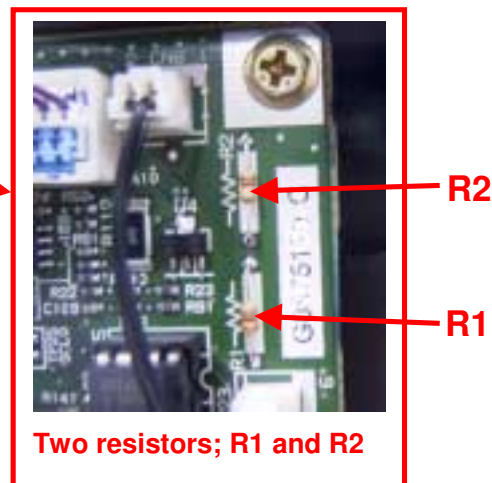
Minor Modification of old G0885123 Engine Board to its New Version

The old engine board (G0885123) contains two resistors, R1 and R2, but the new board for NA (G0885121) contains only R2 and the new board for EU/Asia (G0885122) contains only R1.

1. If the old engine board is already installed in the machine:
 - i) Open the front door.
 - ii) Remove the operation panel (2 hooks, 1 harness).
 - iii) Remove the rear cover and option top cover.
 - iv) Remove the top cover (4 screws).
 - v) Remove the left cover (2 screws).
2. **For NA version**
 Remove R1 as shown below using a pair of wire cutters (nippers).
