Technical Bulletin

Model: Model K-P4	Date: 17	-Feb-05	No.: RG116001a
RTB Reissue			
The items in bold italics have been added.			
Subject: Controller Firmware Release History (System)	Prep	pared by: A. I	shiyama
From: 1st Tech. Support Sec. Service Support Dept.

This RTB has been issued to announce the firmware history for the System of the Model K-P4 (G116 model).

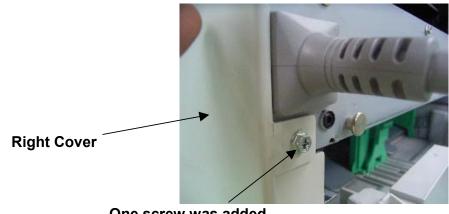
The procedure below was changed from the beginning of mass production: One screw (x 1) was added to the step for removing the right cover. See the **bold**, underlined area.

One screw was added

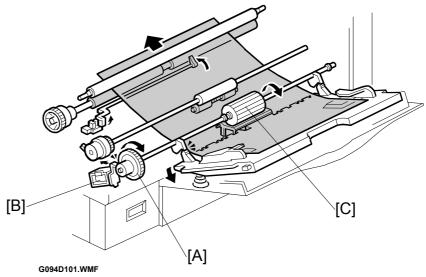
Solenoid System: Same as the C-P1/K-P3 system

- This is the same solenoid system that is used on the C-P1/K-P3.
- See MB MG116005 for the P/N details.

- [A] Bypass feed gear
- [B] Solenoid
- [C] Bypass feed roller

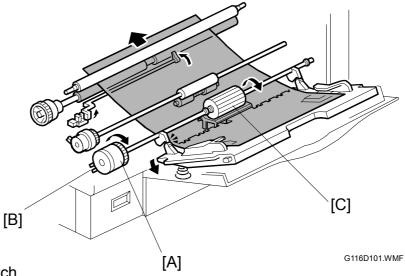
Clutch System: Originally designed for the C-P2/K-P4

- [A] Bypass feed clutch
- [B] Stopper
- [C] Bypass feed roller

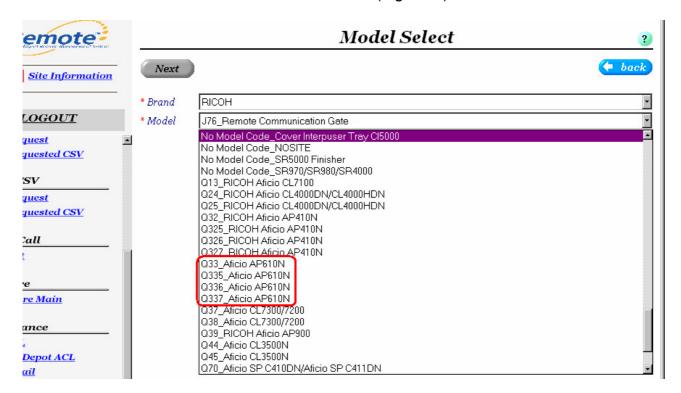
- 1. The format of the ID2 is incorrect on the SMC printout (SP5811-003) and in the RC Gate UI when trying to register a device as "managed".
- 2. The target device cannot be found in the @Remote Center GUI when trying to perform a remote firmware update (RFU).

Note: Most devices are listed with the incorrect ID2 format (e.g. Q335, Q336 or Q337), but some are listed with the correct ID2 format (e.g. Q33).
