Model: Adonis-P		Date: 31-Oct-99	No.: RG035001
Subject: Service Manual Corrections		Prepared by: K. Takagi	
From: Technical Service Dept., GTS Division			
Classification:	<input type="checkbox"/> Troubleshooting <input type="checkbox"/> Part information <input type="checkbox"/> Action required		
	<input type="checkbox"/> Mechanical <input type="checkbox"/> Electrical <input checked="" type="checkbox"/> Service manual revision		
	<input type="checkbox"/> Paper path <input type="checkbox"/> Transmit/receive <input type="checkbox"/> Retrofit information		
	<input type="checkbox"/> Other (      )

Model: Adonis-P		Date: 31-Jan-00	No.: RG035002
Subject: Service Manual Correction		Prepared by: K. Takagi	
From: Technical Service Dept., GTS Division			
Classification:	<input type="checkbox"/> Troubleshooting <input type="checkbox"/> Part information <input type="checkbox"/> Action required <input type="checkbox"/> Mechanical <input type="checkbox"/> Electrical <input checked="" type="checkbox"/> Service manual revision <input type="checkbox"/> Paper path <input type="checkbox"/> Transmit/receive <input type="checkbox"/> Retrofit information <input type="checkbox"/> Other (       )

Model:

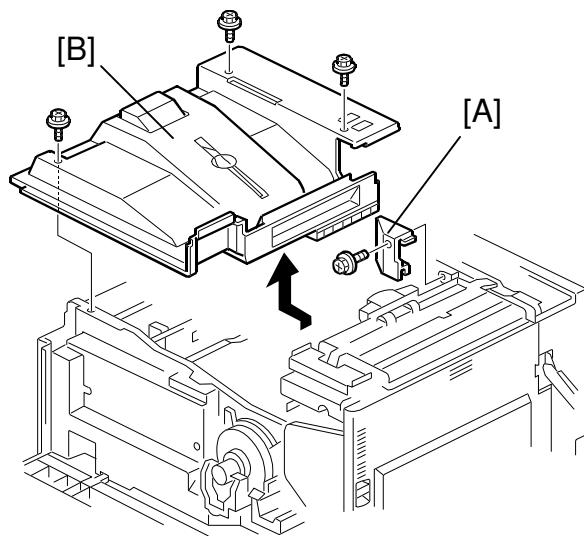
- **Upper Cover (Page 6-48)**

The wrong illustration is attached for the upper cover removal.

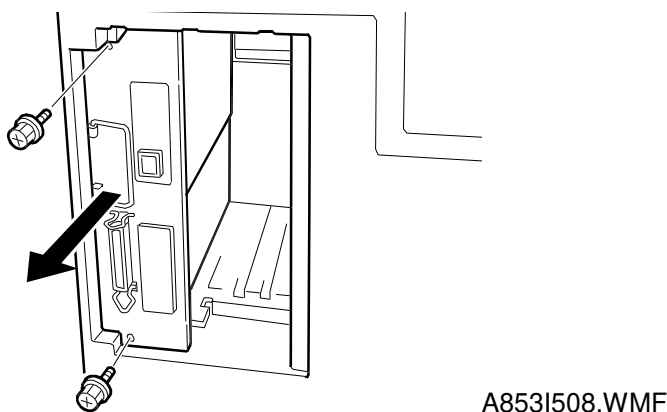
- **Printer Control Board and NIB (Page 6-50)**

The wrong illustration was attached.

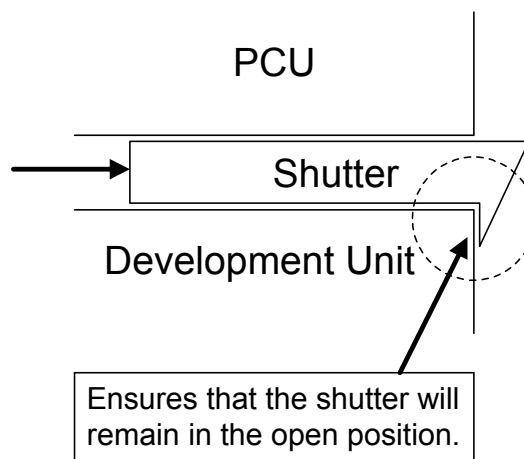
- Light print problem is not fixed after developer is replaced.
- The Toner End message does not disappear after the toner bottle is replaced.

The toner supply shutter (parts catalog pg.27, index #28) returns to the closed position when the PCU unit (PCU and development unit) is put in the machine.

Normally, the shutter is not in the closed position when the machine is shipped out. However, if the technician removes the PCU unit from the machine and attempts to separate the PCU from the development unit, the shutter may return to the closed position.

1. The length of the pawl edge of the shutter was increased by 2.5 mm to prevent the shutter from returning to the closed position.
2. The tension spring (parts catalog pg.27, #27) included in the user maintenance kit was deleted.

If you should experience any future occurrences, remove the PCU unit from the machine, check the position of the shutter and return it to the open position if necessary (see the illustration below). After this, carefully place the unit back in the machine.

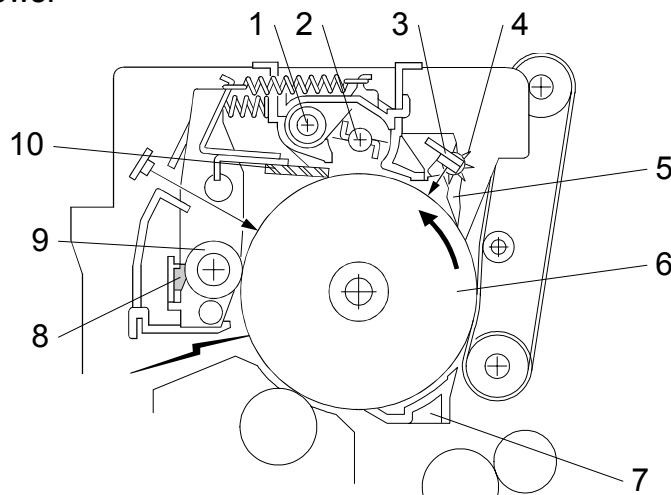
### • PHOTOCONDUCTOR UNIT (Page 2-16)

There were incorrect callout numbers for the overview illustration. Correct the illustration as follows:

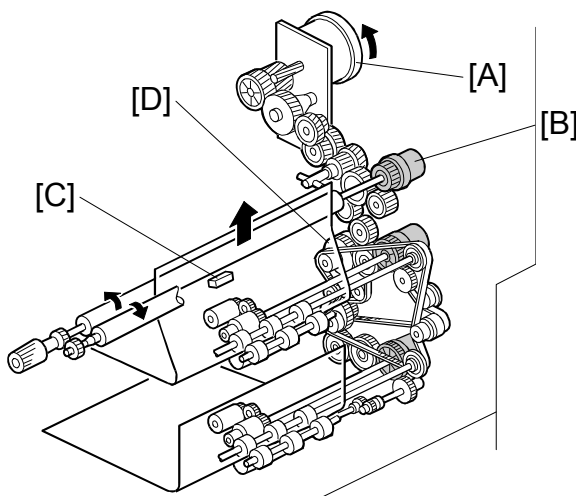
### • PAPER REGISTRATION (Page 2-44)

There was a missing callout and an incorrect callout in the illustration. Correct the illustration as follows:

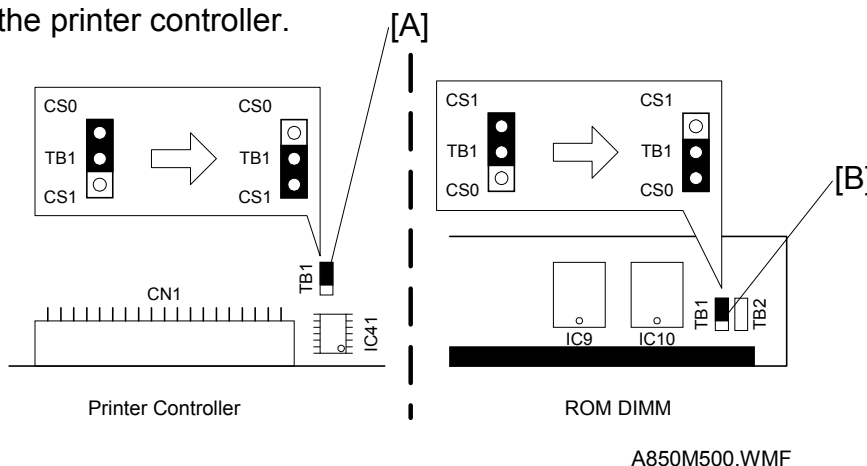
When downloading of the controller firmware is not successful from either the flash memory card or PC (and the printer controller does not start up), any attempts after that to download from the card or PC will not be possible. In addition, it will not be possible to return the machine to operating condition.

2. Change the position of the TB1 jumper [A] on the controller from CS0 to CS1.
  3. Change the position of the TB1 jumper [B] on the ROM DIMM that contains the controller firmware from CS1 to CS0.
  4. Install the ROM DIMM on the controller.
- CAUTION:** Make sure to install the correct ROM DIMM in the PS SIMM connector.
