Model: Model A-P3		Date: 27-Nov-01	No.: RG065001
Subject: Service Manual Correction		Prepared by: E. Fukuyama	
From: Technical Services Dept., GTS Division			
Classification:	<input type="checkbox"/> Troubleshooting <input type="checkbox"/> Part information <input type="checkbox"/> Action required <input type="checkbox"/> Mechanical <input type="checkbox"/> Electrical <input checked="" type="checkbox"/> Service manual revision <input type="checkbox"/> Paper path <input type="checkbox"/> Transmit/receive <input type="checkbox"/> Retrofit information <input type="checkbox"/> Other ()

Model: General (GW Models)		Date: 20-Dec-01	No.: RGene010
Subject: Series Print Mode		Prepared by: K. Misugi	
From: Technical Services Dept., GTS Division			
Classification:	<input checked="" type="checkbox"/> Troubleshooting <input type="checkbox"/> Part information <input type="checkbox"/> Action required <input type="checkbox"/> Mechanical <input type="checkbox"/> Electrical <input type="checkbox"/> Service manual revision <input type="checkbox"/> Paper path <input type="checkbox"/> Transmit/receive <input type="checkbox"/> Retrofit information <input type="checkbox"/> Other ()

Model: Model A-P3		Da

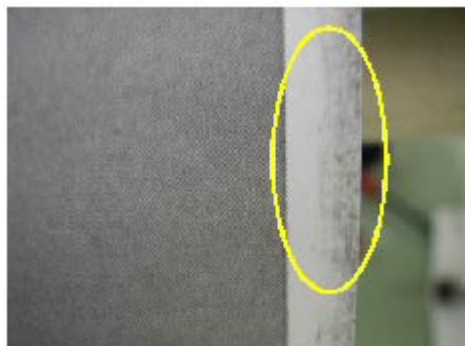
Toner dirtying appears on both sides of the printout just after a new PCU or Maintenance Kit A is installed.

Too much grease was applied to the drum or charge roller during factory assembly. As a result, some of the grease moved to the image area of the drum or roller and attracted toner.

3. Take 10 more all-white copies (A3/DLT).
4. If the symptom still occurs, measure the distance between each dirty image.
 - If the distance is about **180mm**: Remove the **drum** and clean the drum surface (dry cloth +alcohol).
 - If the distance is about **44mm**: Remove the **charge roller** and clean the roller surface (dry cloth +alcohol).
5. Reinstall the same part you removed in step 4 (drum or charge roller).
6. Take 5 all-white copies (A3/DLT).
7. If the symptom still occurs:
 - If the distance is about **180mm**: Replace the **drum**.
 - If the distance is about **44mm**: Replace the **charge roller**.

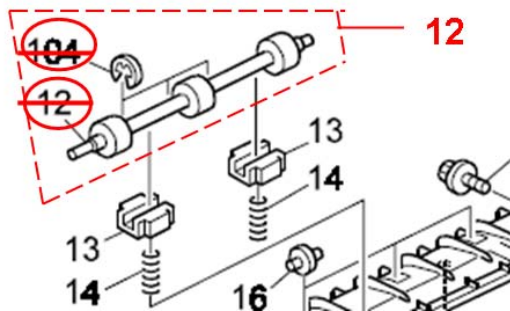
Change: The retaining ring was deleted as an individual service part and included as part of the driven roller service part.

Reason: It is no longer possible to provide the retaining ring as an individual service part.
