Model: Model PL-P1	Date: 25-Jun-04	No.: RG108001d
--------------------	-----------------	----------------

Subject: Firmware Release History (printer)		Prepared by: H.K.	
From: 1st Tech. Support Sec. Service Support Dept.			
Classification:	<input type="checkbox"/> Troubleshooting	<input type="checkbox"/> Part information	<input type="checkbox"/> Action required
	<input type="checkbox"/> Mechanical	<input type="checkbox"/> Electrical	<input type="checkbox"/> Service manual revision
	<input type="checkbox"/> Paper path	<input type="checkbox"/> Transmit/receive	<input type="checkbox"/> Retrofit information
	<input type="checkbox"/> Product Safety	<input checked="" type="checkbox"/> Other (Firmware History)	<input type="checkbox"/> Tier 2

Model: Model PL-P1		Date: 15-Sep-04	No.: RG108007
Subject: Dust cover		Prepared by: H.Taguchi	
From: 1st Tech. Support Sec. Service Support Dept.			
Classification:	<input checked="" type="checkbox"/> Troubleshooting	<input type="checkbox"/> Part information	<input type="checkbox"/> Action required
	<input type="checkbox"/> Mechanical	<input type="checkbox"/> Electrical	<input type="checkbox"/> Service manual revision
	<input type="checkbox"/> Paper

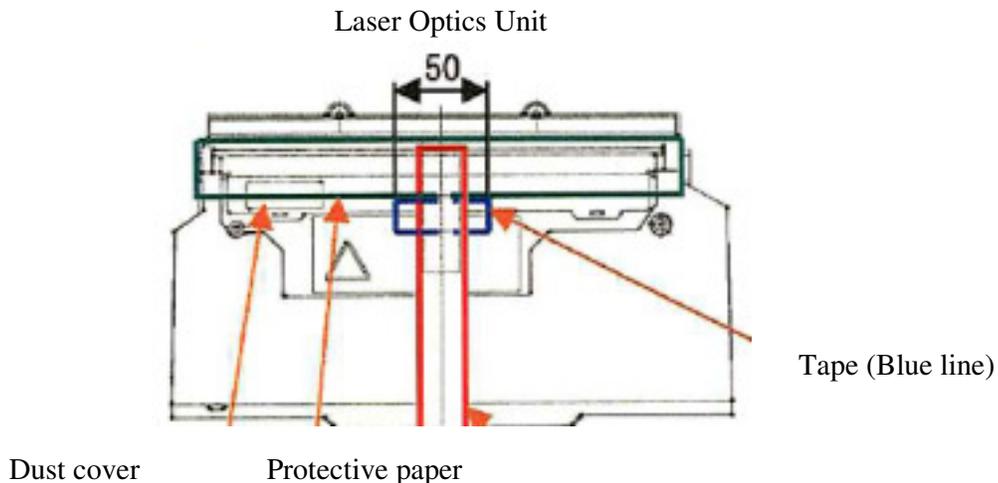
No image is printed at installation.

The dust cover for the optics unit comes loose and blocks the laser.

Sometimes, customers reach through the top cover and remove the protective sheet for the optics unit. In some cases, the dust cover opens and then comes loose when the toner cartridge is pushed in.

If the symptom is reported, close the dust cover or replace it if it is broken.

A strip of tape was added to the dust cover to keep it closed.

**Important:** You do not need this tape after installation. Remove the tape if you need to open the cover to do regular maintenance (for example, to clean the dust glass).
