Model: Model PL-MF	Date: 25-May-06	No.: RG157001a
--------------------	-----------------	----------------

Subject: Firmware History - Main Unit Controller		Prepared by: H.K.	
From: 1st Tech. Support Sec. Service Support Dept.			
Classification:	<input type="checkbox"/> Troubleshooting	<input type="checkbox"/> Part information	<input type="checkbox"/> Action required
	<input type="checkbox"/> Mechanical	<input type="checkbox"/> Electrical	<input type="checkbox"/> Service manual revision
	<input type="checkbox"/> Paper path	<input type="checkbox"/> Transmit/receive	<input type="checkbox"/> Retrofit information
	<input checked="" type="checkbox"/> Other (Firmware History)

Model: Model PL-MF		Date: 22-Dec-06	No.: RG157003
Subject: ADF Jam or skew (US & European versions only)		Prepared by: H.K.	
From: 1st Tech. Support Sec. Service Support Dept.			
Classification:	<input checked="" type="checkbox"/> Troubleshooting	<input type="checkbox"/> Part information	<input checked="" type="checkbox"/> Action required
	<input type="checkbox"/> Mechanical	<input type="checkbox"/> Electrical	<input type="checkbox"/> Service manual revision
	<input type="checkbox"/> Paper path	<input type="checkbo

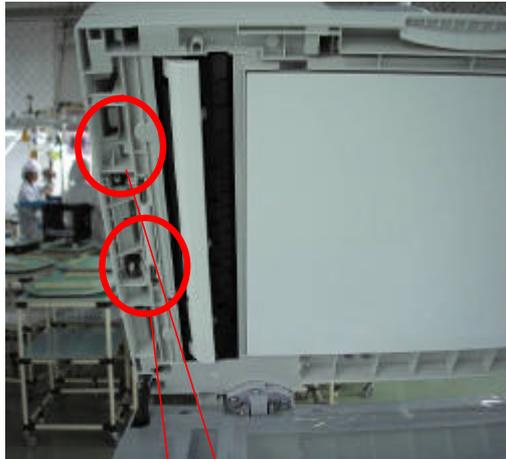
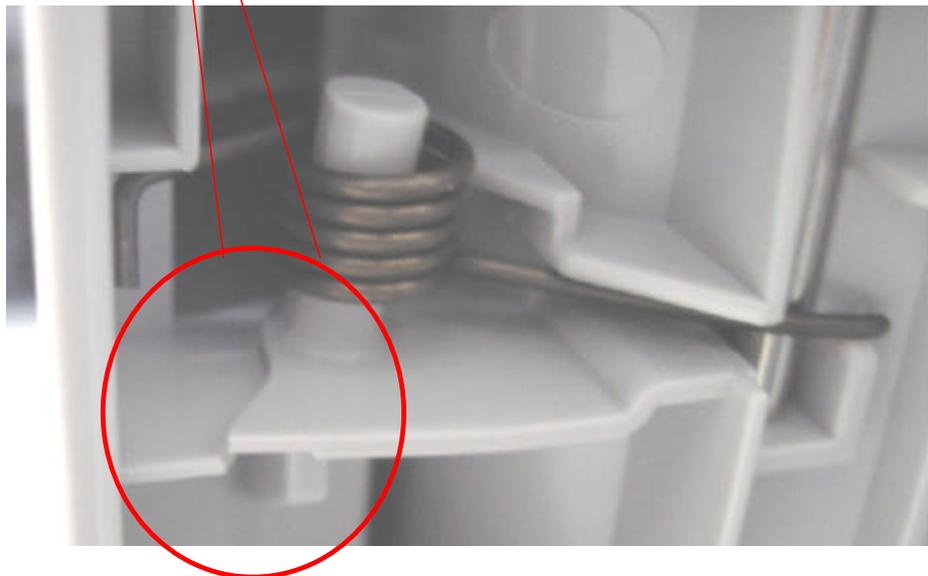
Original jam or skew occurs.

The rib near the pin on which the roller spring is anchored breaks (see the picture below), which is due to a manufacturing error and insufficient strength of the part.

1. The thickness of the rib has been changed from 1.5 mm to 2.0mm.
2. The foot of the pin has been strengthened as shown below.
3. An inspection procedure using a double strength spring (compared to the actual production spring) has been added to the production process.

When the ribs near the pins are NG (No Good or defective), the ADF should be replaced.
When the ribs are OK, add the reinforcement plate to ensure the function of the pin.

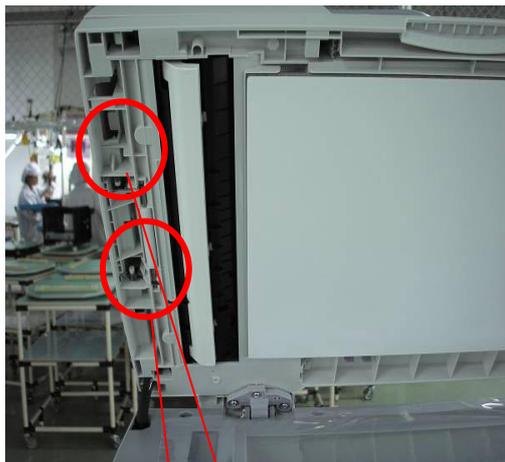
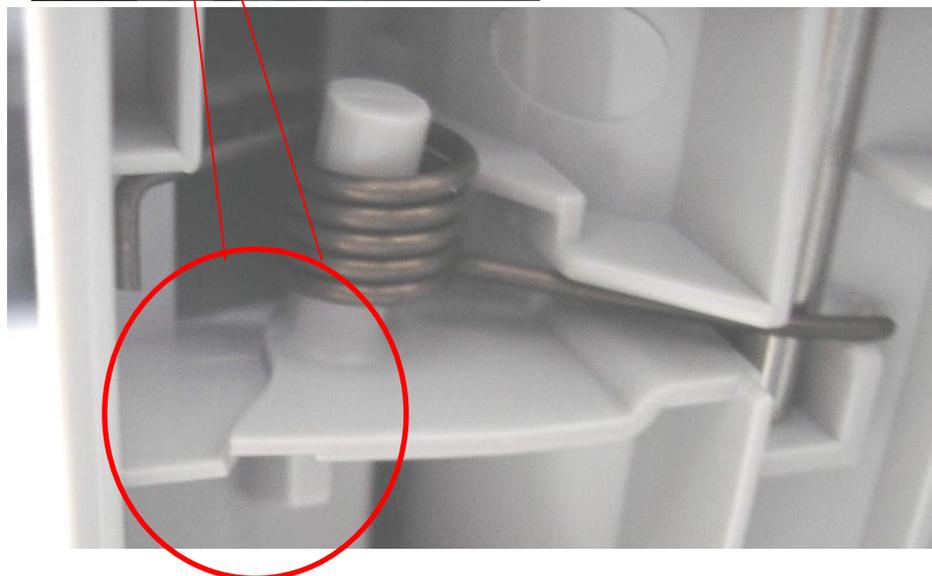
Original jam or skew occurs.

The rib near the pin on which the roller spring is anchored breaks (see the picture below), which is due to a manufacturing error and insufficient strength of the part.

1. The thickness of the rib has been changed from 1.5 mm to 2.0mm.
2. The foot of the pin has been strengthened as shown below.
3. An inspection procedure using a double strength spring (compared to the actual production spring) has been added to the production process.
4. **A reinforcement plate was added to machines from July 2007 production (P/N V121379: Reinforcement Plate Kit).**

- **Install the reinforcement plate on the affected units for service calls reported from the field.
SEE THE PROCEDURE BELOW.**

- **The previous RTB recommended replacing the ADF, but it was found that this symptom can be solved by installing the reinforcement plate alone.**
- **The reinforcement plate supports the spring directly, so that the pin does not have to.**

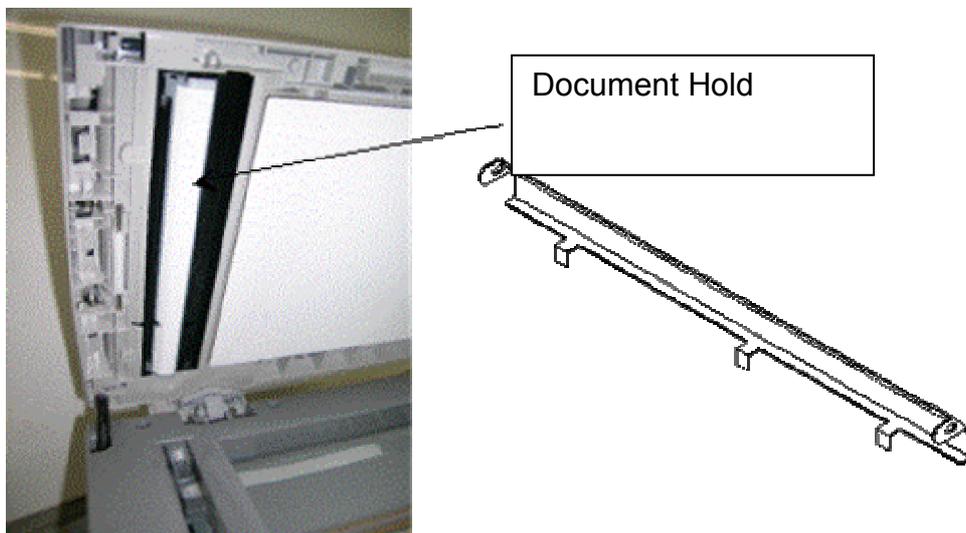
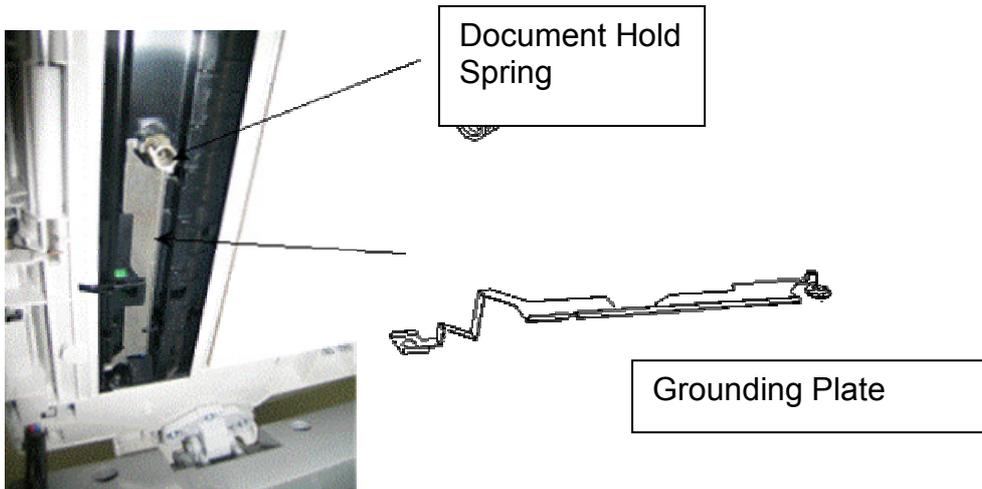
Vertical black lines appear on the image if 40 or more originals are scanned consecutively in the ADF under low-humidity conditions.

Scanning this many originals tends to cause a build-up of static electricity on the separation pad and feed rollers. This charge is transferred to the paper surface and original holder, and then eventually to the CIS. As a result, the CIS malfunctions and produces the black lines.

If this symptom occurs, attach the parts in the new “Document Hold Supply Assembly” (P/N **V121387**) to the ADF.

- The material of the original holder (pg. 19, index 25) was changed from a polymer to metallic material, in order to increase the grounding of the holder.
- A grounding plate was added.
- The number of individual coil rings of the document hold spring (pg. 19, index 26) was reduced from 10 to 6.
