Model: Model AR-P2	Date: 26-Jan-06	No.: RG139001a
--------------------	-----------------	----------------

Subject: Engine firmware release note for AR-P2		Prepared by: K. Moriizumi	
From: 1st Tech. Support Sec. Service Support Dept.			
Classification:	<input type="checkbox"/> Troubleshooting	<input type="checkbox"/> Part information	<input type="checkbox"/> Action required
	<input type="checkbox"/> Mechanical	<input type="checkbox"/> Electrical	<input type="checkbox"/> Service manual revision
	<input type="checkbox"/> Paper path	<input type="checkbox"/> Transmit/receive	<input type="checkbox"/> Retrofit information
	<input checked="" type="checkbox"/> Product Safety	<input type="checkbox"/> Other ()

Model: Model AR-P2		Date: 10-Apr-08	No.: RG139008
Subject: Black toner dropping		Prepared by: K. Moriizumi	
From: 1st Tech. Support Sec. Service Support Dept.			
Classification:	<input checked="" type="checkbox"/> Troubleshooting	<input type="checkbox"/> Part information	<input type="checkbox"/> Action required
	<input type="checkbox"/> Mechanical	<input type="checkbox"/> Electrical	<input type="checkbox"/> Service manual revision
	<input type="checkbox"/> Paper path	<input type="chec

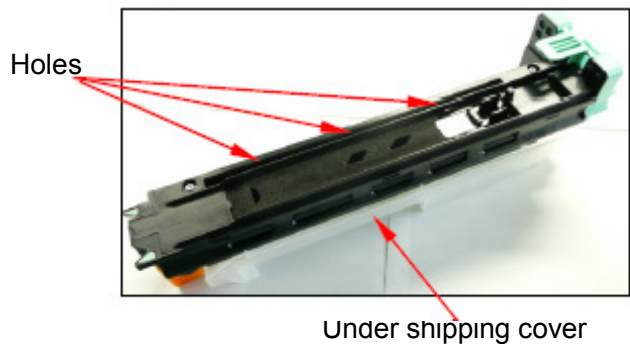
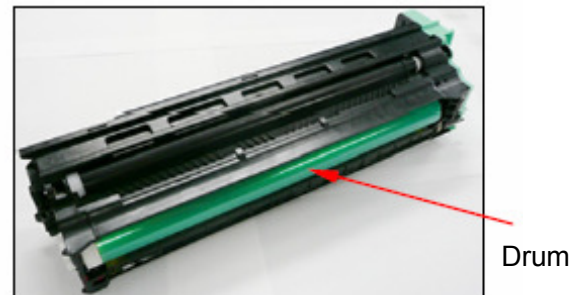
1. Don't touch the drum on the underside of the unit. Attach a shipping cover to this area.
2. Don't expose the holes shown in the photo and drum to any light for more than 10 minutes.
3. Make sure no foreign material gets into the holes shown in the photo.

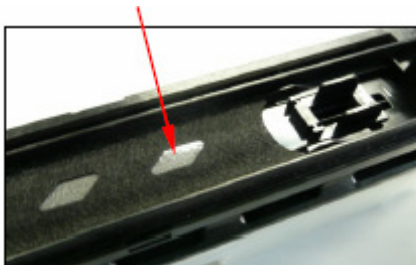
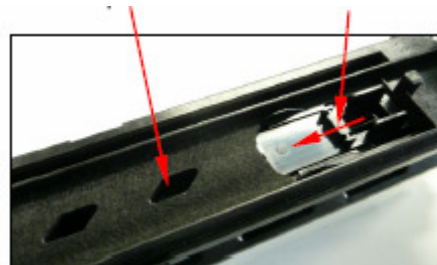
OK: The toner shutter is closed.

NG: The toner shutter is open. Please slide the shutter.

4. Close the toner shutter and keep it shut during the entire procedure.

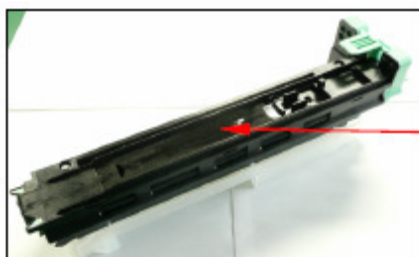
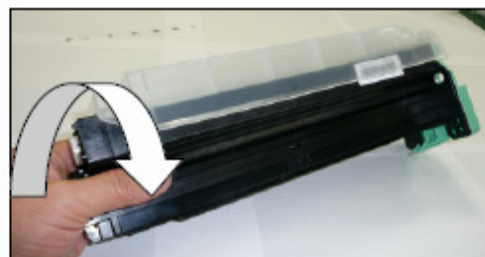
Remove
this toner

1. If there is any toner near the toner supply hole, use a vacuum cleaner to remove this toner. If you don't have a vacuum cleaner, turn the handle slowly in the direction of the white arrow, as shown in the photo.

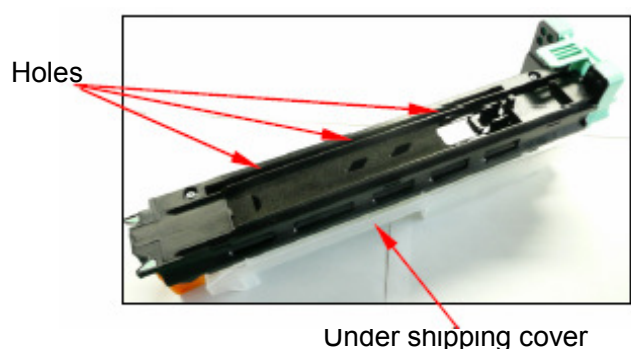
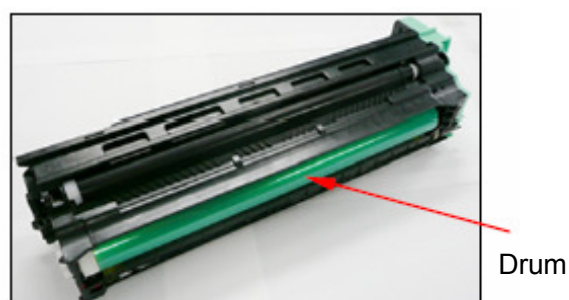
1. Don't touch the drum on the underside of the unit. Attach a shipping cover to this area.
2. Don't expose the holes shown in the photo and drum to any light for more than 10 minutes.
3. Make sure no foreign material gets into the holes shown in the photo.

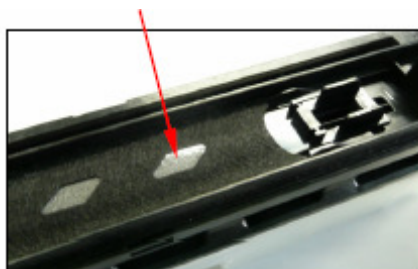
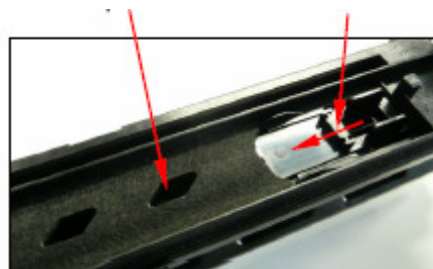
OK: The toner shutter is closed.**NG:** The toner shutter is open. Please slide the shutter.

4. Close the toner shutter and keep it shut during the entire procedure.

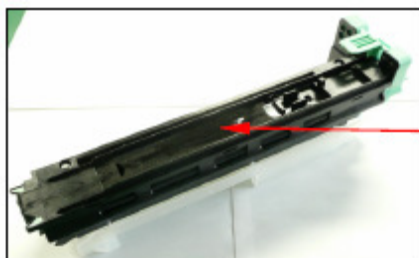
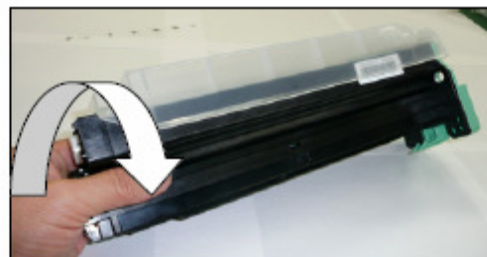
Remove
this toner

1. If there is any toner near the toner supply hole, use a vacuum cleaner to remove this toner. If you don't have a vacuum cleaner, turn the handle slowly in the direction of the white arrow, as shown in the photo.

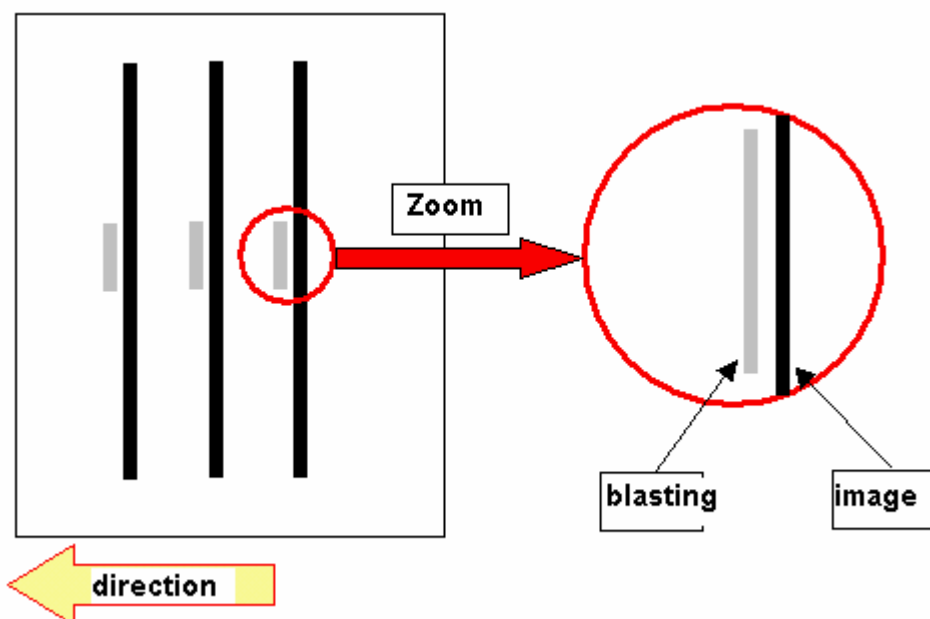
- Location of toner blasting -

Toner blasting appears just ahead of the image along the paper feed direction.

- Occurs only with black and white printing
- Occurs mainly at the center of the image but sometimes at the side edges.

Related to paper transfer roller bias

1. Change the paper transfer roller bias.
SP 2-403-001 Plain: Bias Sep DC: Plain: 1st
34 -> 50

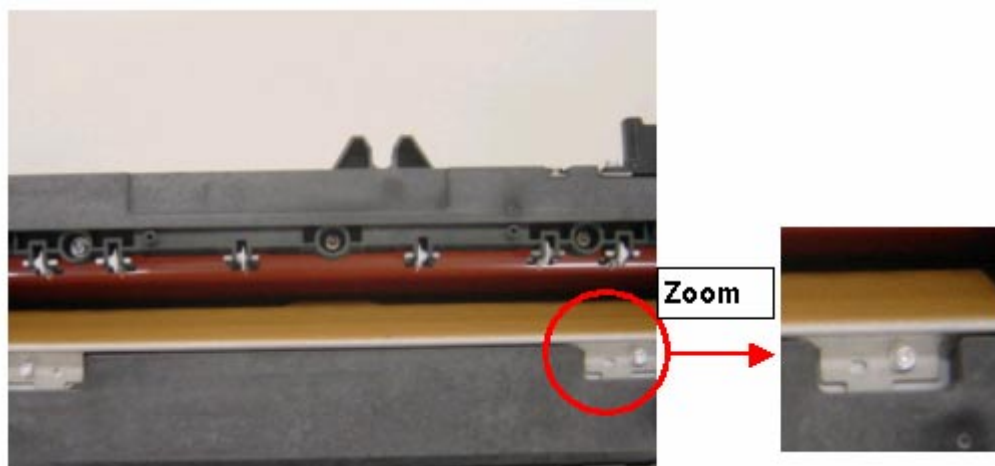
- After the position of the guide plate screw is changed -

After this screw position is changed, in some cases, mimizu ('earth worms', slight wrinkling) may occur with the first print made of the day.

2. Change the position of the fusing guide plate.
- Change the position of the screw shown below, and then move the guide plate toward the pressure roller.
