Model: G-P2L	Date: 15-Jan-08	No.: RG158001a
--------------	-----------------	----------------

Subject: Firmware Release History (System)		Prepared by: K. Moriizumi	
From: 1st Tech. Support Sec. Service Support Dept.			
Classification:	<input type="checkbox"/> Troubleshooting	<input type="checkbox"/> Part information	<input type="checkbox"/> Action required
	<input type="checkbox"/> Mechanical	<input type="checkbox"/> Electrical	<input type="checkbox"/> Service manual revision
	<input type="checkbox"/> Paper path	<input type="checkbox"/> Transmit/receive	<input type="checkbox"/> Retrofit information
	<input type="checkbox"/> Product Safety	<input checked="" type="checkbox"/> Other ()

Model: General		Date: 12-Mar-08	No.: RGene027
Subject: New Wireless LAN Option		Prepared by: H.K.	
From: 1st Tech. Support Sec. Service Support Dept.			
Classification:	<input type="checkbox"/> Troubleshooting	<input type="checkbox"/> Part information	<input checked="" type="checkbox"/> Action required
	<input type="checkbox"/> Mechanical	<input type="checkbox"/> Electrical	<input checked="" type="checkbox"/> Service manual revision
	<input type="checkbox"/> Paper path	<input type="checkbox"/> Transmi

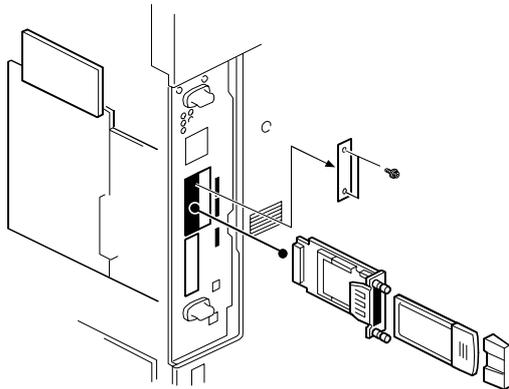
Previous types:
PCB, LAN card, and cover are separate

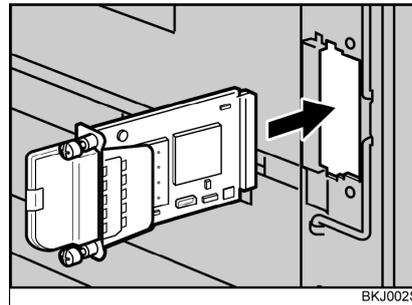
New Type (IEEE802.11b Interface Unit Type N):
Pre-assembled
