Model: Model G-P2	Date: 18-May-06	No.: RG160001d
-------------------	-----------------	----------------

Subject: Firmware Release History (Printer)		Prepared by: S. Tomoe	
From: 1st Tech. Support Sec. Service Support Dept.			
Classification:	<input type="checkbox"/> Troubleshooting <input type="checkbox"/> Mechanical <input type="checkbox"/> Paper path <input checked="" type="checkbox"/> Other ()	<input type="checkbox"/> Part information <input type="checkbox"/> Electrical <input type="checkbox"/> Transmit/receive	<input type="checkbox"/> Action required <input type="checkbox"/> Service manual revision <input type="checkbox"/> Retrofit information

This RTB has been issued to announce the firmware release information for the Printer.

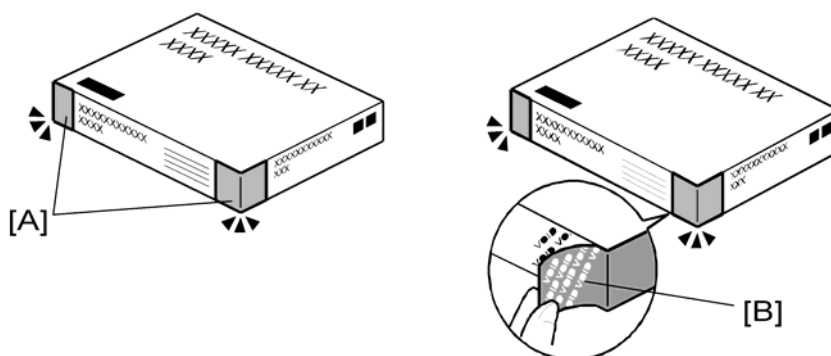
Seal Check and Removal

1. Check the box seals [A] on each corner of the box.
 - Make sure that a tape is attached to each corner.
 - The surfaces of the tapes must be blank. If you see "VOID" on the tapes, do not install the components in the box.
2. If the surfaces of the tapes do not show "VOID", remove them from the corners of the box.
3. You can see the "VOID" marks [B] when you remove each seal. In this condition, they cannot be attached to the box again.

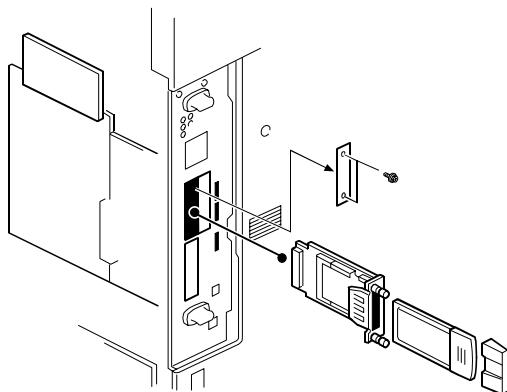
Previous types:
PCB, LAN card, and cover are
separate

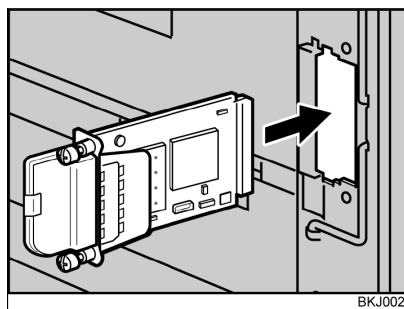
New Type (IEEE802.11b
Interface Unit Type N):
Pre-assembled
