Technical Bulletin

Model: Model G-P1	Date: 24-Feb-05	No.: RG104001a
-------------------	-----------------	----------------

Subject: Engine firmware release note for G-P1		Prepared by: K. Moriizumi	
From: 1st Tech. Support Sec. Service Support Dept.			
Classification:	☐ Troubleshooting ☐ Mechanical ☐ Paper path ☐ Other ()	☐ Part informa☐ Electrical☐ Transmit/rec	☐ Service manual revision

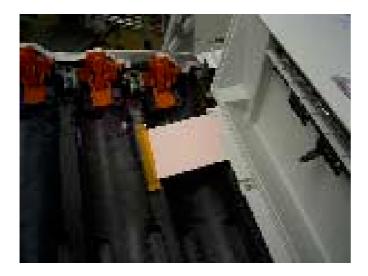
When you pre-install a machine, do the following before you send the machine to the customer site. This will protect the top cover open sensor from damage during transport.

Important: Make sure that the protective sheet covers the Top Cover Open Sensor.

- Insert the toner bottle protective sheet under the top cover.
 - > Use the protective sheet that came with the machine.
 - If you do not have this sheet, use a sheet of plain paper.

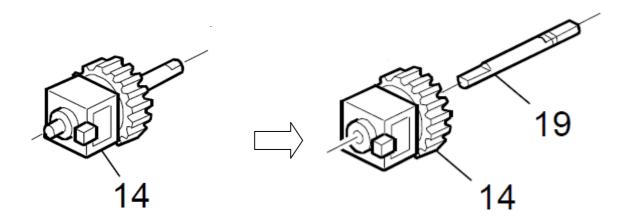
Change/Reason: This part was missing from the Parts Catalog.

Old part	New part	Description	Q'ty	Int	Page	Index	Note
number	number						
-	GA145008	Shaft: Development	1		33	19

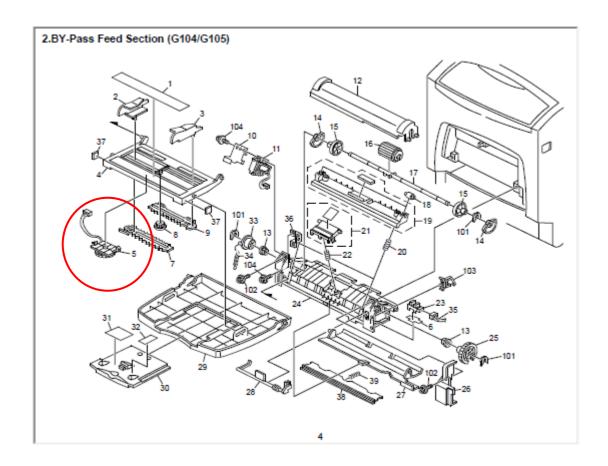
Change/Reason: This part is not used on the G-P1.

Old part number	New part number	Description	Q'ty	Int	Page	Index	Note
GW500003		Rotary Switch: Paper Size Sensor	1 – 0		4	5	Del
