Model: General (GW Models)		Date: 20-Dec-01	No.: RGene010
Subject: Series Print Mode		Prepared by: K. Misugi	
From: Technical Services Dept., GTS Division			
Classification:	<input checked="" type="checkbox"/> Troubleshooting	<input type="checkbox"/> Part information	<input type="checkbox"/> Action required
	<input type="checkbox"/> Mechanical	<input type="checkbox"/> Electrical	<input type="checkbox"/> Service manual revision
	<input type="checkbox"/> Paper path	<input type="checkbox"/> Transmit/receive	<input type="checkbox"/> Retrofit information
	<input type="checkbox"/> Other (      )

Model: Model U-P1		Date: 20-Dec-02	No.: RG071001
Subject: Image Skew		Prepared by: H.K.	
From: Technical Services sec. Service Planning Dept.			
Classification:	<input checked="" type="checkbox"/> Troubleshooting	<input type="checkbox"/> Part information	<input type="checkbox"/> Action required
	<input type="checkbox"/> Mechanical	<input type="checkbox"/> Electrical	<input type="checkbox"/> Service manual revision
	<input type="checkbox"/> Paper path	<input type="checkbox"/> Transmit/receive	<input type="checkbox"/> Retrofit information
	<input type="checkbox"/> Other (       )

Model: Model U-P

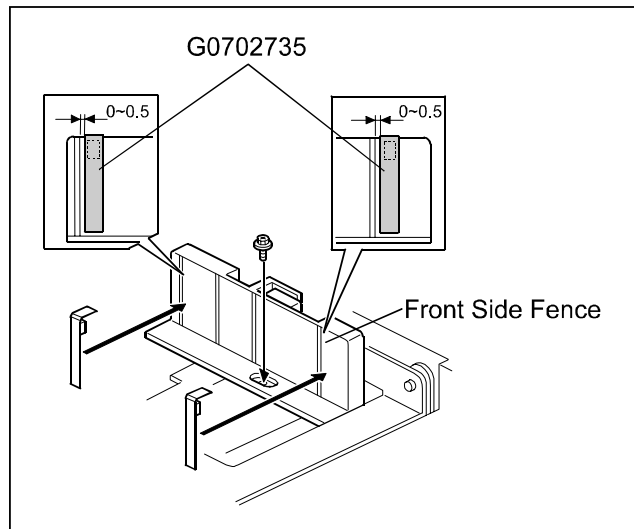
As a supplement, the level of skew can be further minimized by increasing the paper buckle with SP1-003. Try adjusting this value several times while checking the level of skew on the printouts, keeping in mind that a higher value tends to cause Z-folds and a lower value tends to cause paper jams.

1. Clean the attachment surface on the Front Side Fence (AF016097) with alcohol.
2. Attach the Mylar (G0702735) to the Front Side Fence as shown in the illustration.

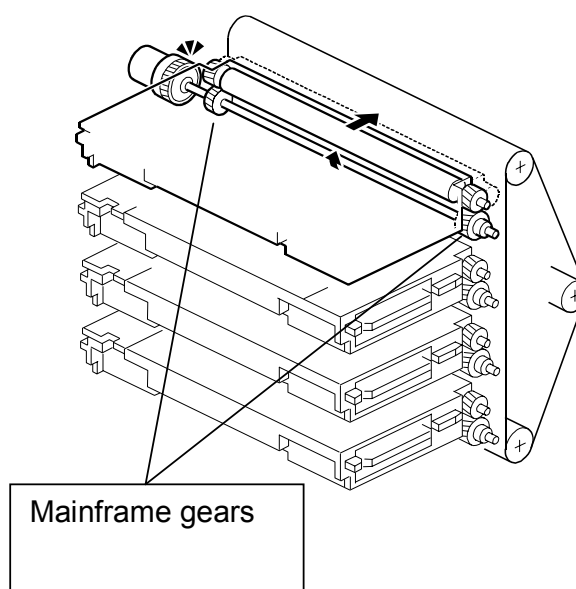
A blank area may appear on one side of the image (development unit front or rear).

The development unit front gears engage their mainframe counterparts slightly differently than the rear gears.

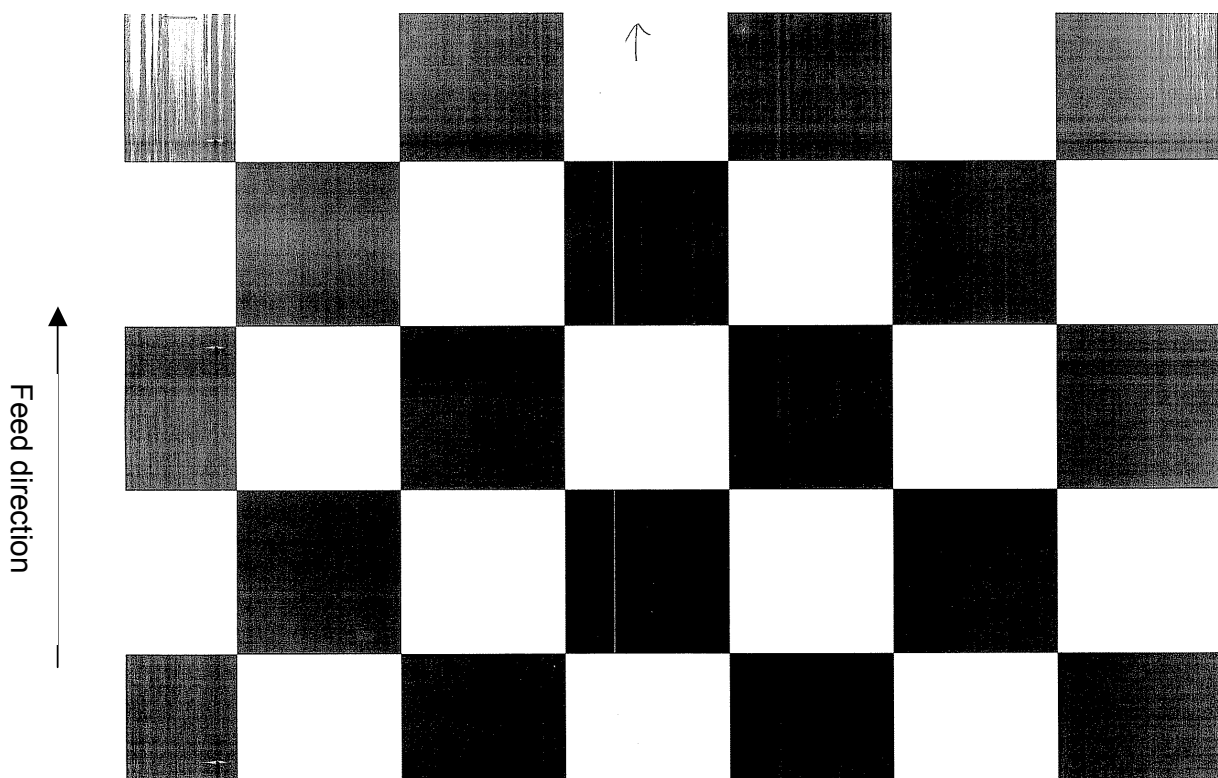
Sample:

- 1) B/W image areas
- 2) Originals with low image coverage ratios and
- 3) Jobs with a low quantity of sets (e.g. 1 or 2P/J)

The lubricant applied to the OPC belt gets inside the black development unit via the development roller, causing the friction level on the roller surface to decrease. This makes it more difficult for the toner to be transferred onto the roller surface, causing the image to gradually get lighter.

Please perform the following update and replacements, which will minimize the chances of symptom occurrence. The modified firmware reduces the amount of lubrication used on the OPC, which in effect minimizes the amount of lubrication that can get inside the development unit and toner cartridge.

- 2) Replace the black development unit.

- 3) Replace the black toner cartridge.

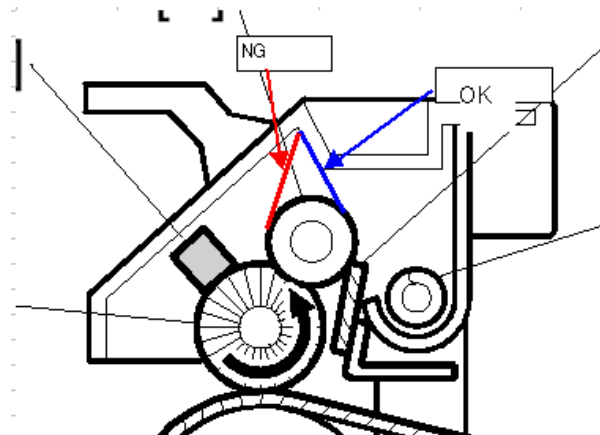
The Mylar next to the cleaning roller in the image transfer belt cleaning unit was placed in the opposite position. Refer to the following illustration. (Incorrect position: red, correct position: blue)

These machines were picked up for the QA sample check after they were produced in the production line. After the QA check, the cleaning unit was cleaned in the line. It is likely that the mylars were moved to the opposite position during cleaning the ITB cleaning unit. If the cleaning roller is rotated by turning the gear incorrectly during the cleaning stage, the mylar is then in the opposite position.

Replace the image transfer belt cleaning unit (G0706300: Belt Cleaning Assembly).

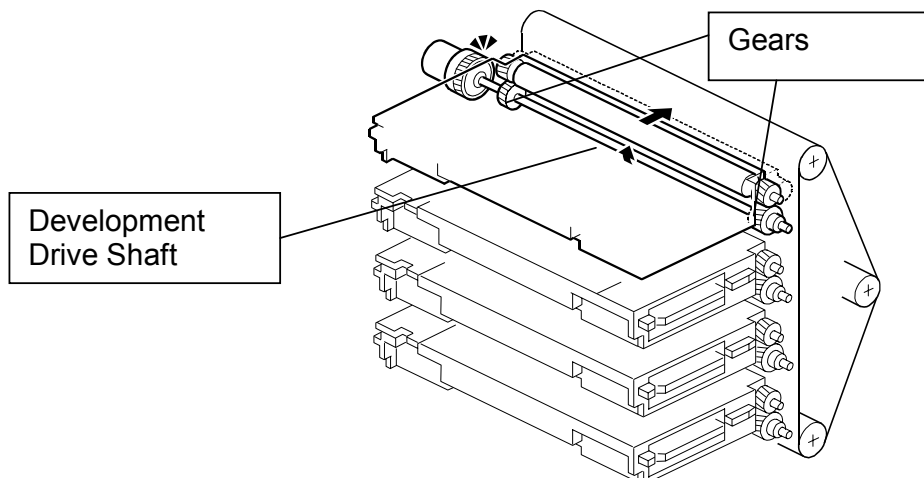
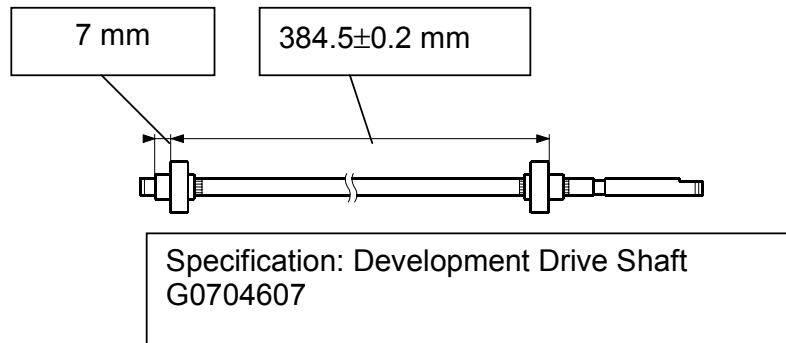
The gear on the development shaft shifts when the development drive is supplied.

The manufacturer reported that they normally perform surface grinding if dirt or other materials or scratches are detected on the shaft. This can cause the diameter to be reduced to below spec minimum.

Replace the development shaft with the spare part (G0704607: Development Shaft - FC).

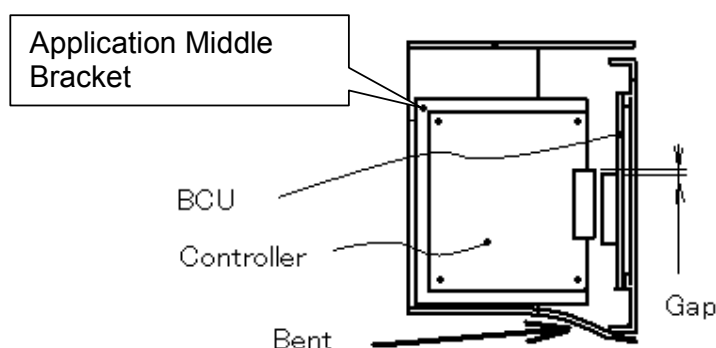
The height of the application middle bracket has been reduced by 0.6 mm to ensure the controller is always attached in the optimal position.

P/N change for this part: G0705523 → G0705520

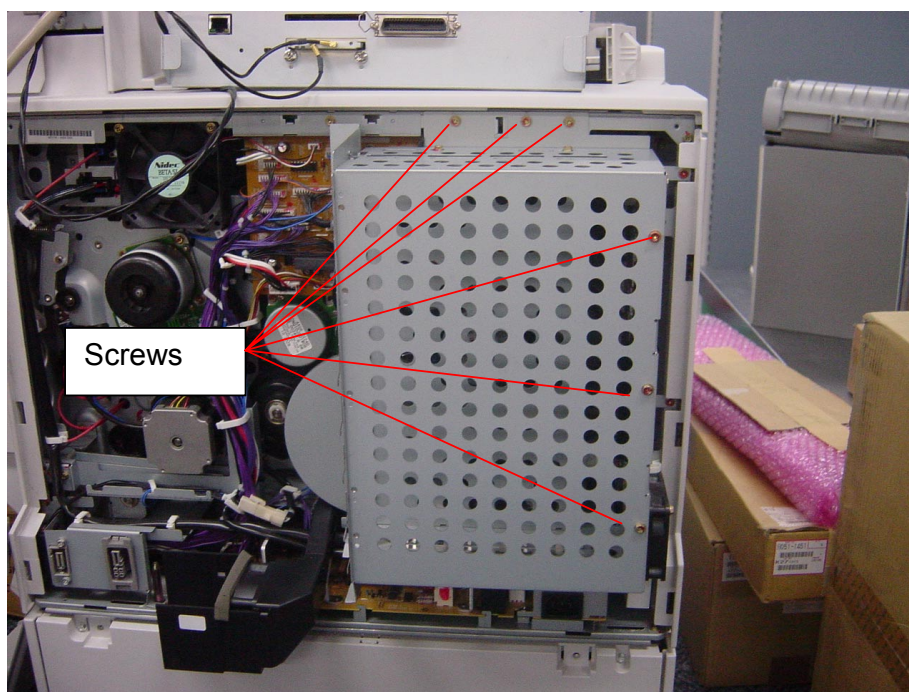
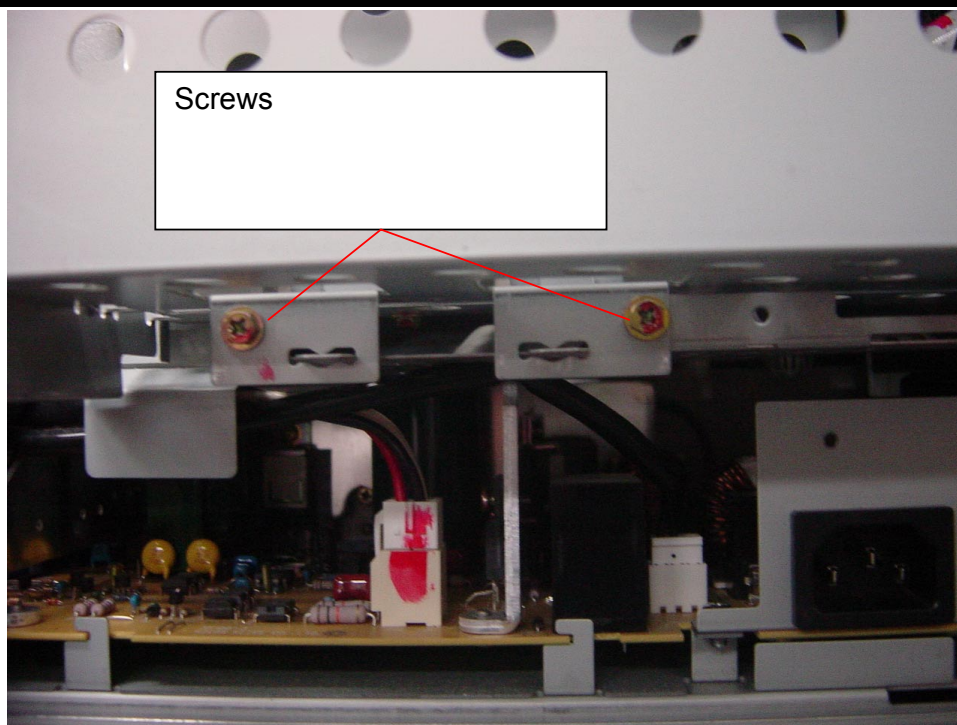
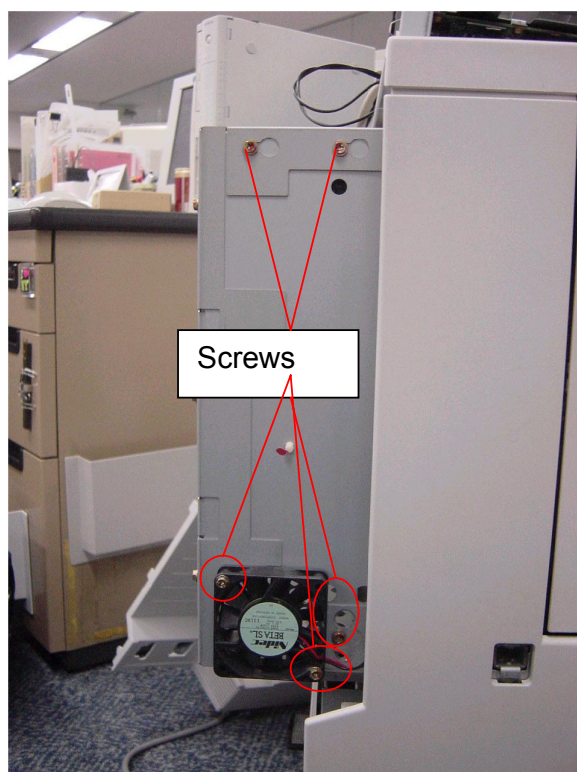
**Point:** The controller box is attached in this lower position to prevent poor connection between the BCU and controller. If the controller box is assembled in the upper position, a poor connection may occur.

If the above symptom occurs, reattach the controller box as shown below to ensure a proper connection between the controller box and BCU board.

1. Turn off the main switch and remove the duct cover, ozone filter, printer controller, and rear cover.
2. Loosen the 13 screws that secure the controller box and cooling fan.

3. While holding the controller box in its lower position, secure the 13 screws.

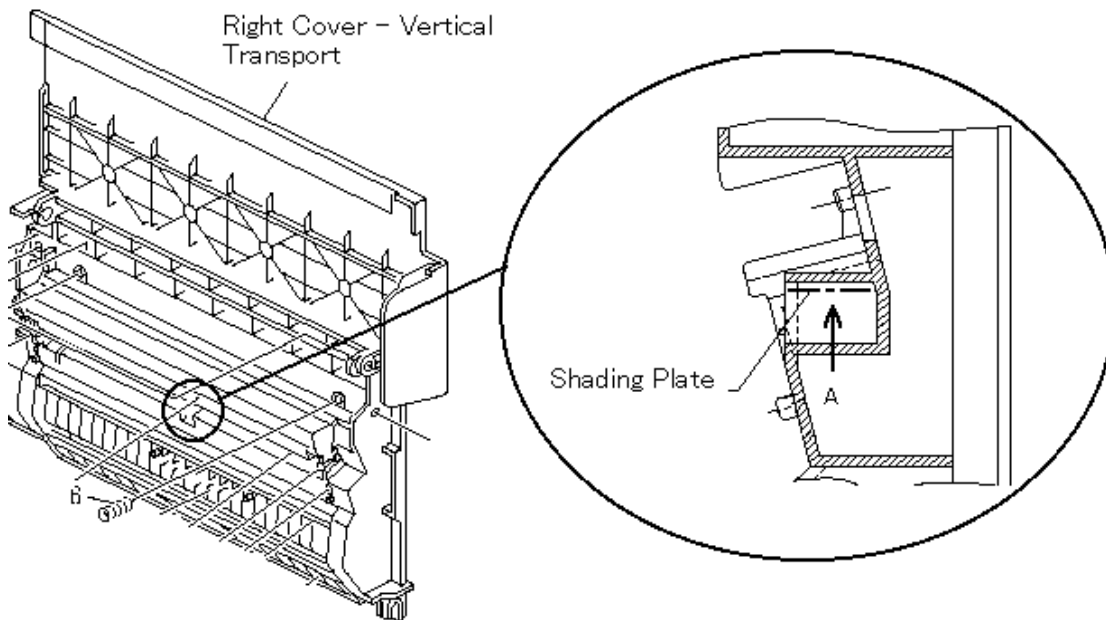
Paper dust in the machine reflects and diffuses light, which causes a registration sensor misdetection and the jam condition.

A black seal (G0702136: Grid Shading Plate) has been added to the right cover from October 2002 production. For the cut-in serial numbers, please refer to MB #MG071022.

Clean the area shown in the illustration, and remove any sheets of paper still left in the registration area.

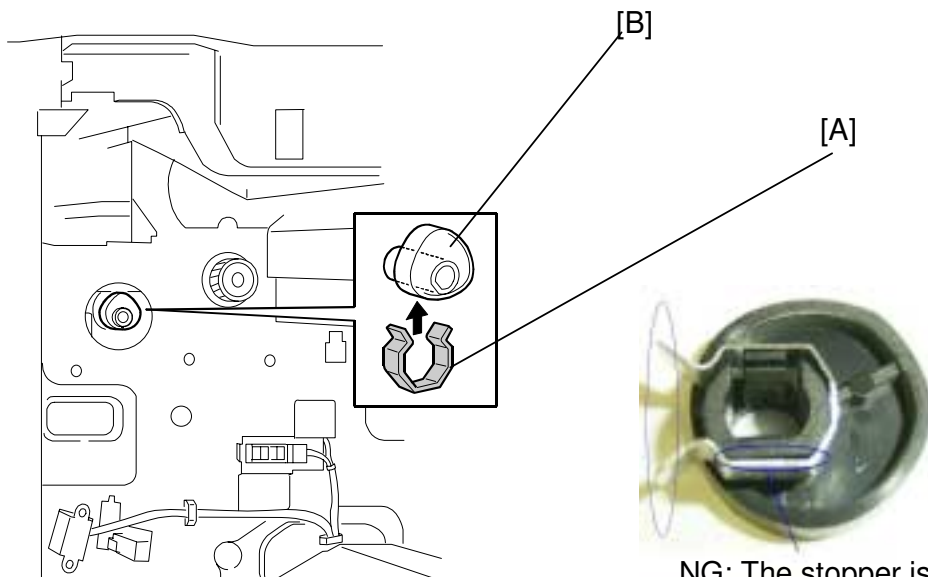
NG: The stopper is sticking out from the cam.

1. Turn off the main switch.
2. Open the front cover.
3. Remove the old PCU.
4. Install the cam stopper [A] on the cam [B] so that the stopper does not stick out from the cam.  
**Note:** The straight edges of the cam stopper and cam are aligned with each other. The cam stopper will snap into position.
5. Install the new PCU.

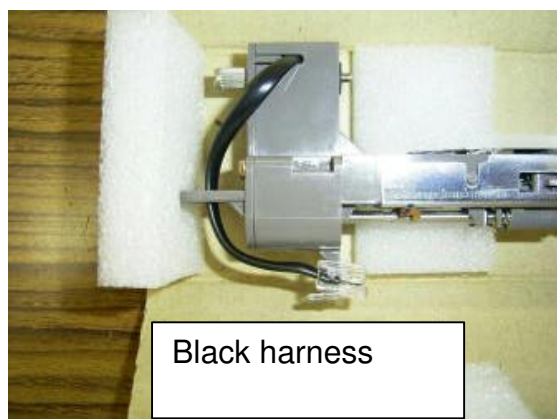
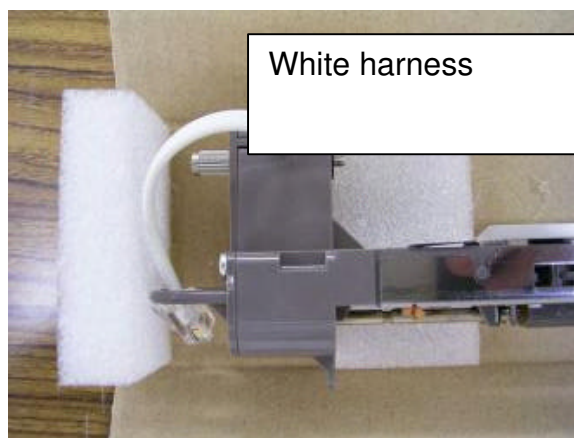
- From May 2006 production, the material of the harness was changed to a more environmentally-friendly type. The new harness is **white** and the material is harder than the black harness.
- The new harness is bent at the factory. This is to make sure that harness does not push the quenching lamp (QL).
- If you straighten the white harness, an error will be displayed ("Reset Charger Correctly").

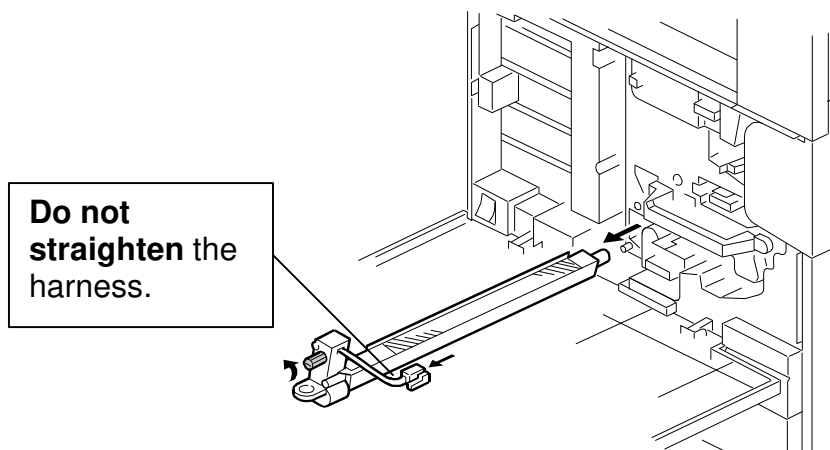
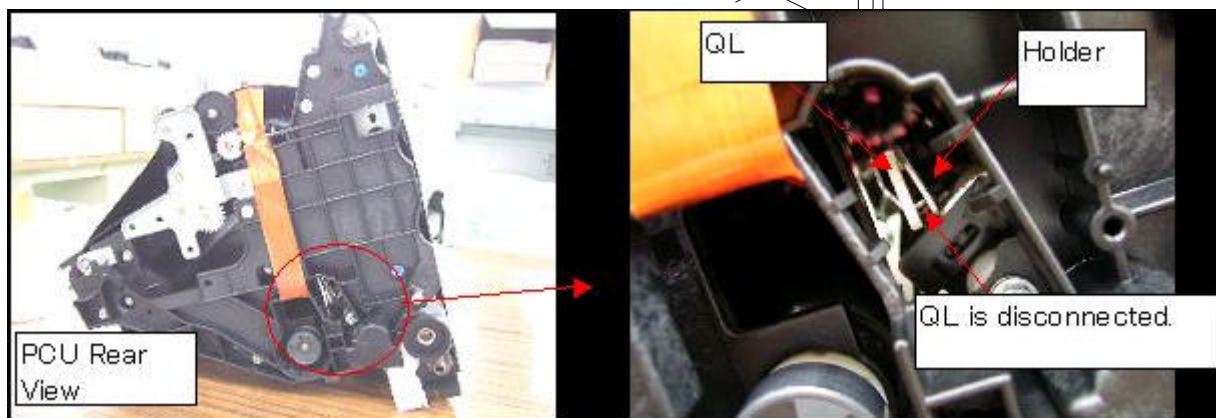
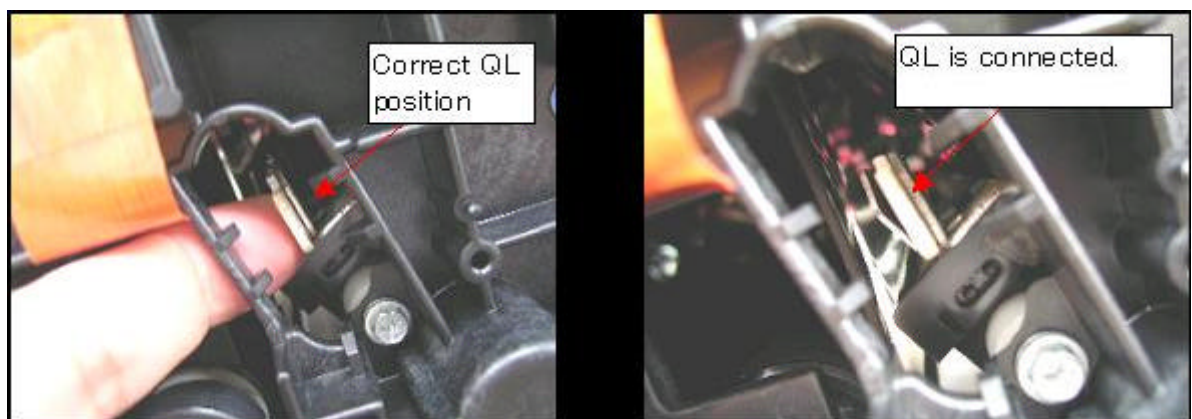
This means the white harness is straight, and is pushing on the QL/holder connection (see the photos on the next page).

**Action:** Correct the QL position and bend the white harness so that it does not push the QL.

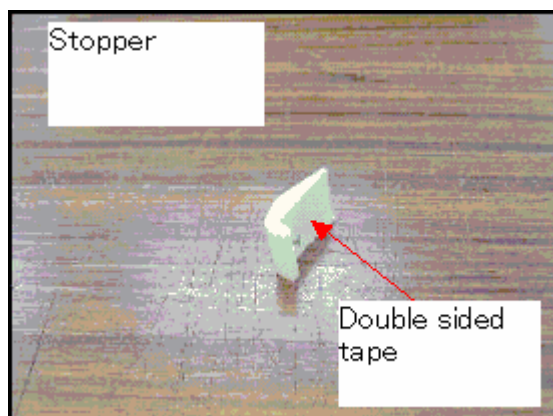
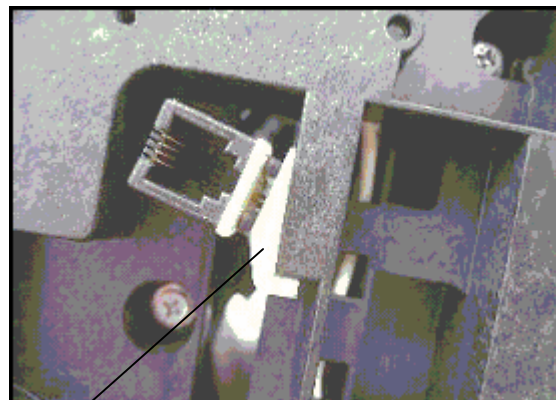
- Temporary: More tape was added to support the QL and its holder (from Aug 06).
- Permanent: Another stopper was added to make sure the QL stays connected to the holder (from the middle of Nov 06).

A stopper was added to the front side of the PCU: The color of the actual stopper is black.
