Model: General RTB	Date: 4-Feb-03	No.: RGene013b
--------------------	----------------	----------------

Subject: Service remarks at installation		Prepared by: T. Itoh	
From: Technical Service Sec. Service Planning Dept.			
Classification:	<input type="checkbox"/> Troubleshooting	<input type="checkbox"/> Part information	<input type="checkbox"/> Action required
	<input type="checkbox"/> Mechanical	<input type="checkbox"/> Electrical	<input type="checkbox"/> Service manual revision
	<input type="checkbox"/> Paper path	<input type="checkbox"/> Transmit/receive	<input type="checkbox"/> Retrofit information
	<input checked="" type="checkbox"/> Other (Specification change)

Model: Model J-P2		Date: 2-Apr-03	No.: RG080001
Subject: Service Manual Revision		Prepared by: H.Taguchi	
From: 1st Tech. Support Sec. Service Support Dept.			
Classification:	<input type="checkbox"/> Troubleshooting <input type="checkbox"/> Mechanical <input type="checkbox"/> Paper path <input type="checkbox"/> Other (      )	<input type="checkbox"/> Part information <input type="checkbox"/> Electrical <input type="checkbox"/> Transmit/receive	<input type="checkbox"/> Action required <input checked="" type="checkbox

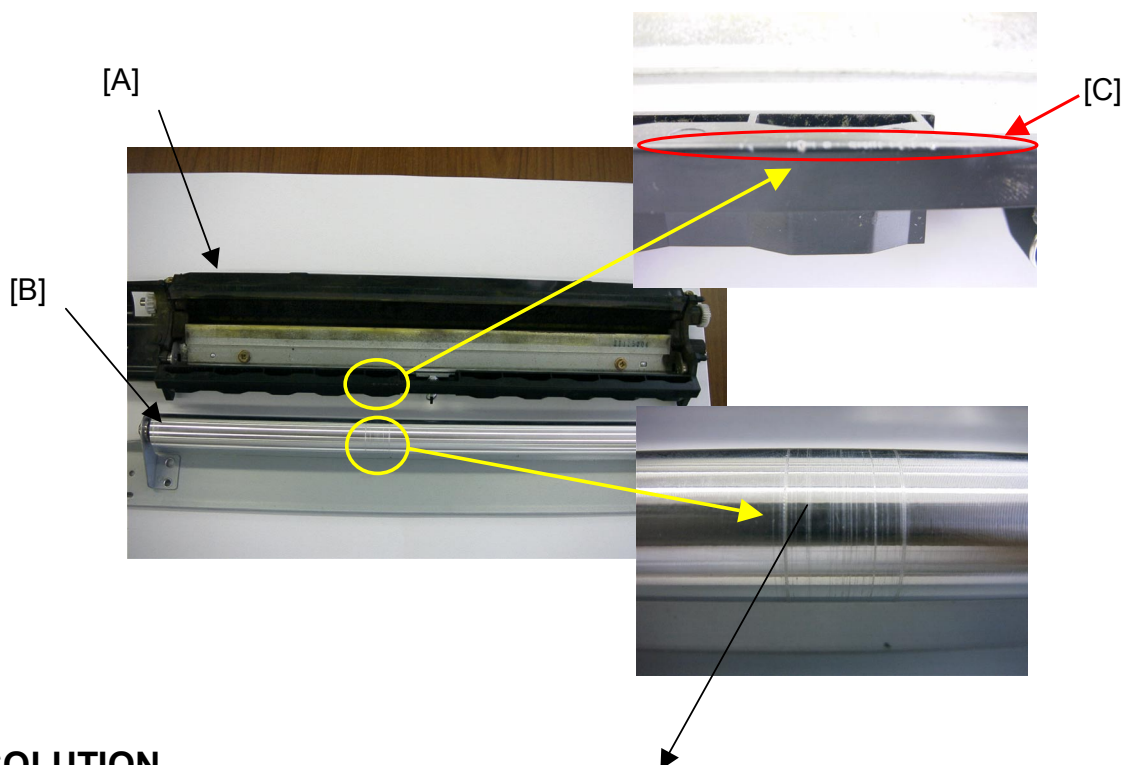
The edge of the cleaning unit [C] bends slightly during operation, causing the gap between it and the left lower driver roller [B] (#G0803945, P/C 41-7) to narrow and the unit to contact the roller.

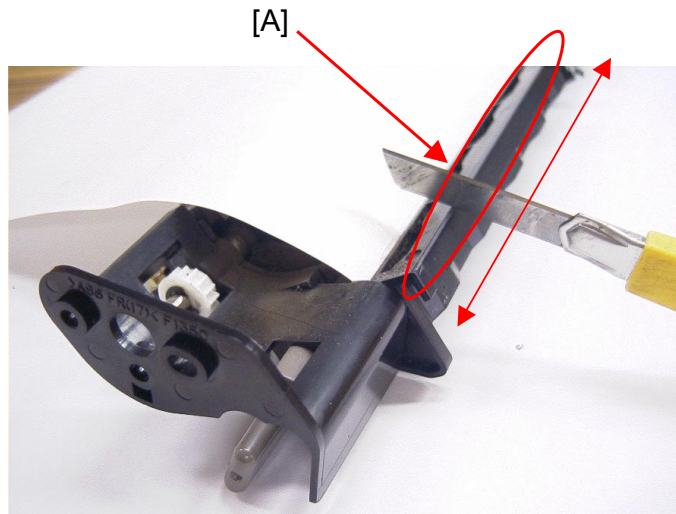
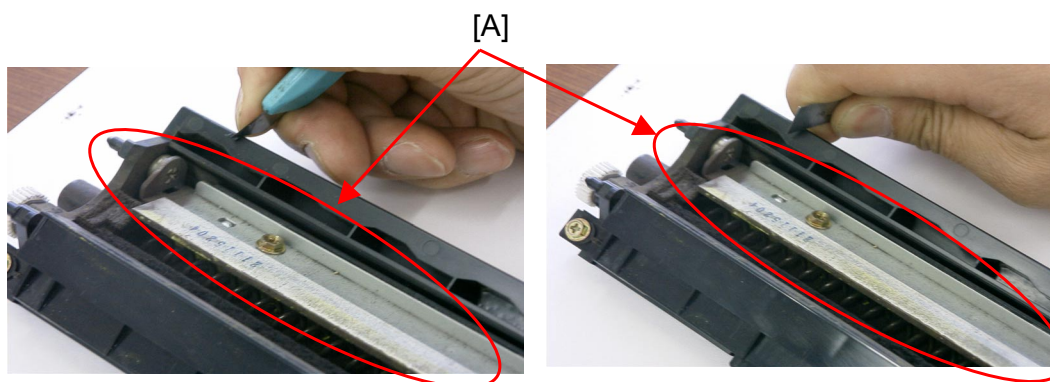
**NOTE:** Make sure to prevent any plastic particles from getting inside the cleaning unit, e.g. by covering the open space [A] with a sheet of paper. If any particles get into the unit, it can cause damage to the cleaning blade, resulting in dirty lines on the rear side of outputs.

**NOTE:** If the rear side of the output already shows the dirty lines, and the roller, cleaning blade or paper transfer belt show scratches, please replace the damaged component(s).

1. Turn off the main switch.
2. Open the front cover and pull out the paper transfer unit (1 screw).
3. Remove the cleaning unit, holding the cleaning blade release lever (1 screw).
4. Place the cleaning unit onto a sheet of paper, as shown below.
5. Using the blunt side of a box cutter or metal ruler, file down the edge [A] of the cleaning unit case, from front to rear, by approximately 1.5 mm (0.06 in.).

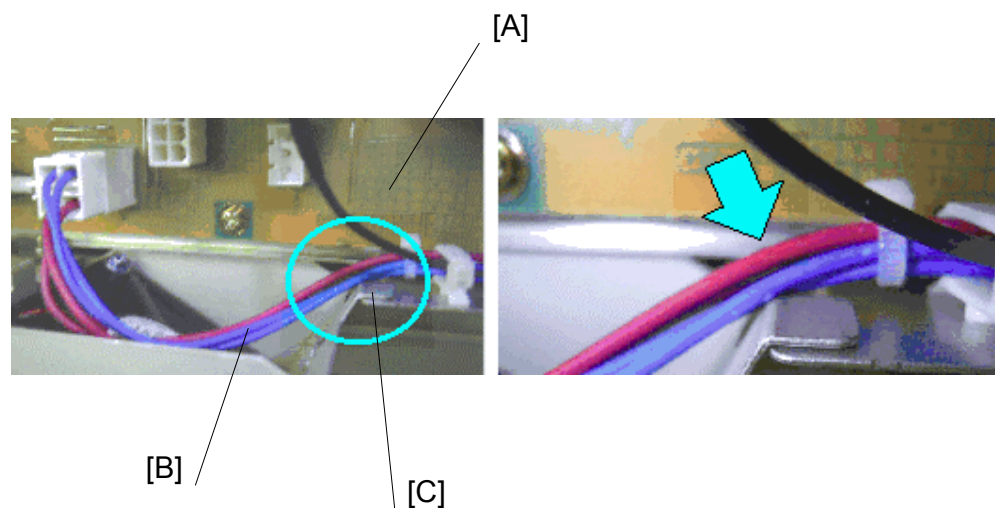
When replacing the above mentioned parts, the harness may be damaged when it comes in contact with the edge of the bracket or PSU bracket.

When replacing the PSU, Harness or Bracket, wrap the area of the harness shown by the arrow in electrical tape to protect it from the bracket edges.

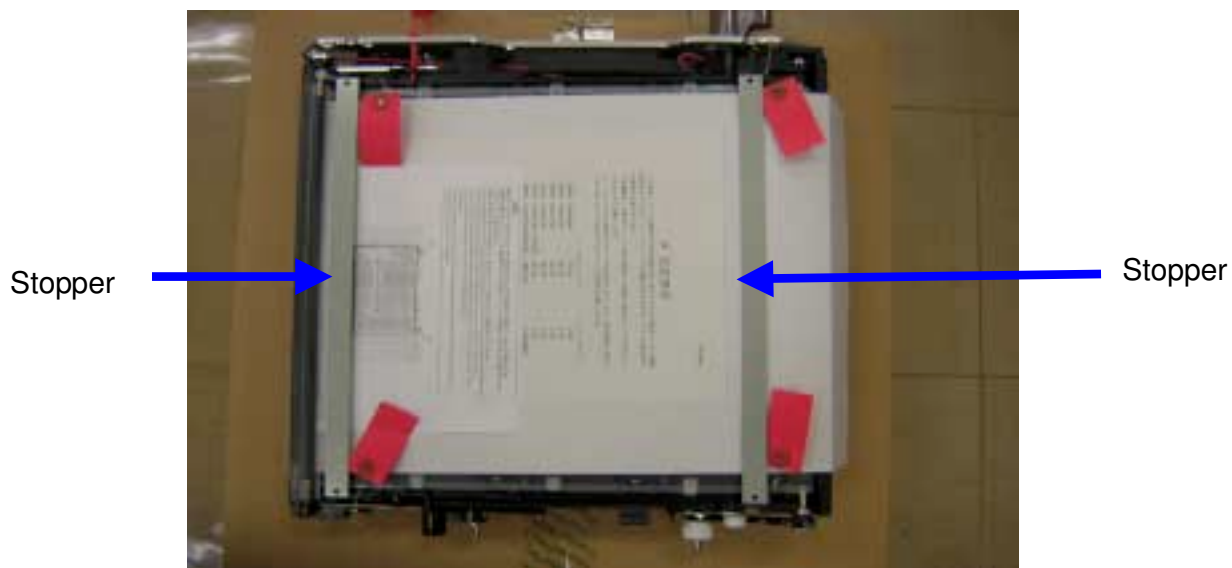
The springs for the transfer unit rollers come loose during transport.

Vibration during transport makes the springs come loose.

When you install the new units (=units with stoppers):

- Remove the two stoppers before you install the new transfer unit.
  - Remove the wires at the four ends of the stoppers
  - Remove the four red tags
