Model: Model J-P3		Date: 14-May-04	No.: RG106001
Subject: The menu key cannot be used		Prepared by: H.Taguchi	
From: 1st Tech. Support Sec. Service Support Dept.			
Classification:	<input checked="" type="checkbox"/> Troubleshooting	<input type="checkbox"/> Part information	<input type="checkbox"/> Action required
	<input type="checkbox"/> Mechanical	<input type="checkbox"/> Electrical	<input type="checkbox"/> Service manual revision
	<input type="checkbox"/> Paper path	<input type="checkbox"/> Transmit/receive	<input type="checkbox"/> Retrofit information
	<input type="checkbox"/> Other (        )

Model: Model J-P3		Date: 14-May-04	No.: RG106002
Subject: Fusing Control		Prepared by: H.Taguchi	
From: 1st Tech. Support Sec. Service Support Dept.			
Classification:	<input checked="" type="checkbox"/> Troubleshooting <input type="checkbox"/> Part information <input type="checkbox"/> Action required <input type="checkbox"/> Mechanical <input type="checkbox"/> Electrical <input type="checkbox"/> Service manual revision <input type="checkbox"/> Paper path <input type="checkbox"/> Transmit/receive <input type="checkbox"/> Retrofit information <input type="checkbox"/> Other (      )

Mode

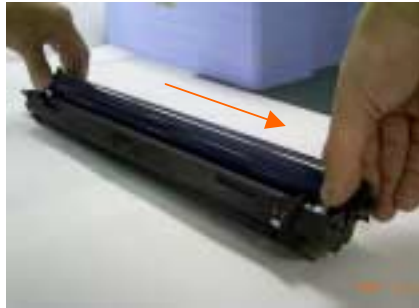
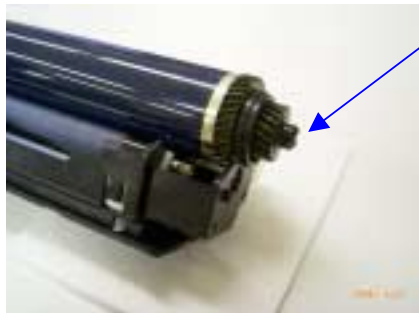
3. Hold the drum at both ends as shown, then slide it in the direction of the arrow until the outer gear has cleared the PCU frame (see the next photo).

Slide the drum until this outer gear clears the PCU frame, as shown.

Replace the PCU or clean the surface of the charge roller according to the following cleaning procedure.

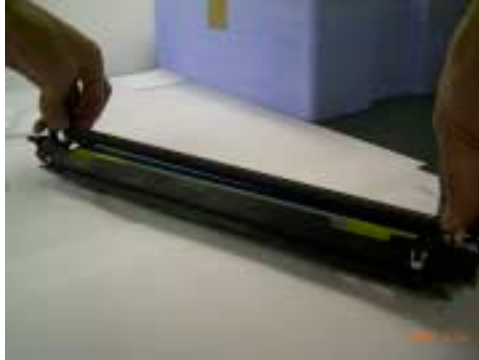
7. Remove the charge roller from the frame along with plastic components B, C, and D shown below, being sure to touch only the tape-covered rubber edges of the roller (see the photo in Step 9 below).

**Note:** Do not touch the cleaning blade or exposed rubber surfaces of the charge roller.

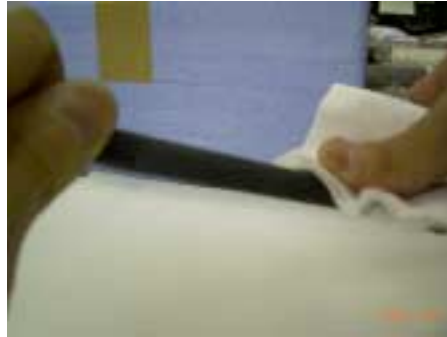
10. Clean the charge roller surface with a new cloth while holding the roller by its metallic edges.

11. Clean the charger roller with alcohol.

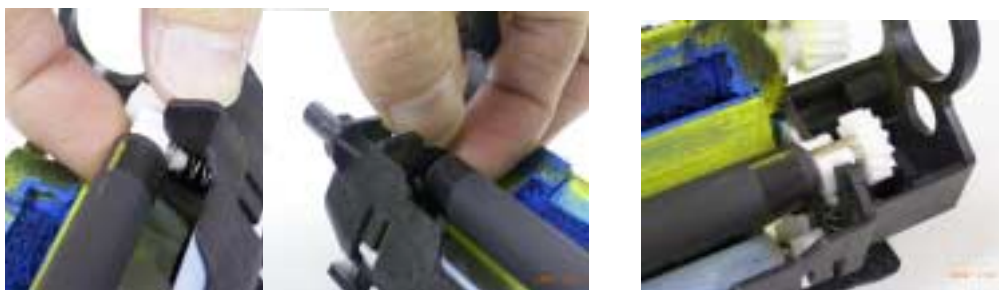
**Note:** Before proceeding to the next step:

- Make sure to attach the charge roller as shown below, i.e. parts B and D should both fit into their respective guide ribs on the unit frame.
- Make sure that: 1) the spring is properly aligned (straight; not bent), 2) the gears on both sides are attached properly to the shaft, and 3) the charge roller cleaner is properly secured in its bushings at both ends.

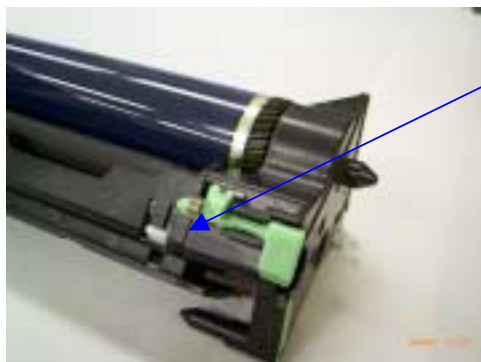
- When reattaching the front cover, make sure there is no gap between the cover and frame.

Make sure there is no gap between the cover and frame.

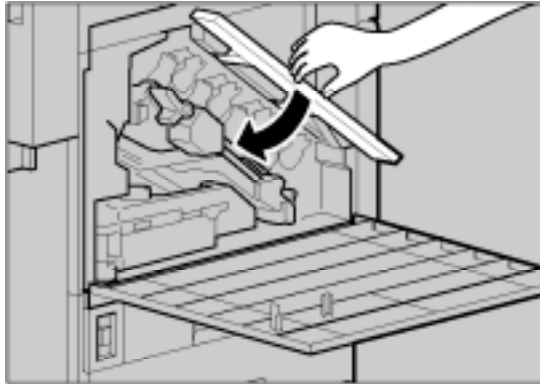
The drum plate bends slightly and the development unit gear cannot join with the mainframe gear.

2. Loosen the two screws on the drum plate.
3. Open the drum plate until you hear a click.

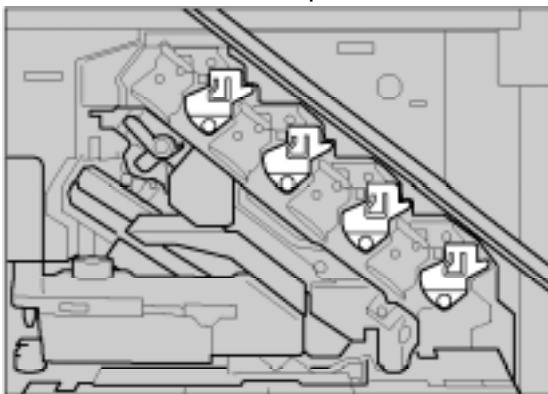
4. Push in the four development units all the way to the rear.

**Important:** Make sure to push the unit all the way to the rear.

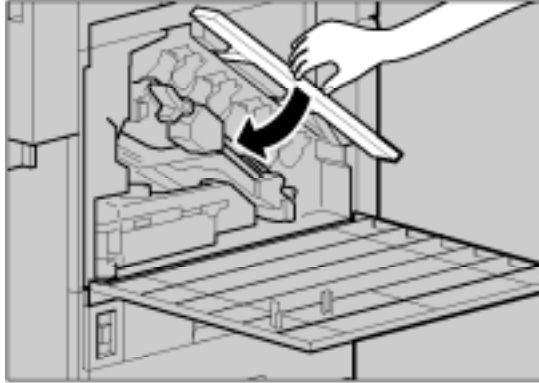
5. Close the drum plate.
6. Tighten the upper-left screw for the drum plate.
7. Tighten the lower-right screw for the drum plate.

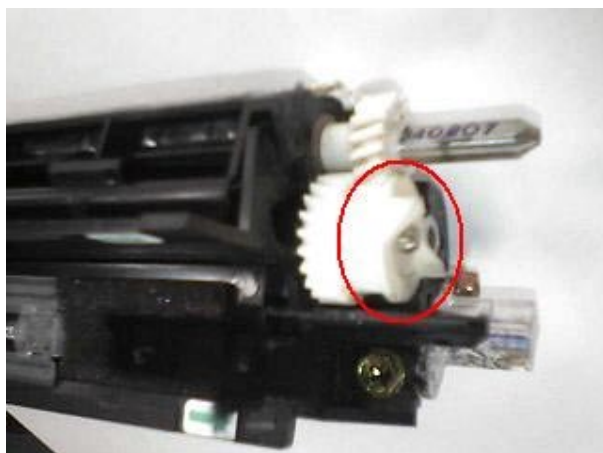
- 1) When you install the development unit:  
Make sure to push it all the way inside the machine so that the **mainframe gear engages with the development unit gear**.
- 2) If the symptom is reported:  
Replace the Gear:Joint:Drive:Z18 with **AB014277**.
