Technical Bulletin

Model: Model J-I	P4		Dat	e: 27-Jul-0	5	No.: RG131001
Subject: Firmwar	re Release History (NIB)			Prepared	l by: H. S	Someya
From: 1st Tech. §	Support Sec. Service Support I	Dept.				
Classification:	Troubleshooting	Part info	orma	tion	Action	required
	Mechanical	Electric	al		Servic	e manual revision
	Paper path	🗌 Transm	it/rec	eive	Retrof	fit information
	Other ()

This RTB has been issued to announce the firmware release information for the NIB.

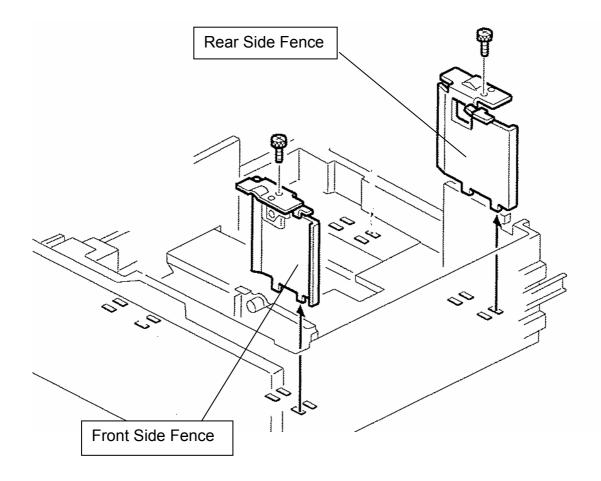
CAUSE

1. Replace the front side fence with **B1809902** (production line temporary solution).

Or,

2. Replace the front side fence and rear side fence with **B6002645** and **B6002655**.

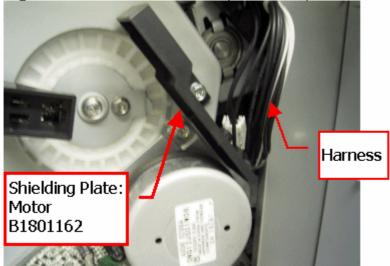
Fig. 1: The old BK drum motor (AX060288) is installed.

- Only use **M3x6** screws to attach the cover. If you use any other screws, they will touch the drum gear.
- When you attach the BK drum motor (AX060340) for the first time, remove the shielding plate (B1801162) that is already attached.
 Note: The shielding plate is not listed in the Parts Catalog (due to an error).
