Model: Model P-G2W		Date: 6-Jan-06	No.: RJ006001
Subject: Special Tool for paper curl problem		Prepared by: Y. Ohtani	
From: 1st Tech. Support Sec. Service Support Dept.			
Classification:	<input checked="" type="checkbox"/> Troubleshooting <input type="checkbox"/> Mechanical <input type="checkbox"/> Paper path <input type="checkbox"/> Other ()	<input type="checkbox"/> Part information <input type="checkbox"/> Electrical <input type="checkbox"/> Transmit/receive	<input type="checkbox"/> Action required <input type="checkbox"/> Service manual revision <input type="checkbox"/> Retrofit information

Model: Model P-G2W		Date: 6-Jan-06	No.: RJ006002
Subject: Special Tool for double feed problem (Envelope)		Prepared by: Y. Ohtani	
From: 1st Tech. Support Sec. Service Support Dept.			
Classification:	<input checked="" type="checkbox"/> Troubleshooting <input type="checkbox"/> Mechanical <input type="checkbox"/> Paper path <input type="checkbox"/> Other ()	<input type="checkbox"/> Part information <input type="checkbox"/> Electrical <input type="checkbox"/> Transmit/receive	<input type="checkbox"/> Action required <input type="checkbox"/> Service manual revision <input type="checkbox"/> Re

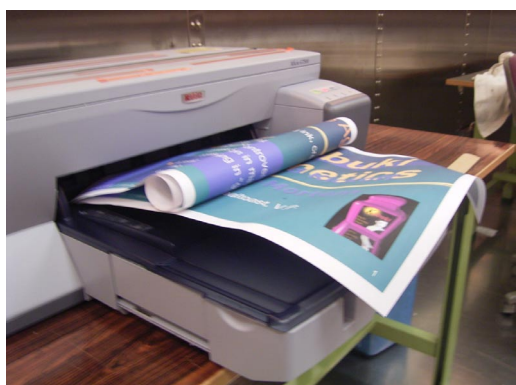
When printing out a job consisting almost entirely of solid image areas onto A3 sheets, this can cause paper curl and the paper is not stacked properly.

Fig.2: Abnormal condition (Paper curl)

When a large amount of ink is used on the paper, the paper has a tendency to curl along the direction of the paper fibers.

This has a greater tendency to occur under low-temperature, low-humidity conditions.

A special tool will be prepared which customers can use to improve the paper stacking. To get good paper stacking, it is important to minimize the height difference between the paper exit position and the exit tray.

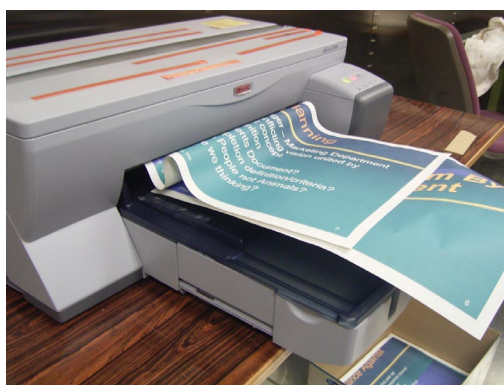
Fig.3: Abnormal condition (Paper jam)

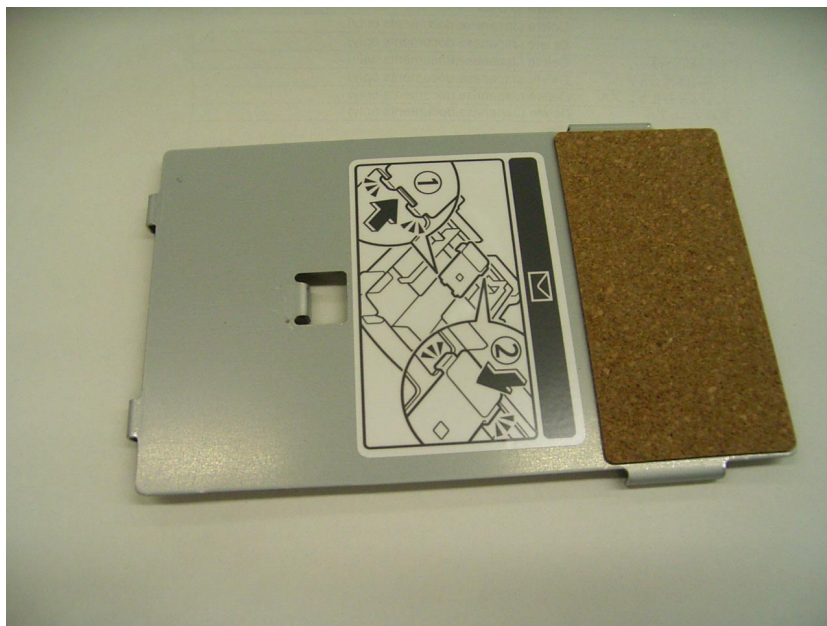
The last two envelopes loaded in the paper tray are sometimes fed together.

Sometimes, the friction with the bottom plate is not enough to keep the envelopes separated when being fed.

A special tool will be prepared which customers can use to improve envelope feeding under these conditions.

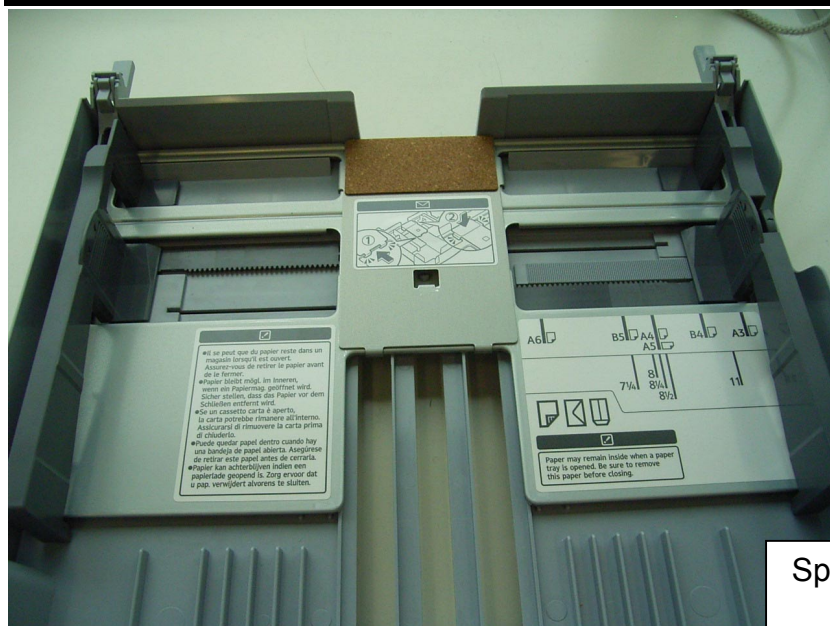
Special tool attached to the machine

We will prepare this countermeasure part. If a customer has the above situation, please arrange to send it.

P/N	Description
J006 9952	Bracket - Envelope
